AIRPROX REPORT No 2024256

Date: 04 Oct 2024 Time: 1227Z Position: 5127N 00015E Location: QE2 Bridge, London

PART A: SUMMARY OF INFORMATION REPORTED TO UKAB

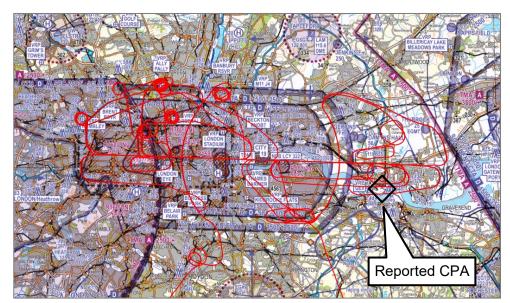
Figure 1: Pilot provided image of the PA31 flightpath for the entirety of its task. Reported CPA (marked): 1226:30

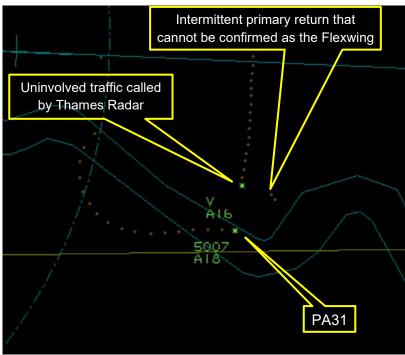
Figure 2: At reported CPA – 1226:30. Southbound aircraft was a Pipistrel 164. 2 unattributed returns to the northeast of the PA31 that could not be positively confirmed as the Flexwing.

The PA31 was tracked at all stages via NATS radar. Unfortunately, despite significant effort, the Flexwing pilot could not be traced. The comprehensive description of the event received from the PA31 pilot when tied to the radar images at Figures 2 and 3 suggests that the primary contact was the other aircraft involved in the Airprox.

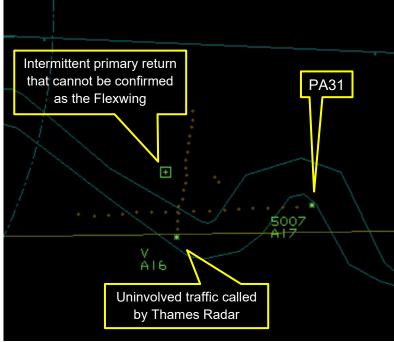
Figure 3: At 1227:08 – a potential continuation of the 'unidentified primary contact'. That return subsequently tracked towards the northeast and disappeared 16sec later just after having crossed the southbound uninvolved aircraft's track.
