**AIRPROX REPORT No 2024258**

Date: 11 Oct 2024 Time: 1400Z Position: 5224N 00004E Location: ivo Sutton Meadows

**PART A: SUMMARY OF INFORMATION REPORTED TO UKAB**

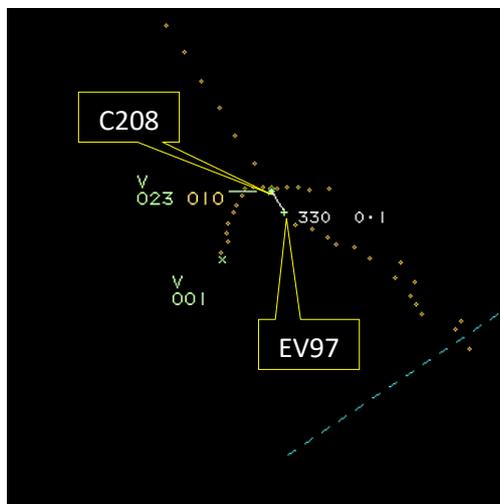
An analysis of the radar replay was undertaken and the C208 was positively identified using Mode S data. The EV97 was showing as a primary track only and matched the EV97 pilot's reported position and actions. At 1400:06 the aircraft were seen to be 0.1NM apart with the altitude of the EV97 not recorded (Figure 1), after which there were 2 radar sweeps where the EV97 disappeared from the radar replay.

Figure 1 -Time 1400:06 lateral separation 0.1NM

The EV97 reappeared on the radar replay at 1400:18, diverging from the C208 with 0.7NM separation. CPA was assessed by interpolation as occurring at 1400:08 with a lateral separation of less than 0.1NM and vertical separation unknown.
