AIRPROX REPORT No 2024259

Date: 13 Oct 2024 Time: 1152Z Position: 5058N 00057W Location: 2NM SW of Petersfield

PART A: SUMMARY OF INFORMATION REPORTED TO UKAB

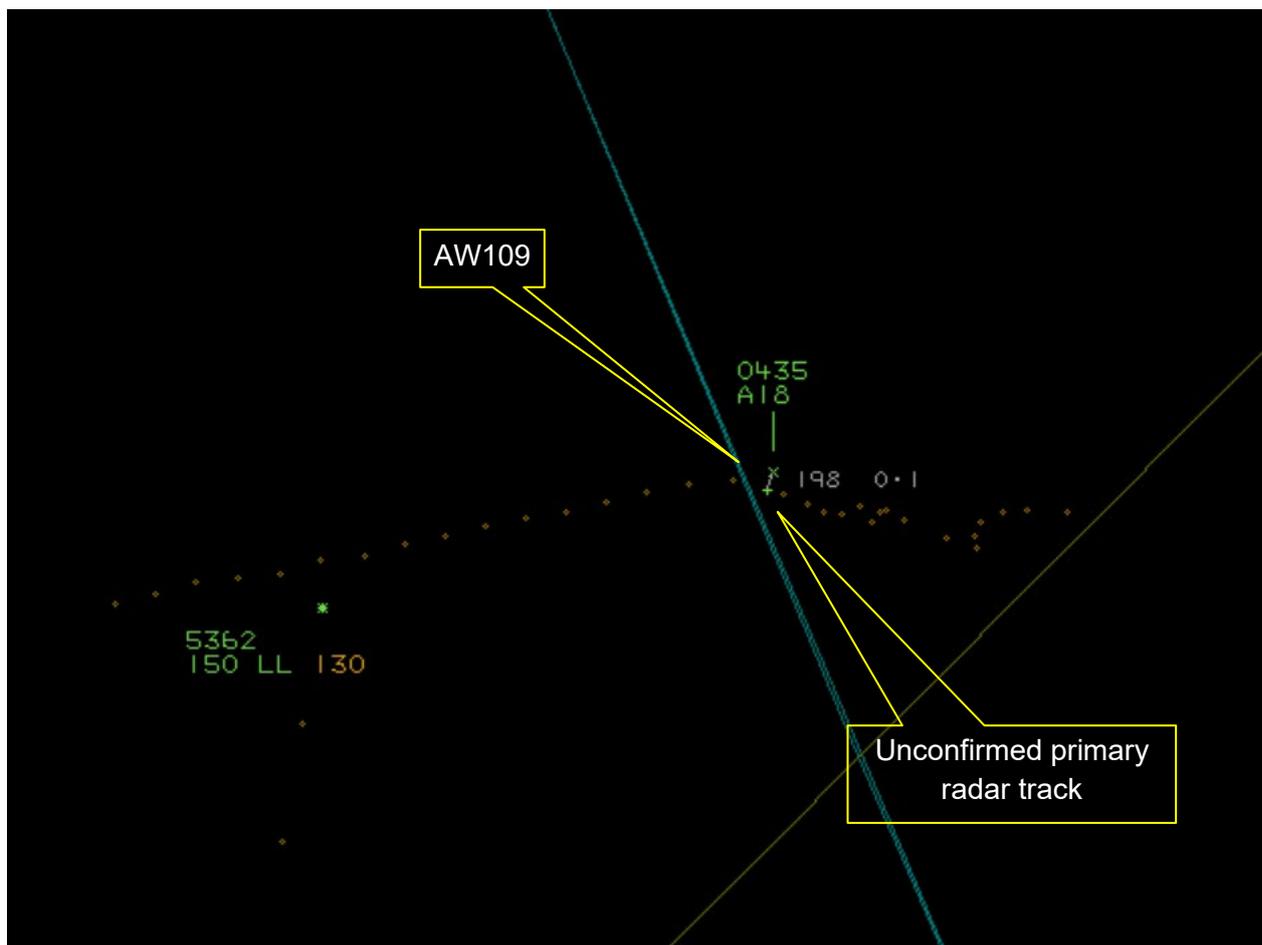
Figure 1: At CPA 1152:02 – NK V/0.1NM H

reduced Traffic Service. At the time of the reported event, the LARS West radar display showed no aircraft in this relative position to the AW109.

The radar screenshot at Figure 1 shows the constant bearing and altitude track of the AW109.
