**AIRPROX REPORT No 2024260**

Date: 11 Oct 2024 Time: 1634Z Position: 5320N 00137W Location: 4.5NM ENE Camphill

**PART A: SUMMARY OF INFORMATION REPORTED TO UKAB**

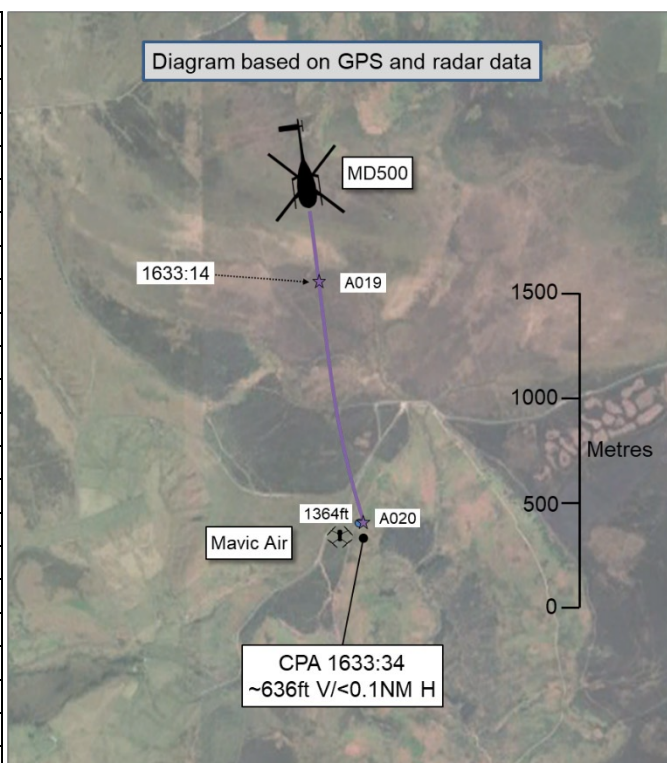
Recorded	Aircraft 1	Aircraft 2
Aircraft	Mavic Air	MD500
Operator	Civ UAS	Civ Helo
Airspace	London FIR	London FIR
Class	G	G
Rules	VLOS (Specific Cat.)	VFR
Service	None	Listening Out
Provider	N/A	Leeds Bradford
Altitude/FL	1364ft	A020
Transponder	Not fitted	A, C, S
<b>Reported</b>		
Colours	White	Orange
Lighting	White, red	Position, anti-col
Conditions	VMC	VMC
Visibility	>10km	>10km
Altitude/FL	6m	NK
Altimeter	NK	QNH
Heading	"NW"	"south"
Speed	0kt	110kt
ACAS/TAS	Not fitted	TAS
Alert	N/A	None
<b>Separation at CPA</b>		
Reported	240ft V/0NM H	"not seen"
Recorded	~636ft V/<0.1NM H

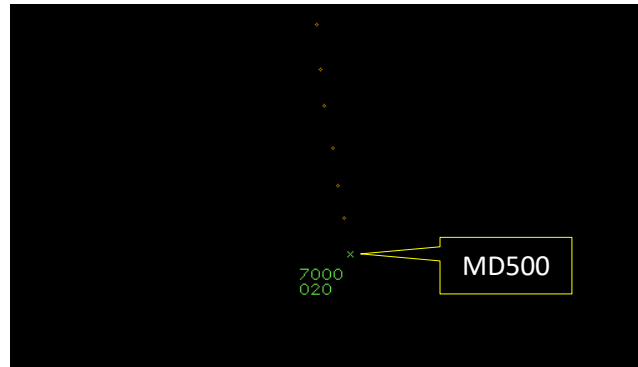
Figure 1 – CPA at 1633:34

An analysis of the NATS radar replay was undertaken and the MD500 could be positively identified from Mode S data (Figure 1). The MD500 was depicted on the replay as flying at a Flight Level. A suitable correction was applied to determine its altitude.

The Mavic Air was not observed on the replay, however, the pilot of the Mavic Air kindly supplied GPS track data for their flight. At the moment of CPA, the elevation of the terrain at the position of the Mavic Air was 1349ft and its altitude was recorded as 1364ft. It was by combining the various data sources that the diagram was constructed and the separation at CPA determined.

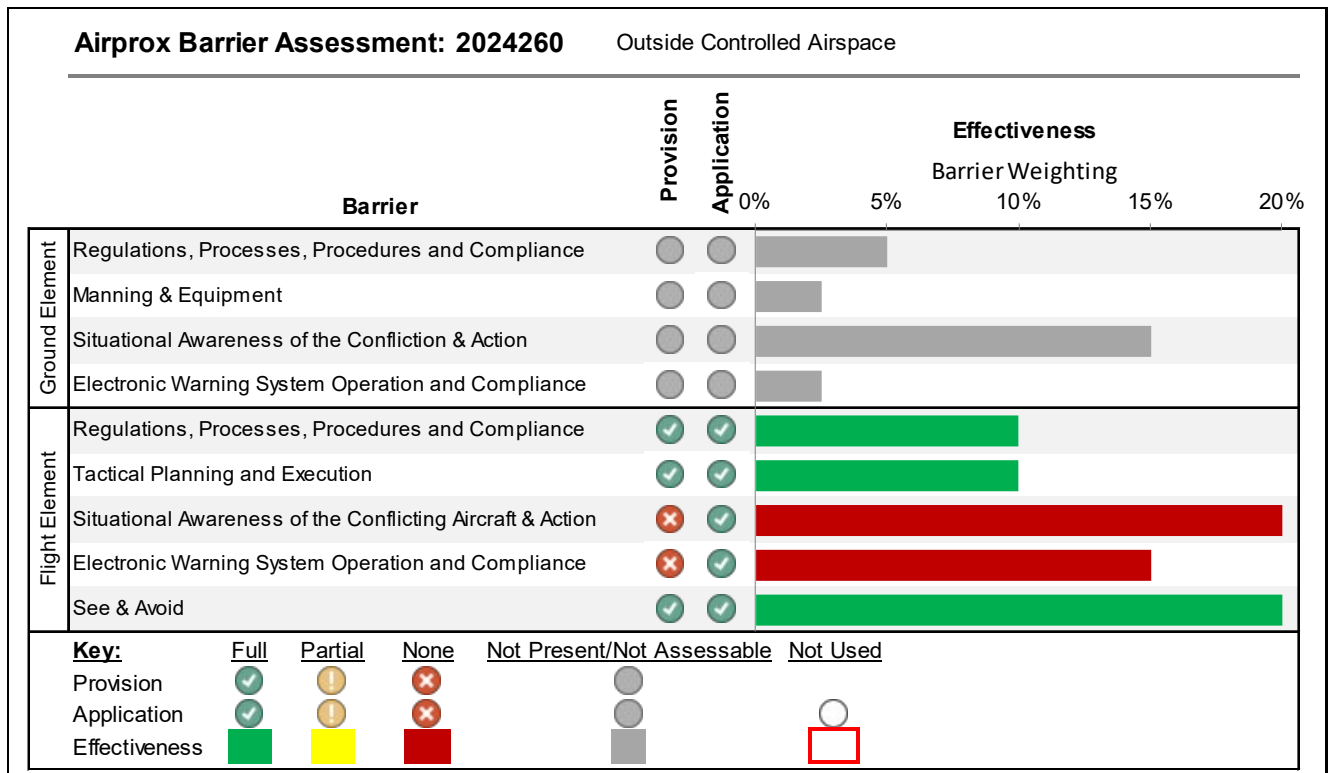
**Situational Awareness of the Conflicting Aircraft and Action** were assessed as **ineffective** because the pilot of the MD500 had not had situational awareness of the presence of the Mavic Air.

**Electronic Warning System Operation and Compliance** were assessed as **ineffective** because the TAS fitted to the MD500 would not have been expected to have detected the presence of the Mavic Air.
