AIRPROX REPORT No 2024261

Date: 13 Oct 2024 Time: 0958Z Position: 5157N 00135W Location: 1.5NM NW Chipping Norton

PART A: SUMMARY OF INFORMATION REPORTED TO UKAB

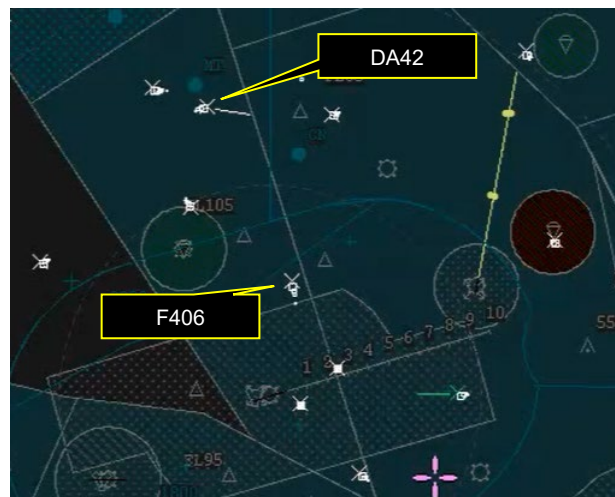
Figure 1 0955:50 F406 pilot requested to change to Birmingham Radar.

At 0955:50, the F406 pilot requested to change frequency from Brize Norton Zone to Birmingham Radar. The Brize Norton Zone controller acknowledged the request, providing the F406 pilot with their position before terminating the radar service and instructing them to change to their enroute frequency (Figure 1).

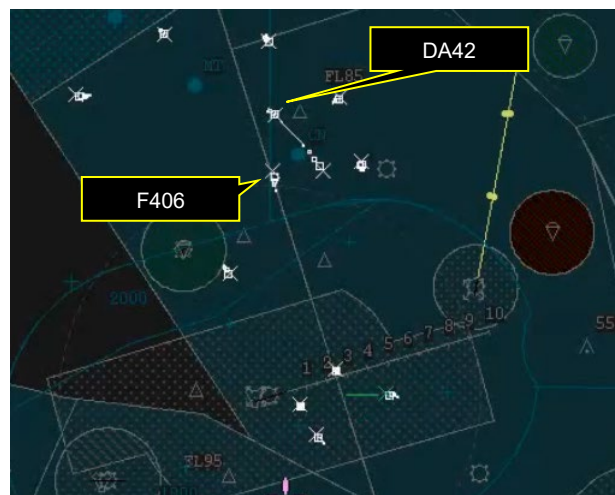
Figure 2 0957:34. The DA42 commenced a turn.
(Separation: 3NM and 200ft)

At 0957:34, the DA42 commenced a right-hand turn, deviating from their previous eastbound profile (Figure 2). CPA occurred at 0958:06 and was recorded as 0.2NM and 300ft separation.

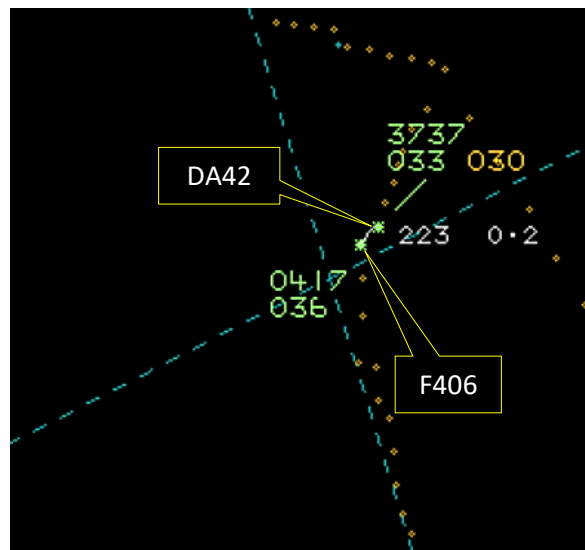
An analysis of the NATS radar replay was undertaken and both aircraft were positively identified using Mode S data. CPA was assessed to have been at 0958:06 with a lateral separation of 0.2NM and a vertical separation of 300ft (Figure 3).

Figure 3 Time 0958:06: CPA with 0.2NM and 300ft separation.
