**AIRPROX REPORT No 2024265**

Date: 17 Oct 2024 Time: 1526Z Position: 5416N 00146W Location: IVO East Witton

**PART A: SUMMARY OF INFORMATION REPORTED TO UKAB**

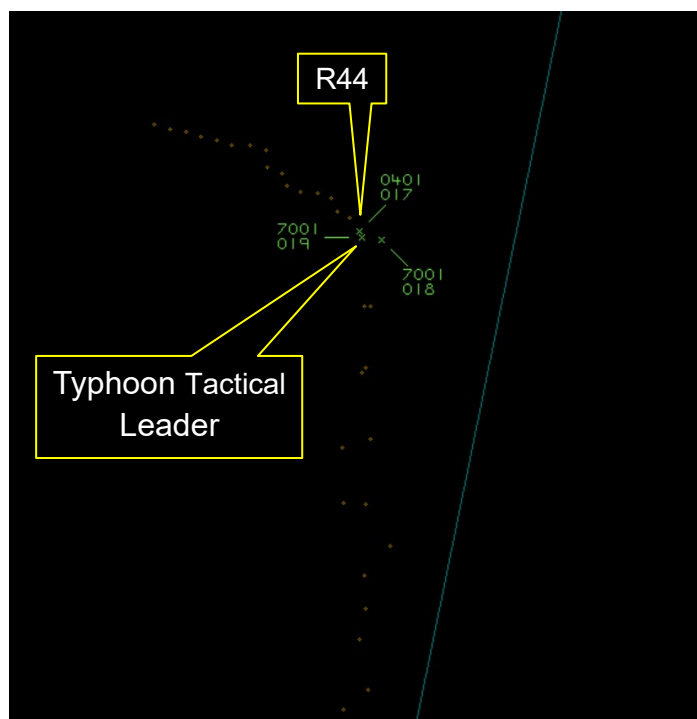
Figure 1: CPA 1526:22 200ft V/<0.1NM H
