AIRPROX REPORT No 2024269

Date: 05 Oct 2024 Time: 1111Z Position: 5206N 00021W Location: 14NM north of Luton Airport

PART A: SUMMARY OF INFORMATION REPORTED TO UKAB

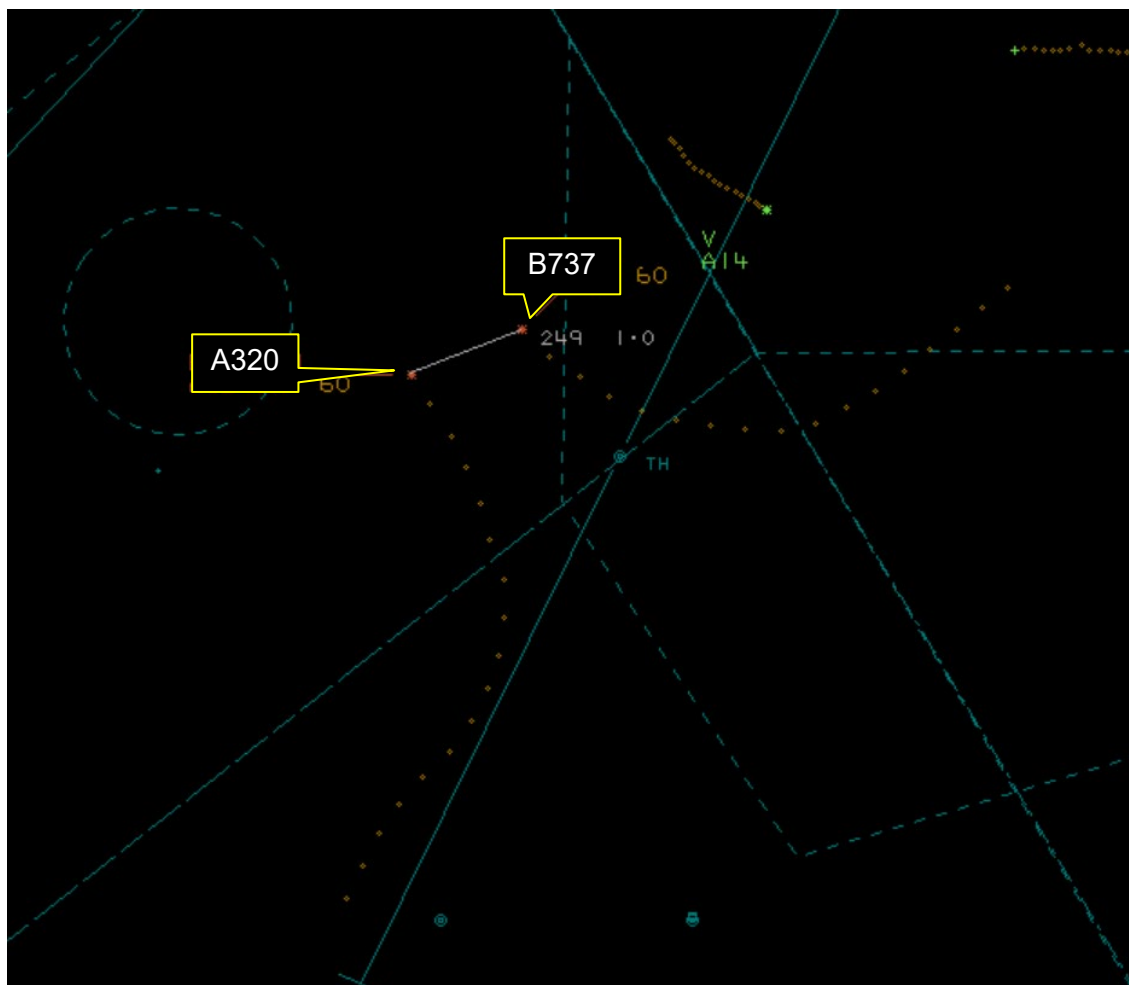
At 1111:12, the GW INT controller passed updated Traffic Information to the pilot of the B737 and four seconds later the pilot had responded, *“we have the traffic”*. Minimum separation occurred at 1111:18 and was recorded on the Multi-Track system as 1.0NM and 100ft where 3.0NM or 1000ft were required. The TC NW controller had issued climb to FL80 to the pilot of the A320 at 1111:23 and a subsequent further left turn onto a heading of 230° to reposition for left hand downwind. Lateral separation was restored at 1111:54 as the pilot of the A320 had read back the turn instruction.

Figure 1: at CPA 111:18 1.0NM H/100ft V

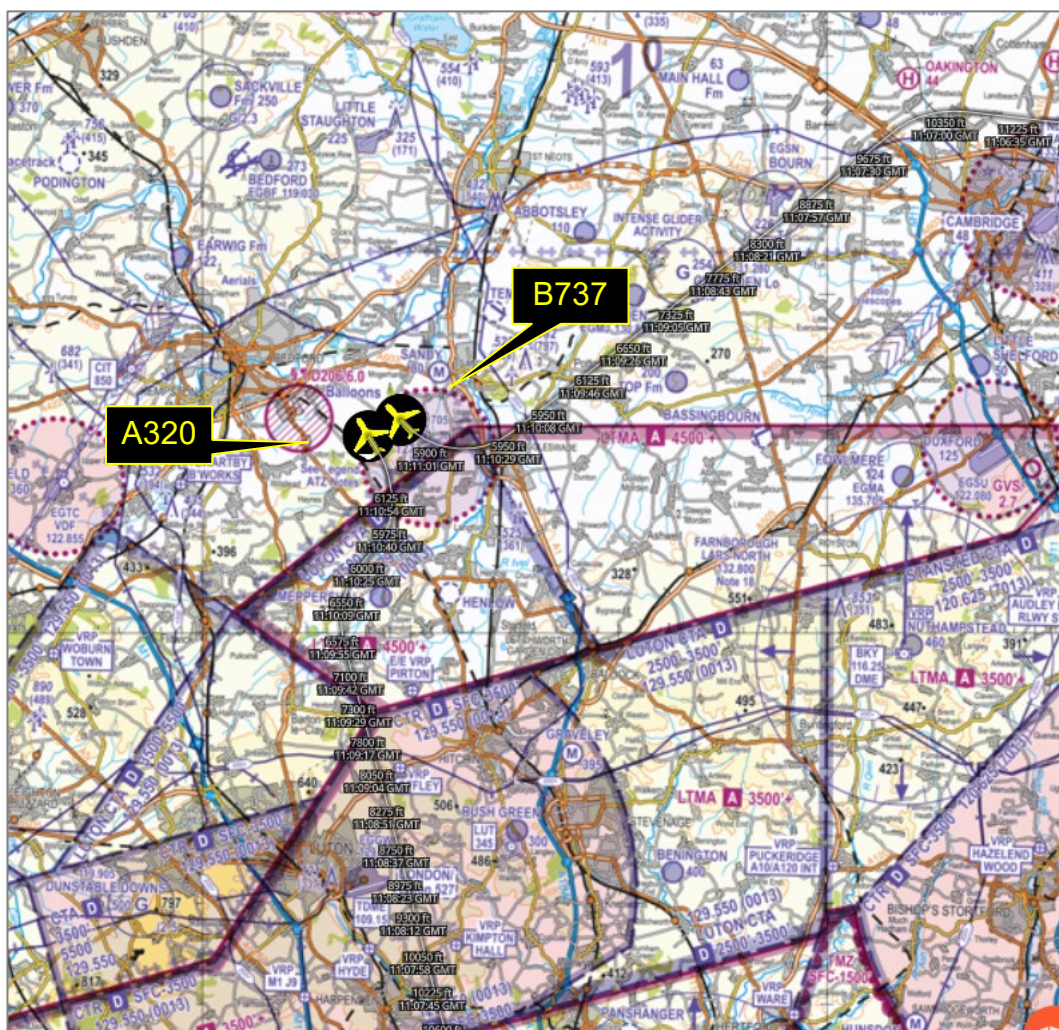
Figure 2: Airspace Analyser extract taken at CPA 1111:18
