AIRPROX REPORT No 2024274

Date: 12 Nov 2024 Time: 1425Z Position: 5205N 00102W Location: 1NM SW Silverstone

PART A: SUMMARY OF INFORMATION REPORTED TO UKAB

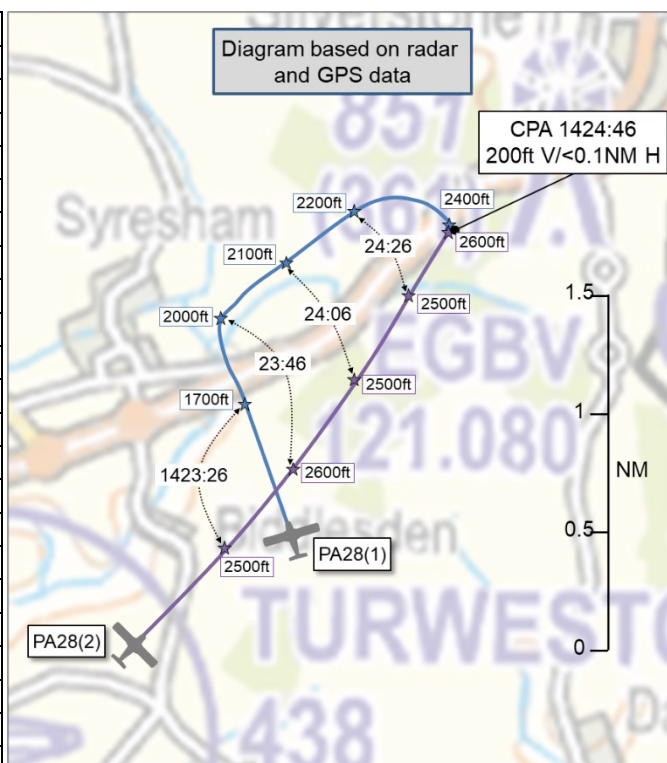
Recorded	Aircraft 1	Aircraft 2
Aircraft	PA28(1)	PA28(2)
Operator	Civ FW	Civ FW
Airspace	London FIR	London FIR
Class	G	G
Rules	VFR	VFR
Service	AGCS	Basic
Provider	Turweston Radio	Cranfield Approach
Altitude/FL	2400ft	2600ft
Transponder	A, C, S	A, C, S
Reported		
Colours	White and Red	White
Lighting	Strobes, ldg, nav.	Standard
Conditions	VMC	VMC
Visibility	>10km	>10km
Altitude/FL	2500ft	NK
Altimeter	QNH (1035hPa)	QNH
Heading	130°	NK
Speed	80kt	100kt
ACAS/TAS	Other SafeSky	Not fitted
Alert	None	N/A
Separation at CPA		
Reported	0ft V/25m H	0ft V/NK H
Recorded	200ft V/<0.1NMH

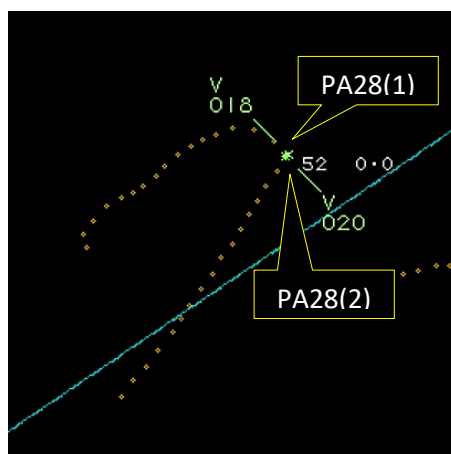
An analysis of the NATS radar replay was undertaken and both aircraft were positively identified using Mode S data. At 1423:26 PA28(1) passed in front of PA28(2) from its right to left at 800ft below in a continuous climb. At 1423:46 PA28(1) turned right, placing it to the left of PA28(2) and slightly converging. This was followed by a further right turn towards PA28(2).

CPA was assessed to have occurred at 1424:46 with 200ft separation vertically and less than 0.1NM lateral separation (Figure 1).

Figure 1 Time 1424:46 CPA 200ft vertical and less than 0.1NM lateral separation.
