**AIRPROX REPORT No 2024275**

Date: 13 Nov 2024 Time: 1334Z Position: 5138N 00008E Location: Stapleford ATZ

**PART A: SUMMARY OF INFORMATION REPORTED TO UKAB**

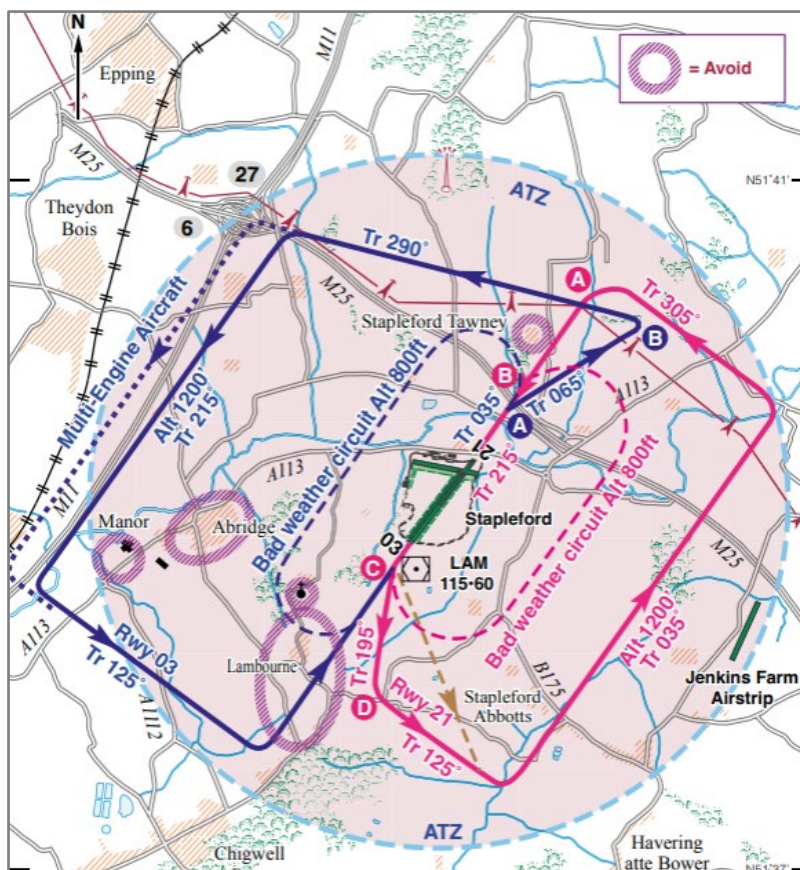
Figure 1

The expected circuit patterns and areas to avoid at Stapleford aerodrome (as published in a popular flight guide).

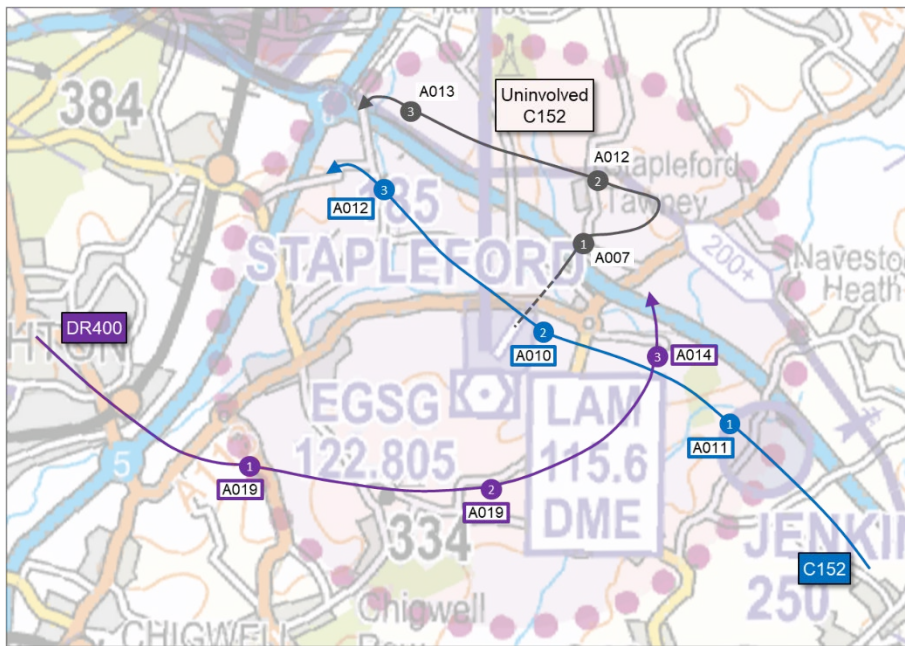
After speaking with the flight examiner in the aircraft behind them, and the radio operator, it was clear that the standard overhead join procedure had not been followed. After descending on the deadside for RW03, the [pilot of the DR400] had joined crosswind but then turned downwind very early, tracking directly towards the final approach course at a similar level [to the C152].

Figure 2 – 1332:16. The joining positions of the C152 and DR400 pilots

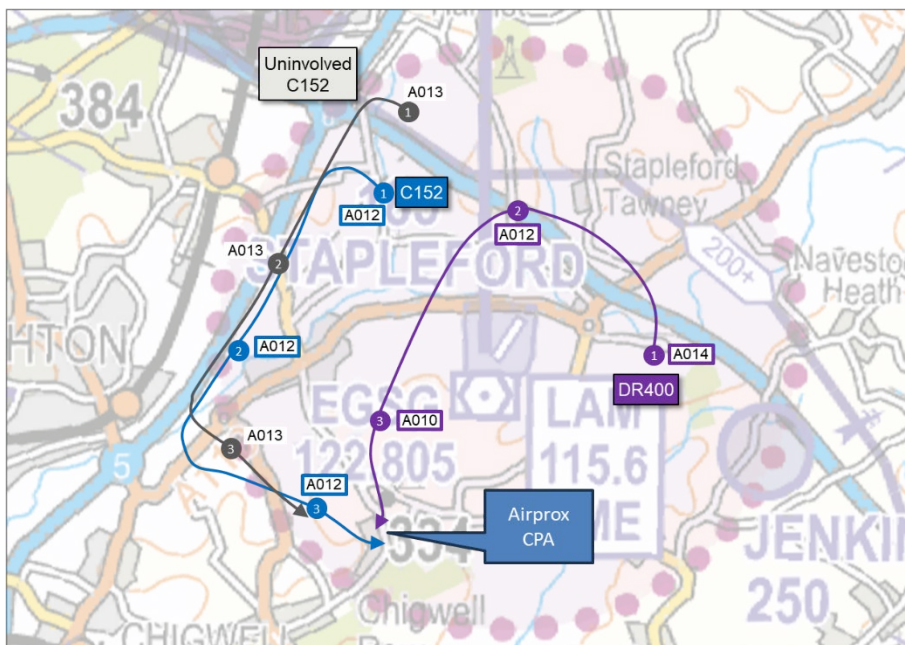
**THE C152 PILOT** reports that, whilst on final approach with a student, the pilot of another aircraft, which they understood to have been making a standard overhead join to Stapleford, ended up flying in an opposite direction to the final approach track, at low level, on a conflicting course with them and another aircraft that was on final approach behind them. [The pilot of the C152 reported that they had] first sighted the DR400 at a range of less than 300m slightly to the north of their position. [The pilot of the C152] rolled to avoid the DR400.

Figure 3 – CPA at 1334:26. Circuit patterns

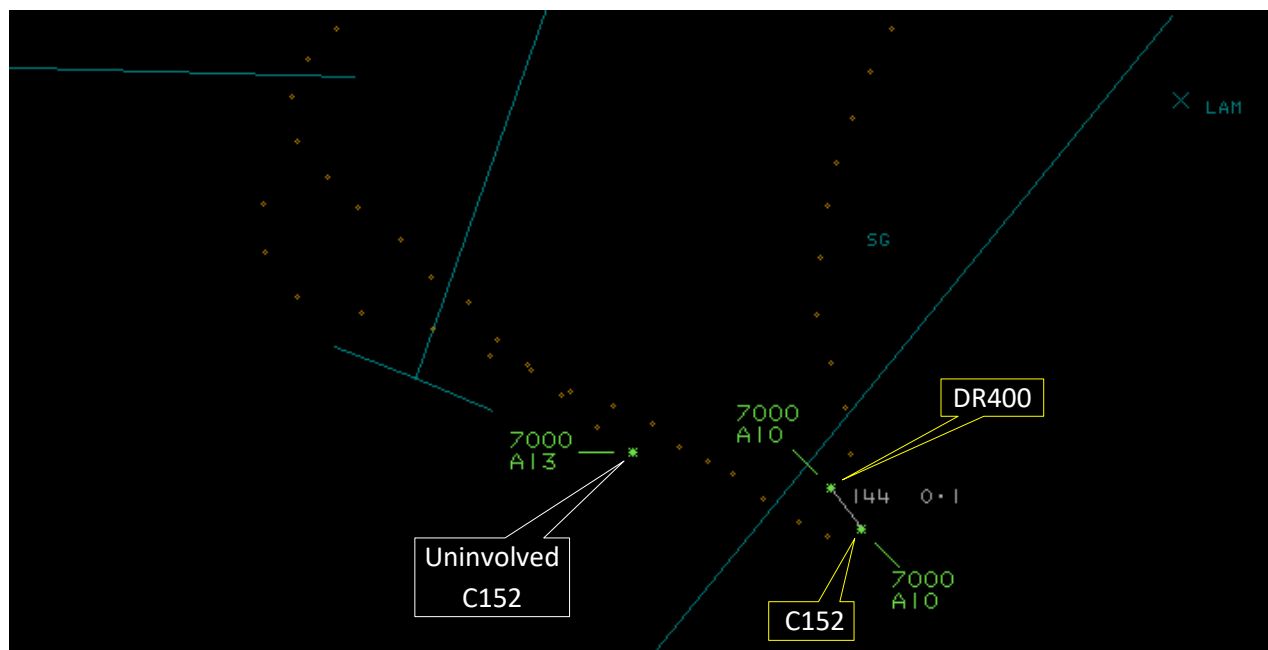
The diagram was constructed and the separation at CPA determined from the radar data.

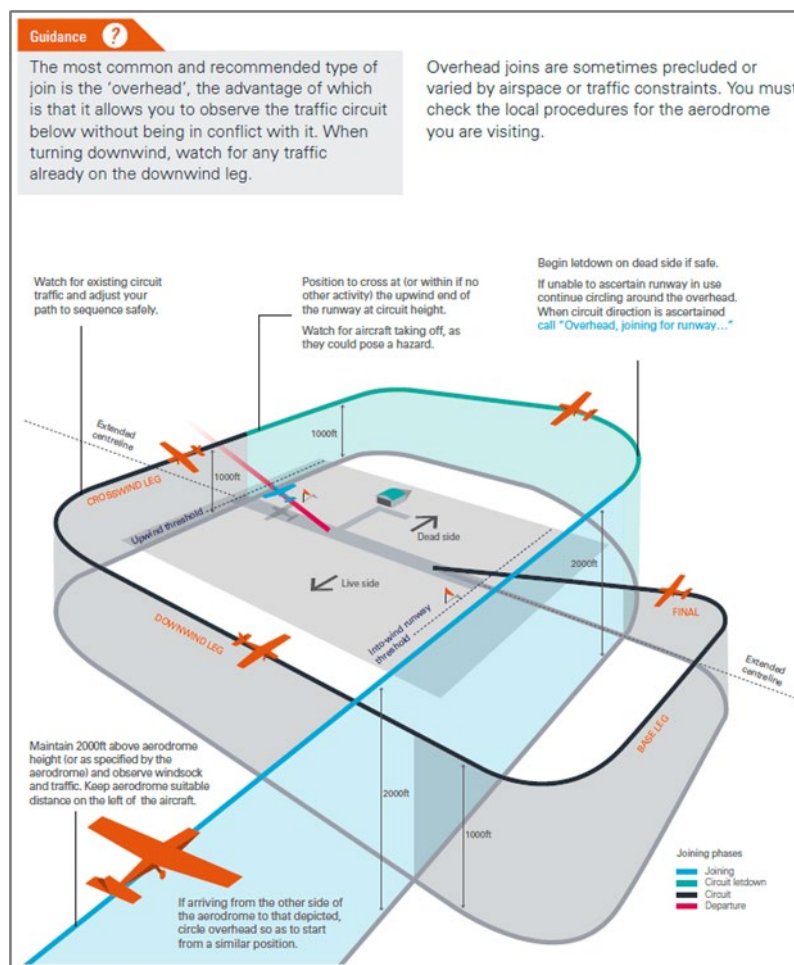
Figure 5 – The Standard Overhead Join

Members wished to emphasise the guidance to 'Position to cross at [...] the upwind end of the runway' and to 'Watch for existing circuit traffic and adjust your path to sequence safely'. Members agreed that the join into the circuit by the pilot of the DR400 had not been in accordance with the guidance, nor had it been in accordance with the expected circuit pattern as promulgated in popular flight guides (CF1). Again, proceeding on the basis that standard circuit calls had been made on frequency by the pilots of the other aircraft in the circuit, members agreed that the pilot of the DR400 had not appropriately monitored their radio (CF6) and surmised that they had had generic awareness of the other traffic (CF7) rather than having gleaned specific situational awareness of the C152 from circuit calls. Members agreed that the EC equipment fitted to the DR400 had alerted the pilot to the presence of aircraft in the vicinity (CF8), but agreed that the information had either not been sufficiently detailed or had not been sufficiently assimilated to have provided confirmation of the circuit pattern. Members were in agreement that the pilot of the DR400 had not executed their join into the circuit correctly (CF2) and had not integrated into the existing pattern of traffic (CF4).
