AIRPROX REPORT No 2024277

Date: 17 Nov 2024 Time: 1202Z Position: 5213N 00137W Location: Wellesbourne ATZ

PART A: SUMMARY OF INFORMATION REPORTED TO UKAB

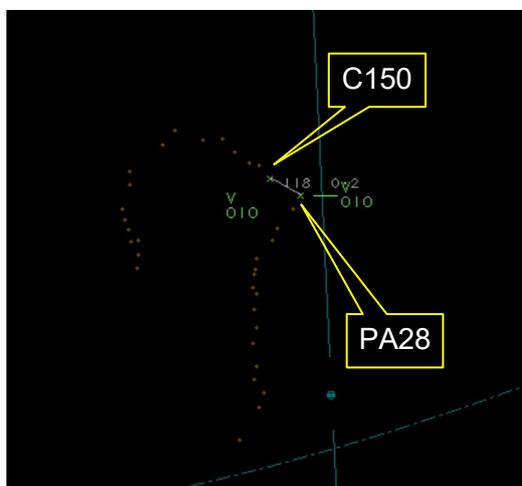
Figure 1: At CPA: 1201:38 0ft V/0.2NM H

Both aircraft were tracked by radar and identified through Mode S. Figures 1-4 above show the relative positions of the C150 and the PA28 at and beyond CPA.

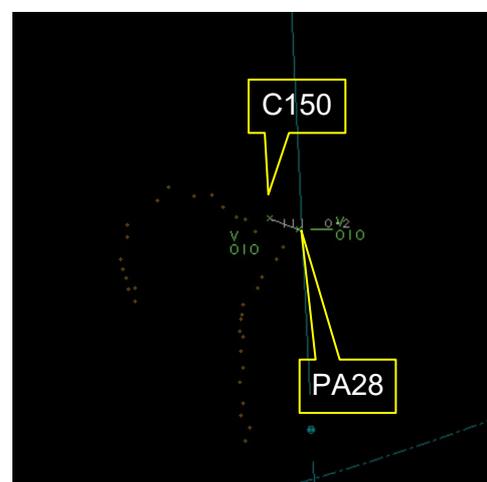
Figure 2: At CPA +4sec

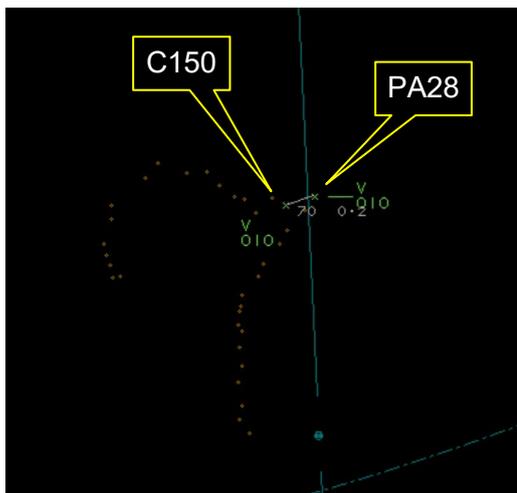
Figure 3: At CPA +8sec

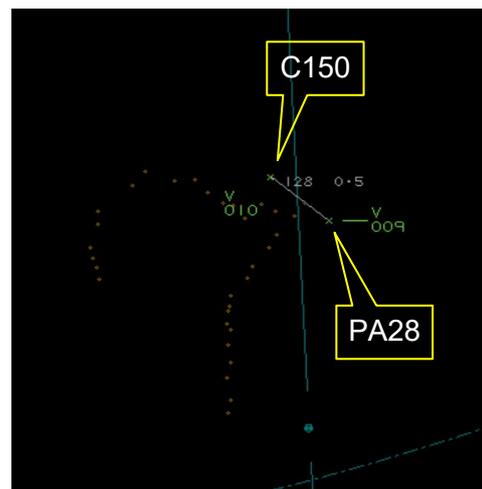
Figure 4: At CPA +12sec
