AIRPROX REPORT No 2024273

Date: 05 Nov 2024 Time: 1131Z Position: 5333N 00052W Location: Sandtoft

PART A: SUMMARY OF INFORMATION REPORTED TO UKAB

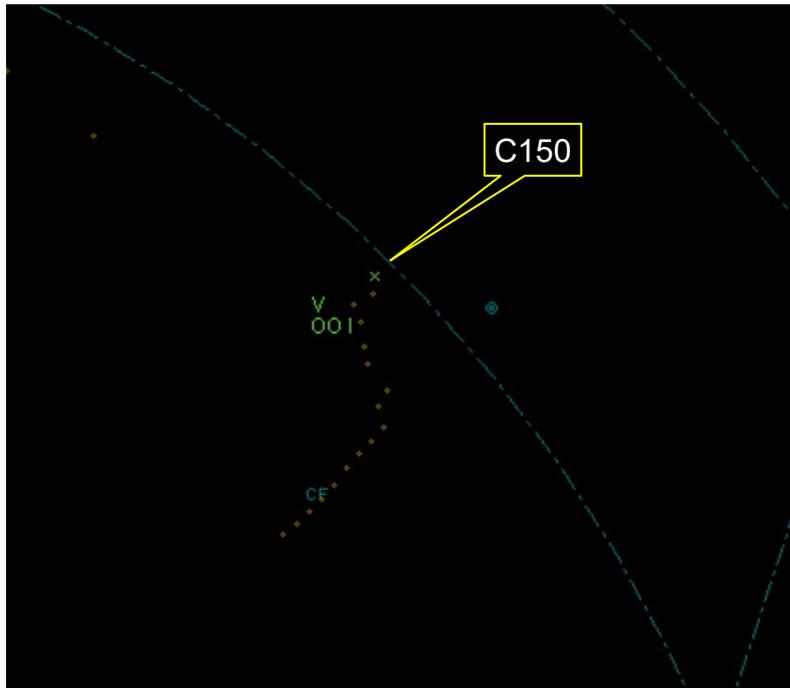
During the flight the pilot had heard a plane nearby but had not expected a plane to be operating close to their area. It had sounded close and as if it was approaching, so they reduced the altitude of the Mavic. At approximately 1131 a small Cessna plane flew through their flight area and had been flying very low. It appeared that it could have been around the max operating height of their drone 120m/400ft, though the Mavic had been operating at a lower altitude of between 40 and 60m (200ft). [The pilot of the Mavic opined that], had it been at 120m/400ft, they were concerned that it may have been in or close to the flightpath of the small plane and could have collided with it, or stalled and crashed due to wind turbulence from the plane. Whilst the intention had been to get some higher altitude pictures of the site they were photographing, the pilot was not comfortable doing so in case other planes flew through this route. They therefore completed the remaining couple of minutes of the flight at around 50m altitude and curtailed any further flight of the site. Having decided not to continue with any further flying [...] they had landed the drone at approximately 1134.

Figure 1: At reported CPA - 1131:15. Mavic not recorded on radar.

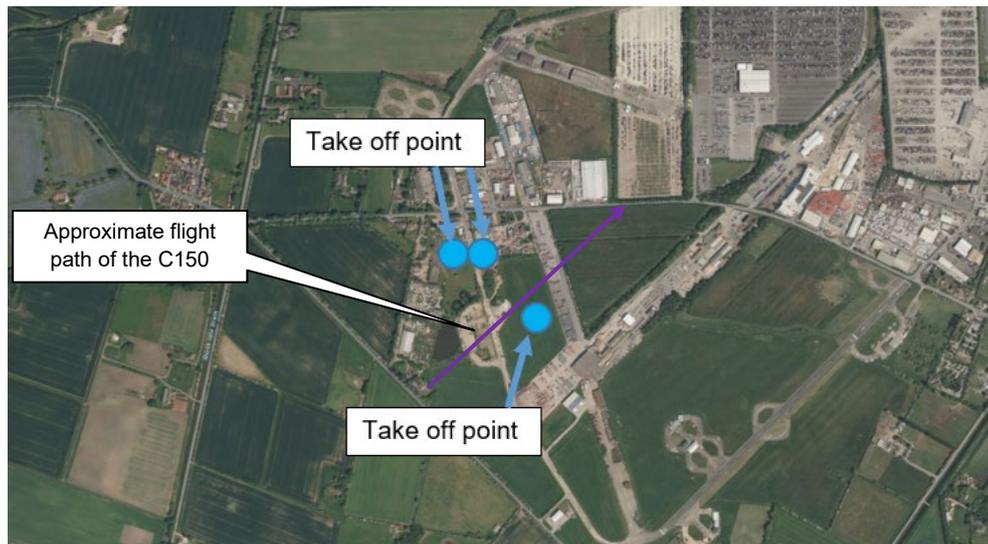
Figure 2: Mavic take-off areas
