AIRPROX REPORT No 2024278

Date: 14 Nov 2024 Time: ~1808Z Position: 5115N 00136W Location: Ludgershall

PART A: SUMMARY OF INFORMATION REPORTED TO UKAB

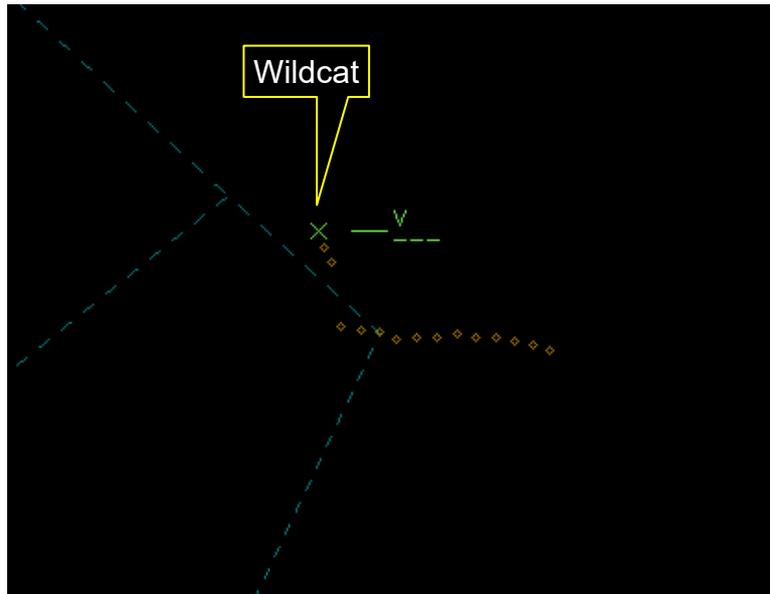
Figure 1: At reported CPA position 1808:00.

Up to the calculated CPA, the Wildcat could be tracked (intermittently) and is shown in Figure 1 having turned north from Ludgershall. The transponder at that point was recorded as Mode A only. The Wildcat ceased to display from the following radar sweep. The Merlin did not show on radar. Figure 2 is an extract from an MLAT-capable tracking tool and shows the (intermittent) flight path of the Wildcat up to and beyond CPA. The Merlin did not appear on this system until approximately 7min beyond CPA. Figure 3 is an extract from the UK eAIP showing detail regarding operations within D126.

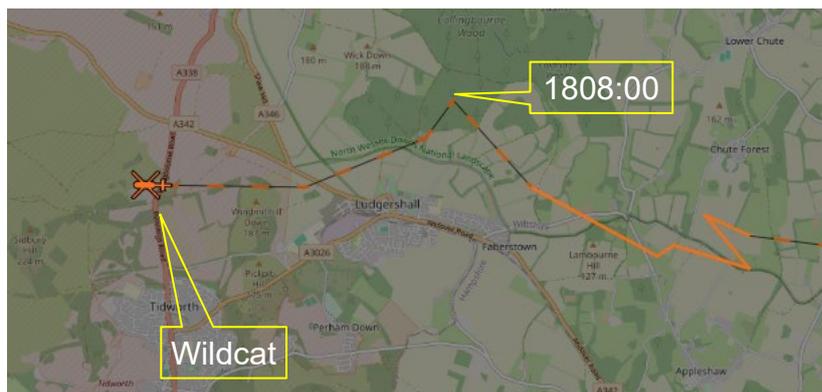
Figure 2: MLAT-capable tracking tool showing the Wildcat at 1809:30
