**AIRPROX REPORT No 2024285**

Date: 22 Nov 2024 Time: 1352Z Position: 5154N 00210W Location: Gloucestershire Airport

**PART A: SUMMARY OF INFORMATION REPORTED TO UKAB**

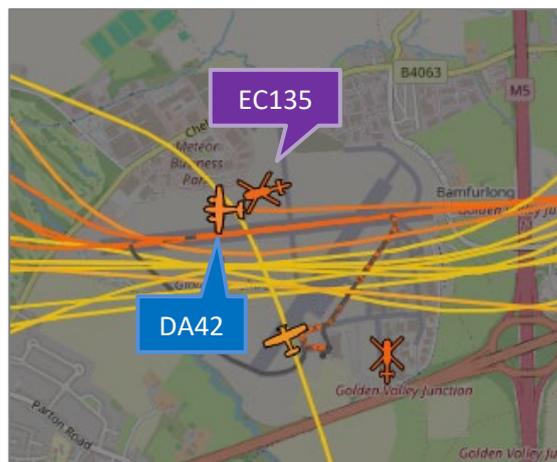
It is clear that [DA42] did drift to the right of RW27 as they carried out a low approach and go-around and this brought them in to conflict with the area normally utilised by helicopters for VFR circuits when RW27 is in use. Having said that, they had not received Traffic Information (generic or specific) on the helicopter circuit being active or the activity of [the EC135]. [The EC135 pilot] had received generic Traffic Information on the right-hand fixed wing circuit being active on RW27 but [the EC135 pilot] could have reasonably expected for a fixed-wing aircraft not to drift right to such a degree that a conflict point would have been created.

Further analysis was undertaken using ADS-B and aircraft tracking software from which both aircraft were positively identified, the DA42 from ADS-B sources and the EC135 using multilateration (MLAT). The tracks for both aircraft were visible throughout and the CPA was assessed to have been at 1352:10 as the DA42 passed the EC135 during its go-around, with 400ft vertical and less than 0.1NM lateral separation (Figure 2). The DA42 tracks were further supported by the GPS navigation data provided by the pilot of the DA42.

Figure 2 - Time 1352:10 400ft vertical and less than 0.1NM lateral separation.
