**AIRPROX REPORT No 2024289**

Date: 13 Nov 2024 Time: 1312Z Position: 5148N 00157W Location: IVO Chedworth

**PART A: SUMMARY OF INFORMATION REPORTED TO UKAB**

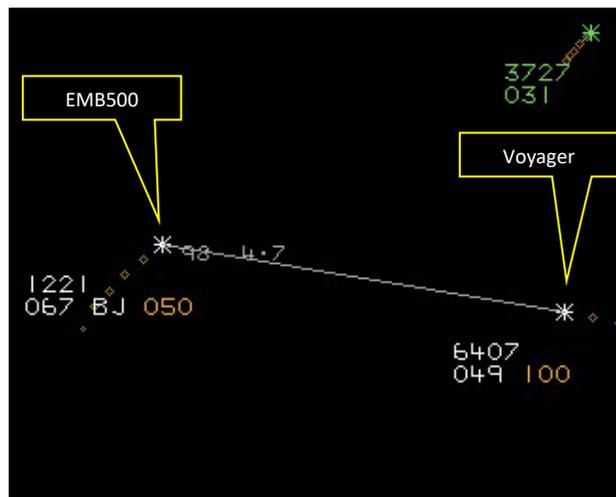
Figure 1 (1310:53). Avoiding Action issued to the EMB500.

At 1310:47, a Short-Term Conflict Alert regarding the EMB500 and Voyager was displayed to the Brize Norton Radar and Approach controllers. This coincided with the Brize Norton Approach controller providing updated Traffic Information to the Voyager [pilot] regarding the EMB500. Whilst, at 1310:53, the Brize Norton Radar controller, following intervention by the OJTI and Supervisor, issued the EMB500 [pilot] “avoiding action turn left immediately heading 360”, which was acknowledged immediately along with reporting the TCAS RA by the EMB500 crew.

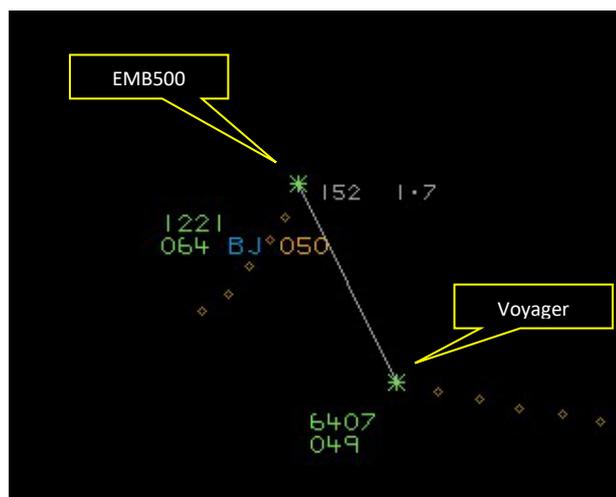
Figure 2 (1311:32). CPA.

CPA occurred at 1311:32 and was recorded as 1.7NM and 1500ft separation.
