**AIRPROX REPORT No 2024295**

Date: 06 Dec 2024 Time: ~1150Z Position: 5127N 00132W Location: 2NM SW of Membury Airfield

**PART A: SUMMARY OF INFORMATION REPORTED TO UKAB**

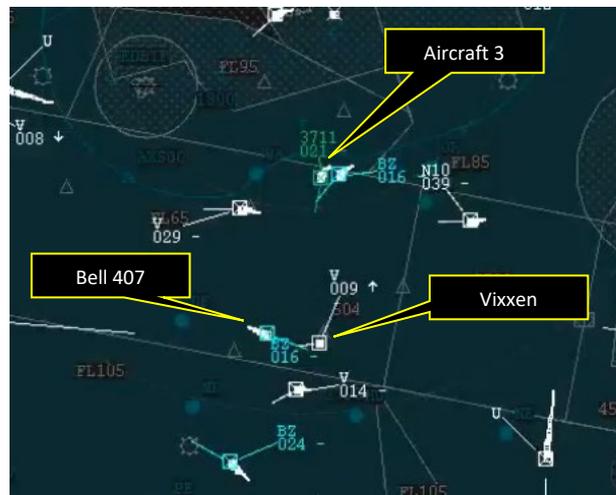
Figure 1: ~1150 – the point at which a radar return (which cannot be confirmed as the Vixxen) first appeared on the Brize Norton radar at a range of ~1.2NM H with ~700ft V separation

The actions of the Brize Norton Radar controller are assessed as correct with prioritisation of activity in accordance with the varying ATS provision levels being provided. Had a Traffic Service been requested by the Bell 407 [pilot], and the Brize Norton Radar controller had capacity available to provide it, then it can be assumed Traffic Information regarding the Vixxen would have been provided given that it was detected by the Brize Norton surveillance system (Figure 1 above).

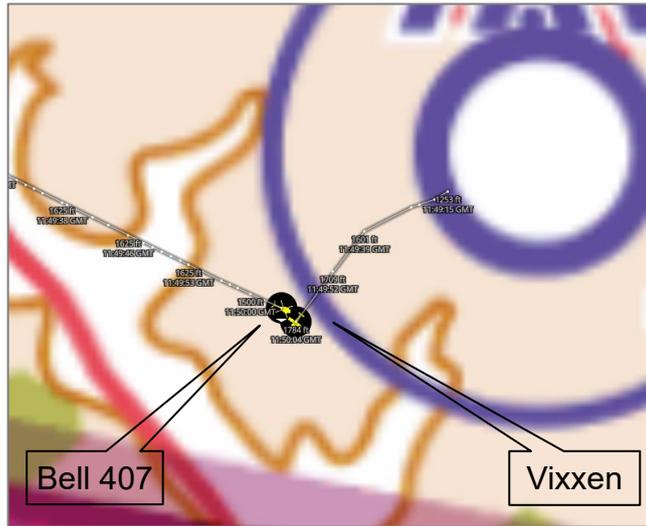
Figure 2: Airspace Analyser Tool view at CPA 1150:04

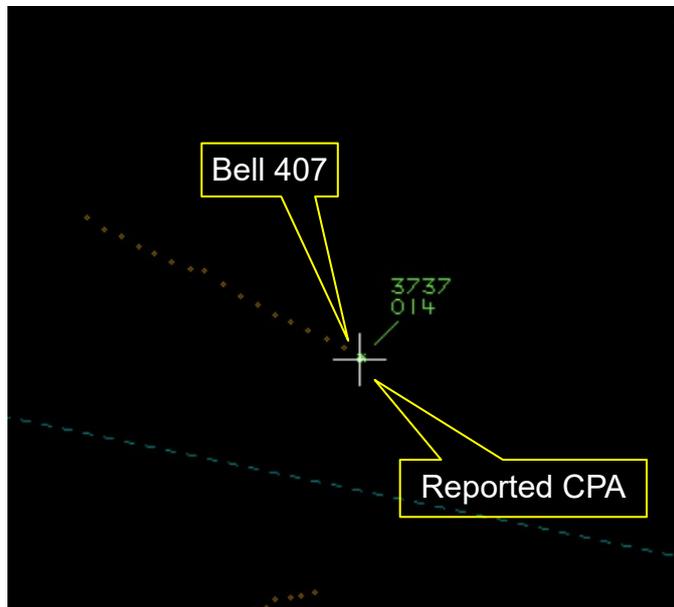
Figure 3: At reported CPA 1150.04

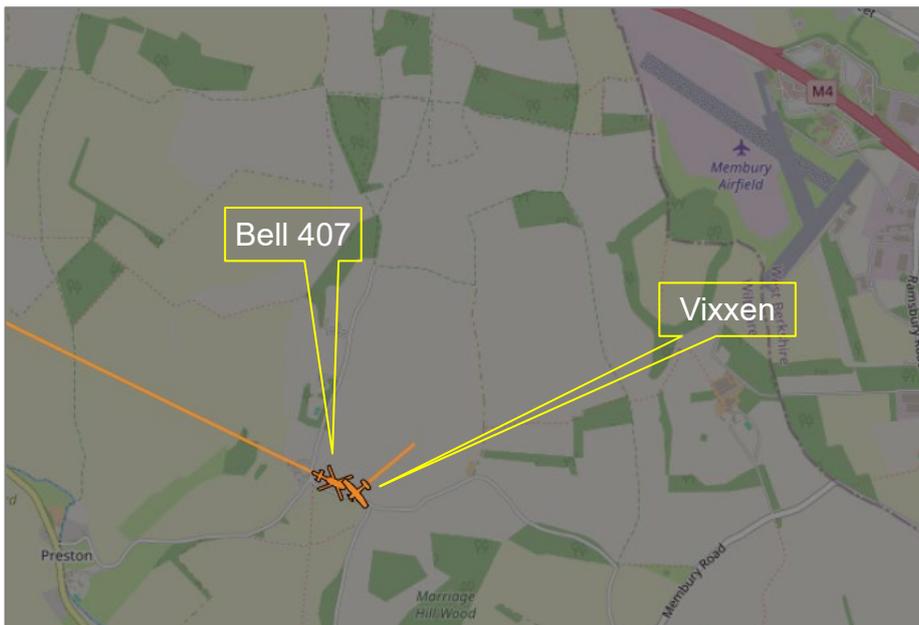
Figure 4: From an ADS-B tracking source at 1150:04

Figure 4 is taken from the CAAs Airspace Analyser Tool. Both the Bell 407 and the Vixxen had shown an SPS-referenced altitude which has had a QNH correction applied to enable an approximate altitude comparison. The Bell 407 shows to have descended as described by the pilot by approximately 200ft between 1150:04 and 1150:08.
