AIRPROX REPORT No 2024292

Date: 28 Nov 2024 Time: 1121Z Position: 5627N 00316W Location: 8NM W Dundee

PART A: SUMMARY OF INFORMATION REPORTED TO UKAB

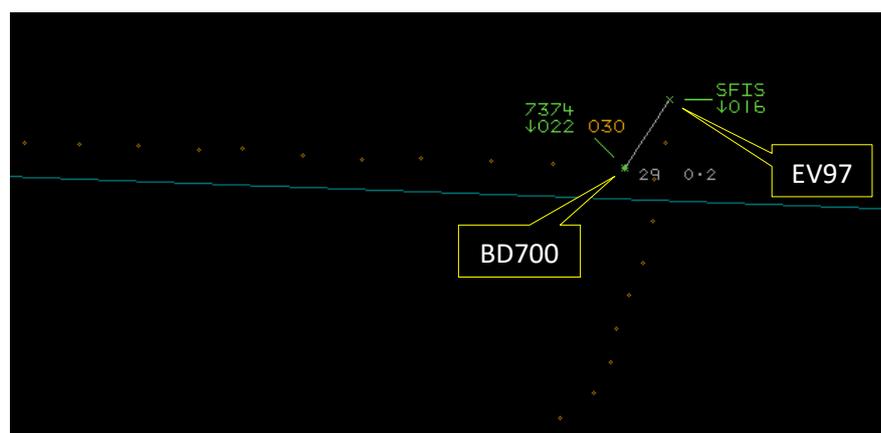
Figure 2 – CPA at 1121:07

As part of this investigation, a review of data from the ADSB-exchange website shows the closest position of [the EV97] to the threshold RW09 at Dundee was approximately 7.2NM. From the website, it can also be approximated that, at their closest point, [the BD700] and [the EV97] were 600ft vertically and 0.4NM horizontally apart. Dundee's instrument approaches are located outside controlled airspace. The RNP procedure for RW09 via IVGEX extends out to a point 12.9NM to the north-west of Dundee Airport and the procedure takes the aircraft just to the west and north of Perth Airport. At the approximate position of the Airprox, at around 7.5NM distance from Dundee, the approach level at that point is recommended as 2500ft.

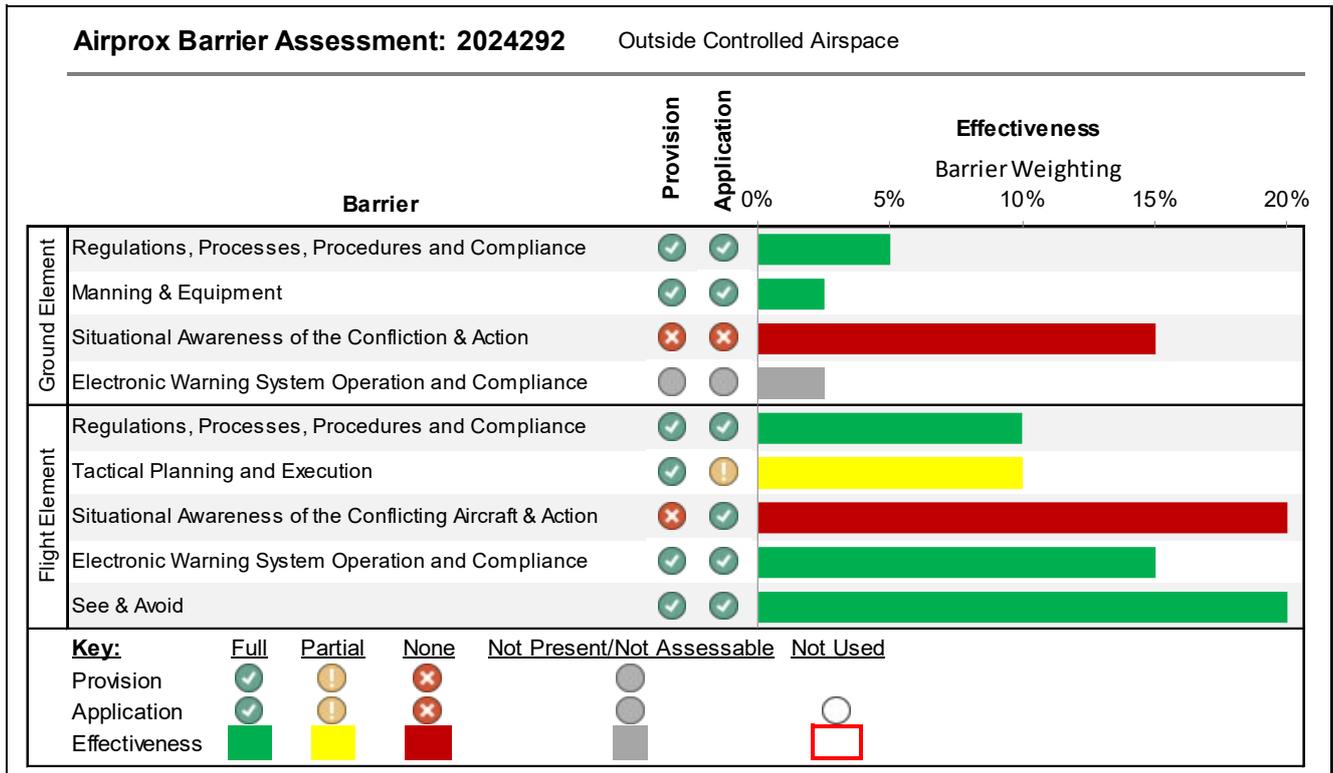
Situational Awareness of the Confliction and Action were assessed as **ineffective** because the Dundee controller had no situational awareness of the presence of the EV97 until after CPA.

Tactical Planning and Execution was assessed as **partially effective** because it had been strongly recommended for the pilot of the EV97 to have contacted the Dundee controller due to their proximity to the Instrument Approach Procedure ‘feathers’.

Situational Awareness of the Conflicting Aircraft and Action were assessed as **ineffective** because the pilot of the EV97 had no situational awareness of the presence of the BD700 until it had been visually acquired.
