AIRPROX REPORT No 2024296

Date: 11 Dec 2024 Time: 1558Z Position: 5309N 00257W Location: 1NM SE Hawarden

PART A: SUMMARY OF INFORMATION REPORTED TO UKAB

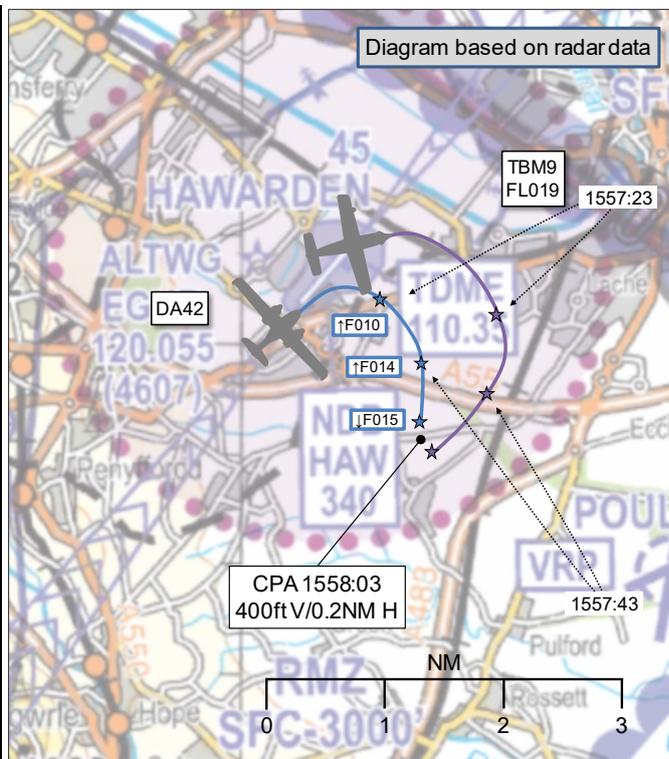
Recorded	Aircraft 1	Aircraft 2
Aircraft	DA42	TBM9
Operator	Civ FW	Civ FW
Airspace	London FIR	London FIR
Class	G	G
Rules	IFR	IFR
Service	Traffic	Traffic
Provider	Hawarden	Hawarden
Altitude/FL	FL015	FL019
Transponder	A, C, S+	A, C, S+
Reported		
Colours	White, Blue	White, Grey
Lighting	Strobes, Nav, Landing, Taxi	Nav, Strobes
Conditions	VMC	VMC
Visibility	5-10km	NR
Altitude/FL	2300ft	NR
Altimeter	QNH (1033hPa)	QNH
Heading	Turning to 150°	NK
Speed	102kt	NK
ACAS/TAS	SkyEcho	Not fitted
Alert	None	N/A
Separation at CPA		
Reported	2-300ft V/0.25NM H	Not Seen
Recorded	400ft V/0.2NM H

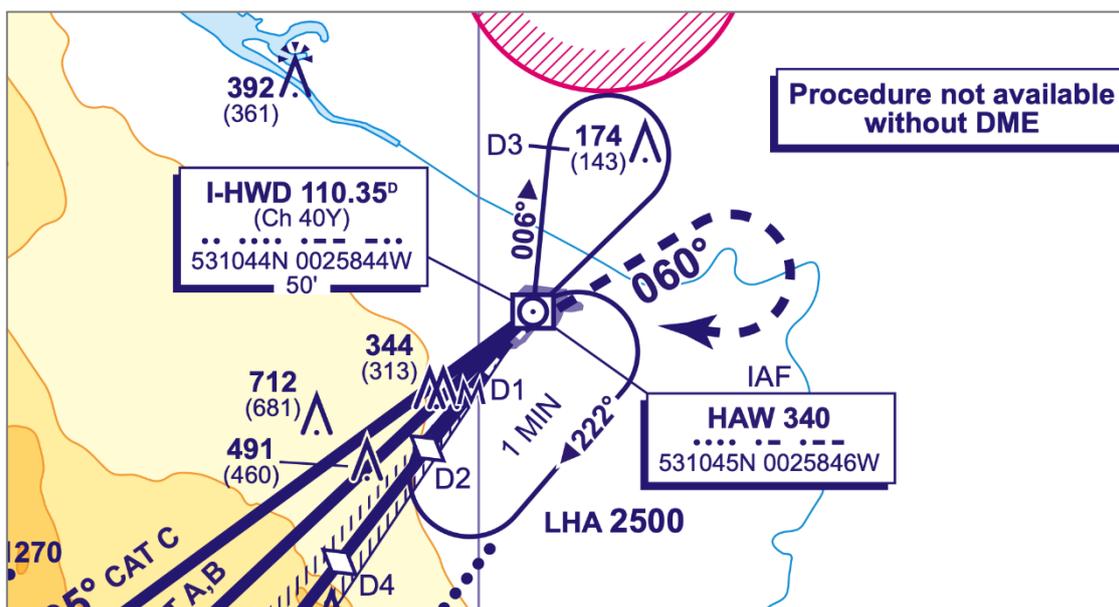
Figure 1: Hawarden Hold position

An extract from the Hawarden Instrument Approach Chart for RW04 is published in the UK AIP as follows:

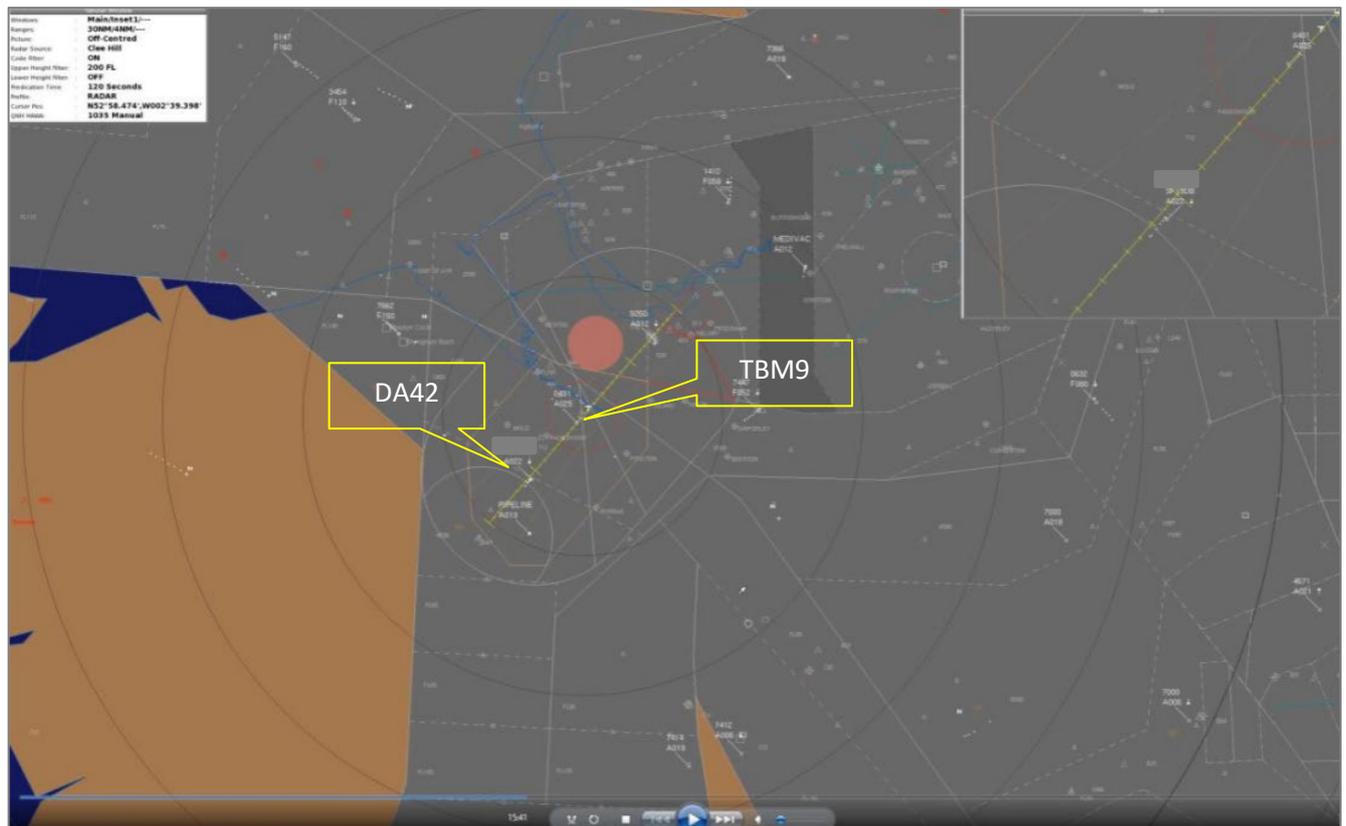
1553:36 – The APS ATCO passed Traffic Information to [DA42 pilot] on [the TBM9] '*established shortly in the HAW altitude 2500ft a TBM9*'.

Figure 2 – Taken from the Hawarden radar replay, Traffic Information passed to DA42 pilot on the TBM9 (0431 squawk in the HAW 2500ft)

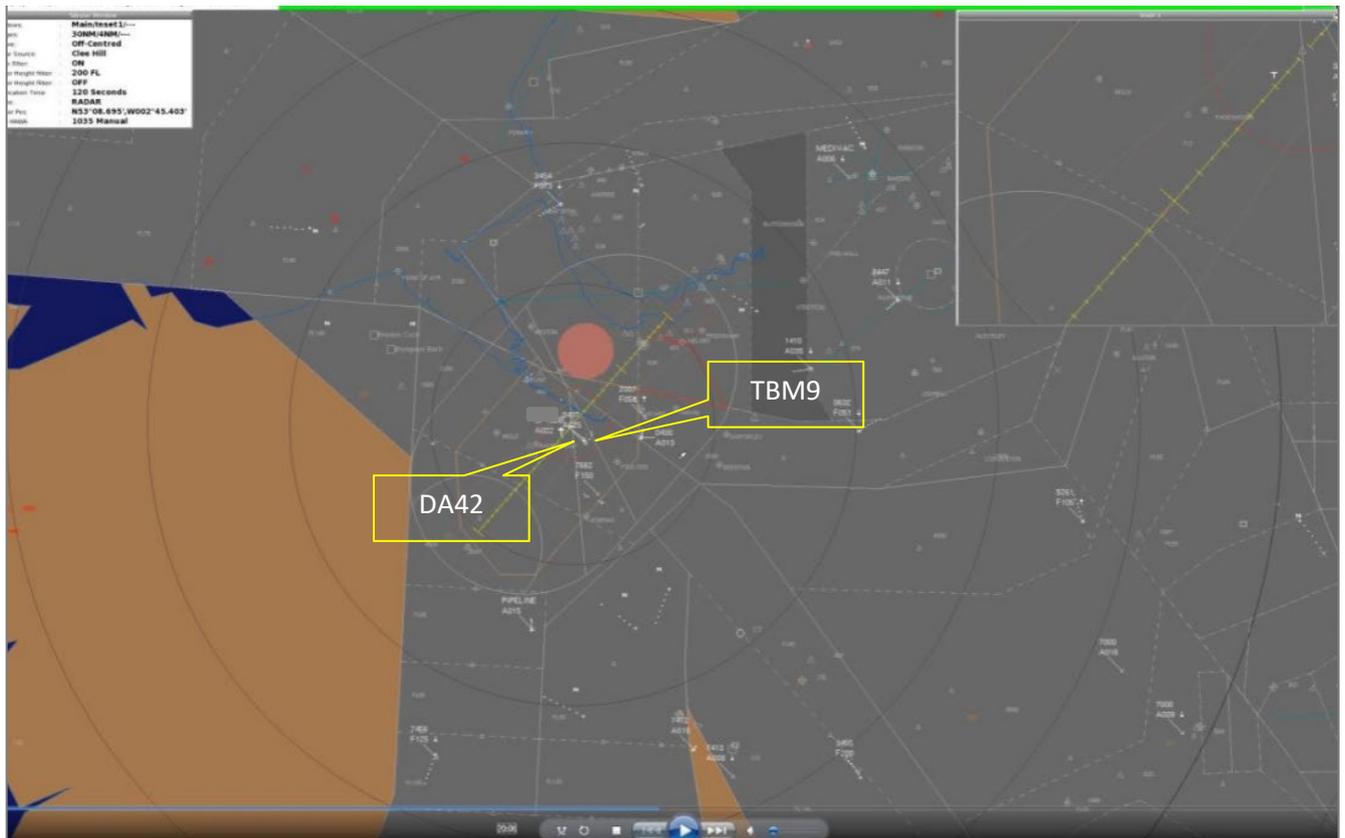
Figure 3 – CPA 1558:03

1558:03 – Point of closest confliction [vertically]. [DA42 C/S] indicated 2200ft on Mode C, [TBM9 C/S] established in the HAW and reported at 2500ft – Mode C readout supported this. Neither pilot raised any concern on the frequency at the time.

APS ATCO issued climbout instructions that placed the DA42 in potential confliction with the TBM9.

The DA42 pilot lost visual contact with TBM9.

- Pilot workload – Student incorrectly inputted information into aircraft navigation equipment (G1000) requiring the instructor to reprogramme the system. This took approximately 15-20

seconds where the instructor was “heads in the cockpit” resulting in a loss of visual contact with the TBM9. There was no request from pilot for traffic update.

- The position of the DA42 after conducting the low-approach to RW04, placed the aircraft directly below the TBM9 which had just become established in the HAW at 2500ft. This could potentially increase the risk of the pilot losing visual contact with the TBM9.

Use of the HAW suspended for training but remains in place for aircraft requiring to fly a missed approach and for aircraft operating in accordance with radio fail procedures - pending review. Hawarden to conduct Safety Review of HAW procedures and consider the following:

- Holding facilities outside controlled airspace.
- Holding at the lowest altitude/level available.
- Is standard separation required?
- Should it be used for training purposes?

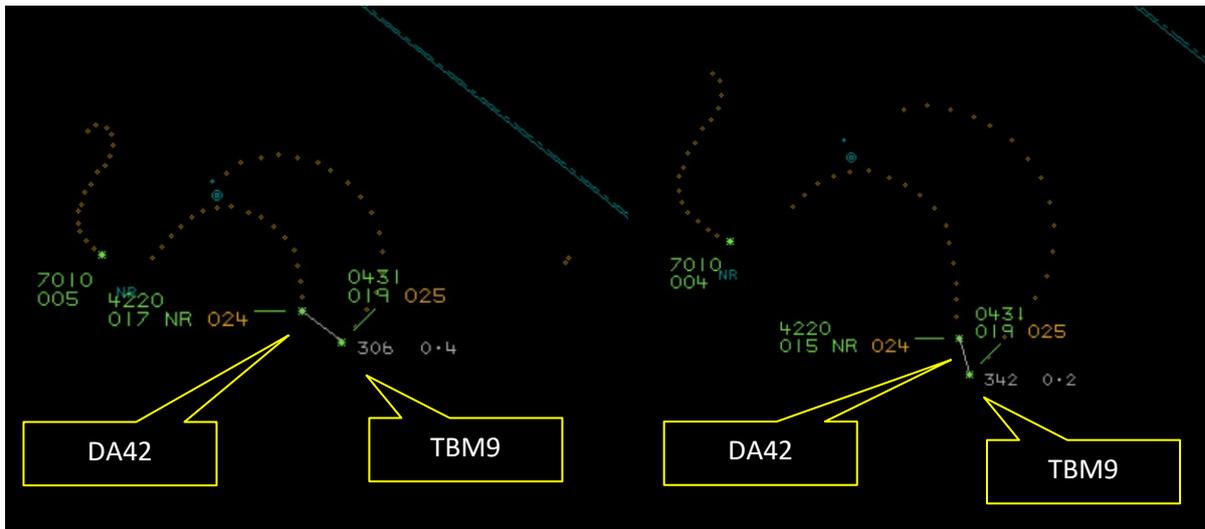
Figure 4 – 1557:55

Analysis of the NATS radar replay was undertaken and both aircraft could be identified using Mode S data. Although the Hawarden radar indicated a separation of 300ft, the NATS radar replay indicated at separation of 200ft at a range of 0.4NM, but the DA42 then descended to give 400ft separation at CPA and this was used for the diagram at the top of the report.

Figure 5 - 1558:03
CPA using NATS radar replay
