AIRPROX REPORT No 2024299

Date: 28 Nov 2024 Time: 1442Z Position: 5211N 00007E Location: IVO Cambridge ATZ

PART A: SUMMARY OF INFORMATION REPORTED TO UKAB

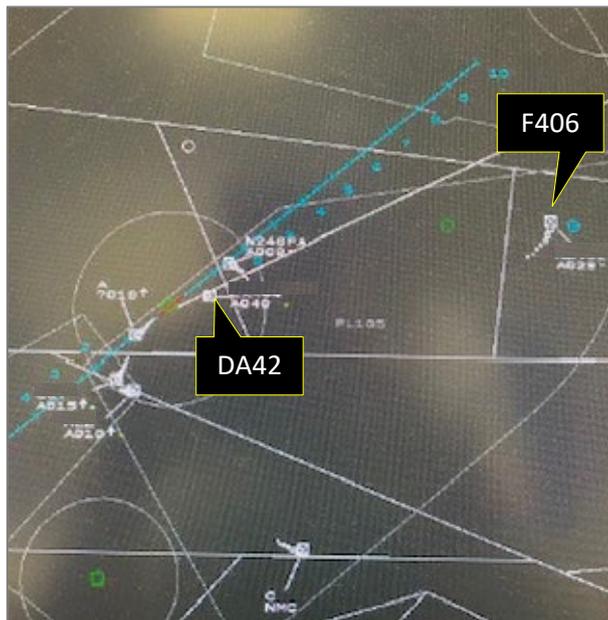
Figure 2 - 1435:24.

[The pilot of the DA42] entered the CAM hold. [The pilot of the F406] had passed GOPOD and was told to “report established on the final approach track”. (Figure 2).

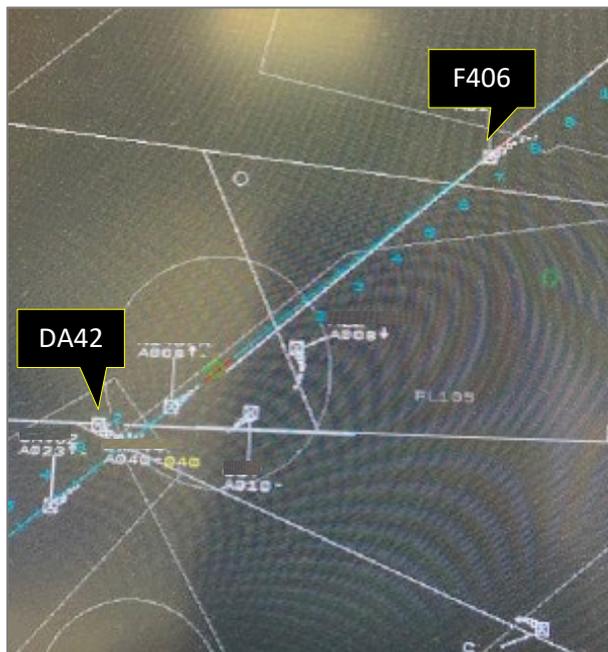
Figure 3 – 1437:44.

[The pilot of the F406] established on the final approach track and was told to contact Tower. The pilot was advised that the circuit was busy ahead. [The F406 pilot] left the Radar frequency. (Figure 3).

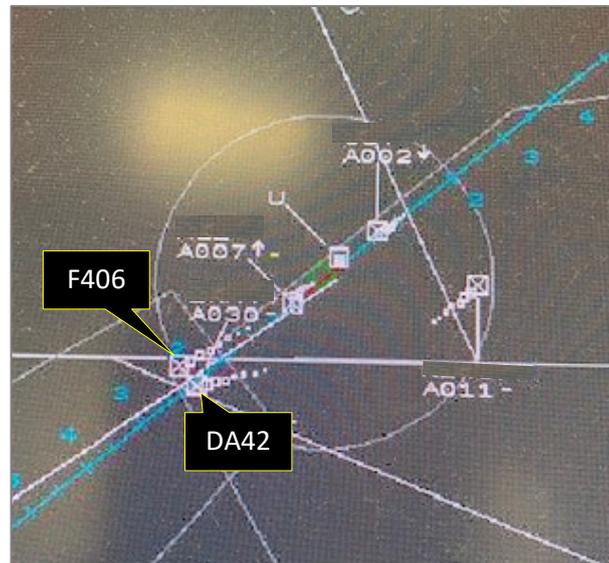
Figure 4 - 1442:20.

- 1442:07 A garbled transmission by [the uninvolved pilot] and [the pilot of the F406] who transmitted at the same time. [The pilot of the F406] reported they were “.....on a heading of 230° and climbing to 4000ft”.
- 1442:20 [The pilot of the F406] was identified and the type of service required was requested. The [F406] pilot requested a Traffic Service which was issued (Figure 4).

[UKAB Secretariat note: CPA was assessed to have occurred at 1442:23]

Traffic Information was then provided “[F406 C/S] roger, traffic in your vicinity just off your right-hand side is [...] in the CAM hold at 4000ft, correction 3000ft”.

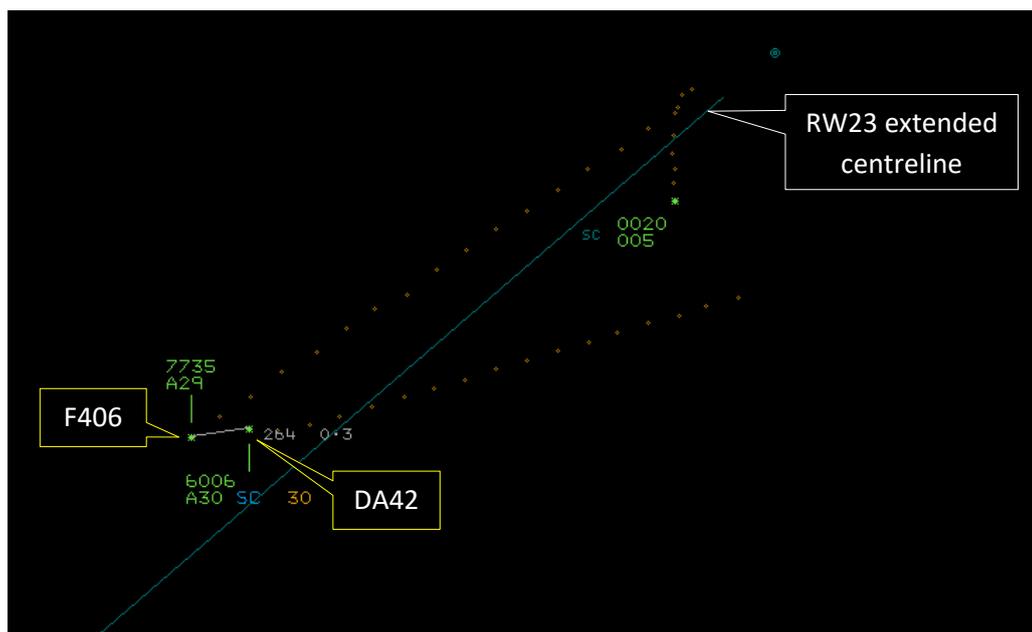
Figure 5 – CPA at 1442:23

An analysis of the NATS radar replay was undertaken and both aircraft could be positively identified from Mode S data (Figure 5). The diagram was constructed and the separation at CPA was determined from the radar data.

The DA42 and F406 pilots shared an equal responsibility for collision avoidance and not to operate in such proximity to other aircraft as to create a collision hazard.¹ If the incident geometry is considered as overtaking then the F406 pilot had right of way and the DA42 pilot was required to keep out of the way of the other aircraft by altering course to the right.²
