**AIRPROX REPORT No 2025014**

Date: 13 Feb 2025 Time: 1142Z Position: 5121N 00114W Location: 4.5NM Southeast of Newbury

**PART A: SUMMARY OF INFORMATION REPORTED TO UKAB**

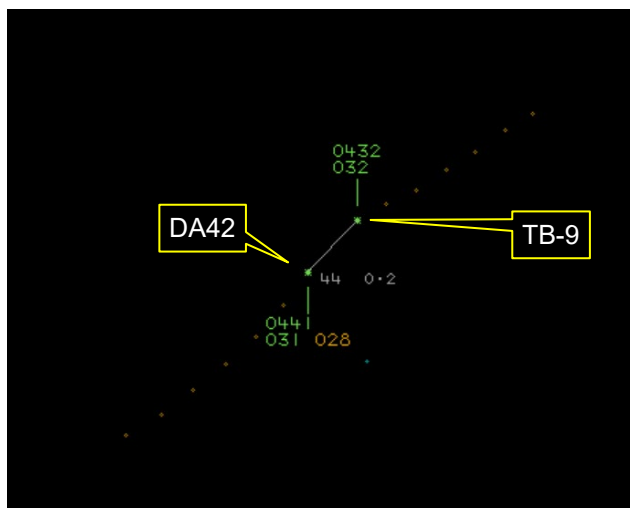
Figure 1: At 1141:51 (CPA minus 4sec)

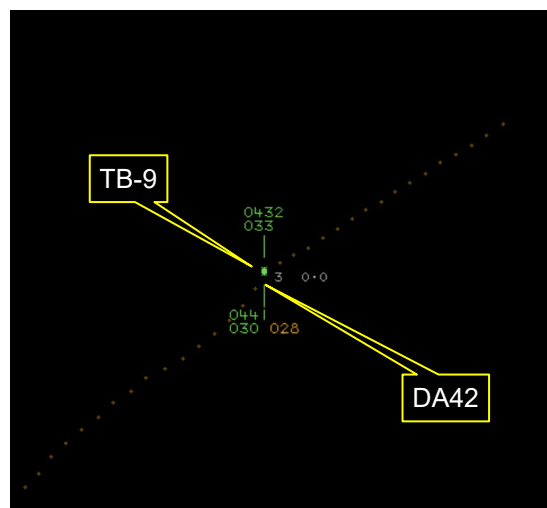
The closest point of approach occurred at 1141:52 and was recorded on NODE Multi-Track Radar as 0.1NM and 100ft. Note: NODE radar trails displayed the DA42 pilot as having performed a left turn manoeuvre with increased rate of descent, whilst the TB-9 pilot maintained their south-westerly track. During the subsequent handover, the LF-LARS controller provided a traffic situation description to the incoming controller, informing them that that the TB-9 was on a *“Traffic Service reduced due to areas of high traffic density”*, with the DA42 also receiving a *“Traffic Service reduced again, going into [...] IFR.”* The pilots of the TB-9 and DA42 did not report any confliction on the Farnborough frequency. The NATS4118 stated that the pilot of the DA42 had contacted Farnborough ATC on the following day to advise they would be submitting an Airprox report.

Figure 2: At CPA - 1141:55 300ft V/<0.1NM H

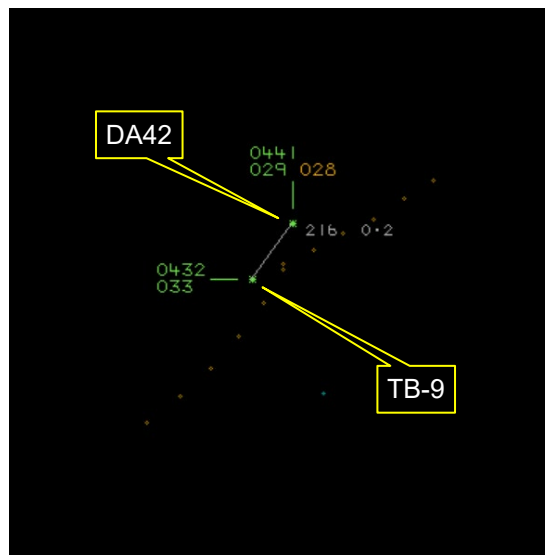
Figure 3: At 1141:59 (CPA plus 4sec)
