**AIRPROX REPORT No 2025063**

Date: 29 Apr 2025 Time: 1335Z Position: 5319N 00056W Location: Retford/Gamston ATZ

**PART A: SUMMARY OF INFORMATION REPORTED TO UKAB**

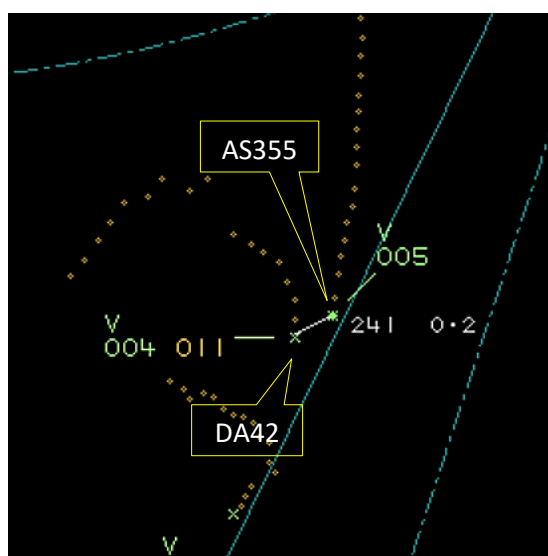
Figure 1 Time 1334:34

An analysis of the NATS radar replay was undertaken and both aircraft were positively identified using Mode S data. The DA42 was seen turning right onto the final approach track for RW20 and the AS355 was seen approaching the same track from a long final position. CPA was assessed to have occurred at 1334:34 with 0.2NM lateral and 100ft vertical separation (Figure 1).

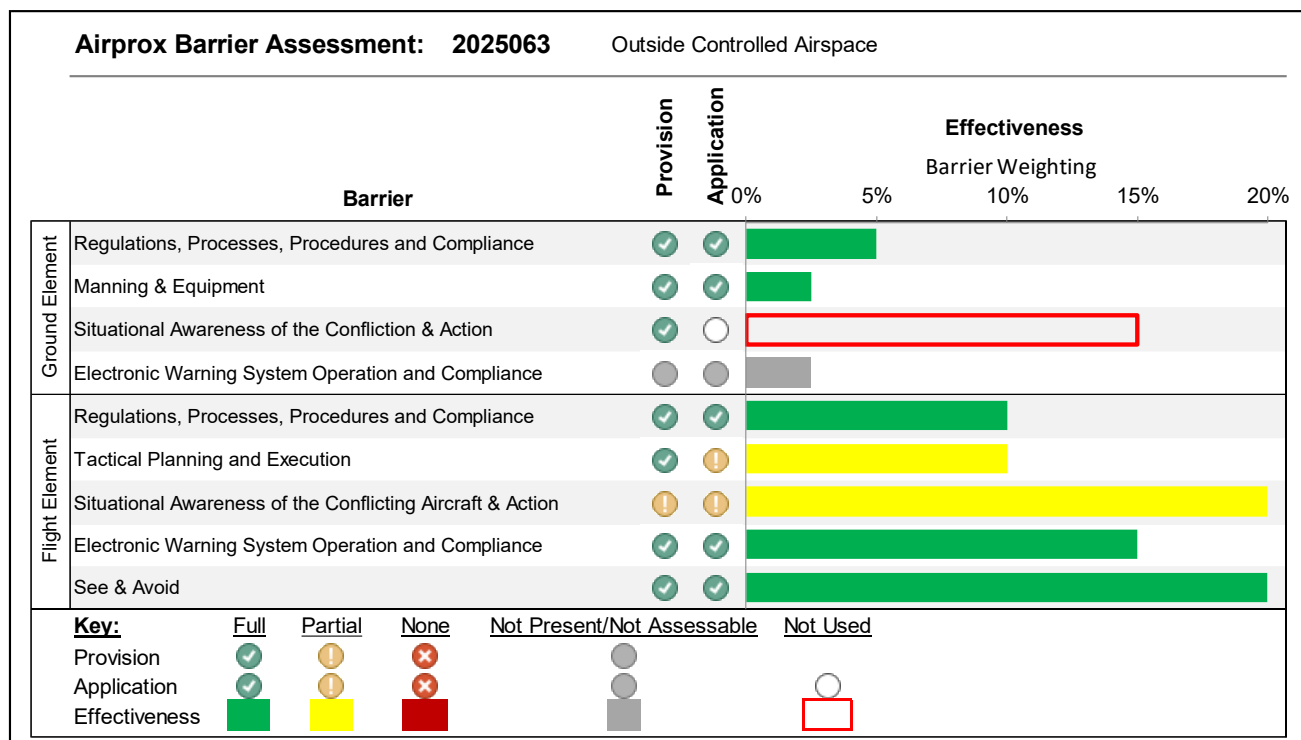
**Situational Awareness of the Confliction and Action** were assessed as **not used** because the Gamston Air/Ground operator was not required to sequence the traffic in the circuit.

**Tactical Planning and Execution** was assessed as **partially effective** because the AS355 pilot did not conform with the pattern of traffic already formed by the DA42.

**Situational Awareness of the Conflicting Aircraft and Action** were assessed as **partially effective** because the AS355 pilot's situational awareness of the DA42's position within the circuit was inaccurate.
