**AIRPROX REPORT No 2025067**

Date: 29 Apr 2025 Time: ~1230Z Position: 5420N 00056W Location: Spaunton Moor, Yorkshire

**PART A: SUMMARY OF INFORMATION REPORTED TO UKAB**

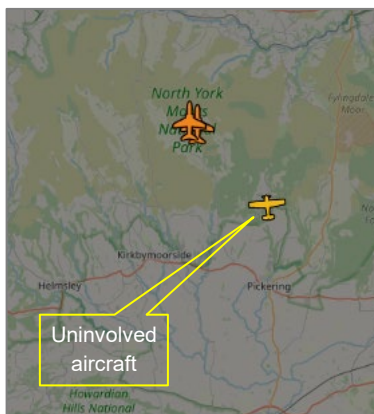
Figure 1: from an ADS-B source (as an MLAT track) - Hawks re-appeared at 1230:00.

The Hawks had been operating in the area and had appeared as intermittent contacts on radar and other tracking systems with the most significant contact at 1229:52 (CPA plus ~22sec). The G109 showed on the CAA's Airspace Analyser Tool (AAT) as an ADS-B return until 1229 (CPA minus ~30sec). Interpretation between the various systems has created the diagram at page 1 and the derived CPA. Unfortunately, no direct comparison of precise position or altitude can be made at CPA.

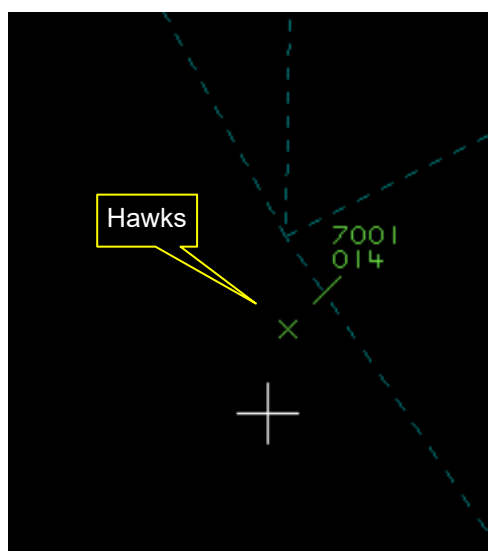
Figure 2: from radar - Hawks re-appeared at 1259:50. White cross marks the CPA.

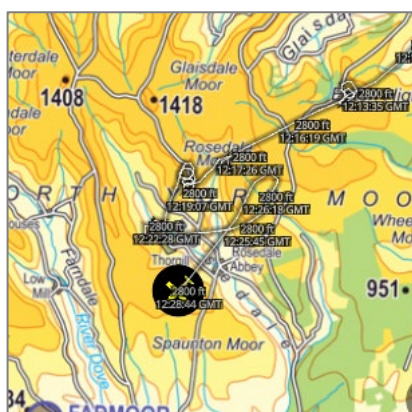
Figure 3: from the CAA's Airspace Analyser Tool - G109 showed for the last time ~0.5NM short of CPA at 1229:00 at 2800ft (SPS).
