AIRPROX REPORT No 2025071

Date: 01 May 2025 Time: 1500Z Position: 5202N 00215W Location: 2NM SW Upton-upon-Severn

PART A: SUMMARY OF INFORMATION REPORTED TO UKAB

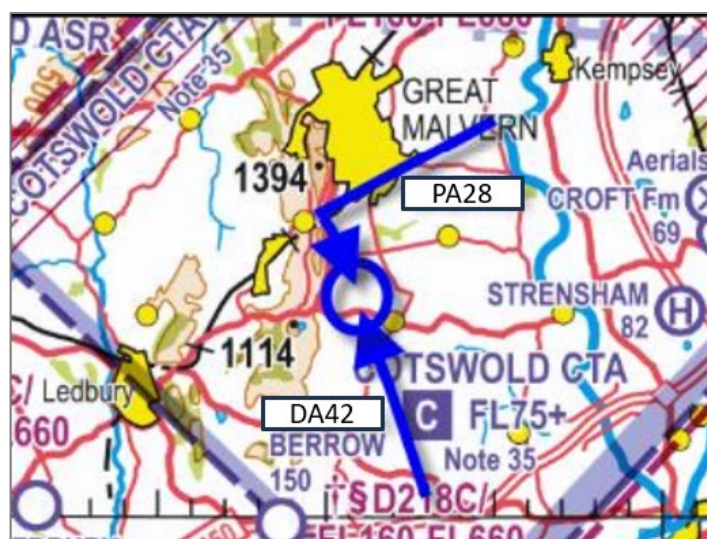
Figure 1 - Approximate aircraft tracks and position of conflict.

As [the PA28] tracked towards Great Malvern, radar displayed [that the DA42] turned sharp left at 1459:08 onto an opposite direction track to [the PA28] at the same altitude. As both aircraft approached each other, at 1459:22 both aircraft appeared to initially turn right, however [the DA42] then appeared to turn left on the next radar update, reducing the lateral distance, resulting in the closest point of approach (CPA) being 0.3NM and 100ft occurring at 1459:36 (Figure 2).

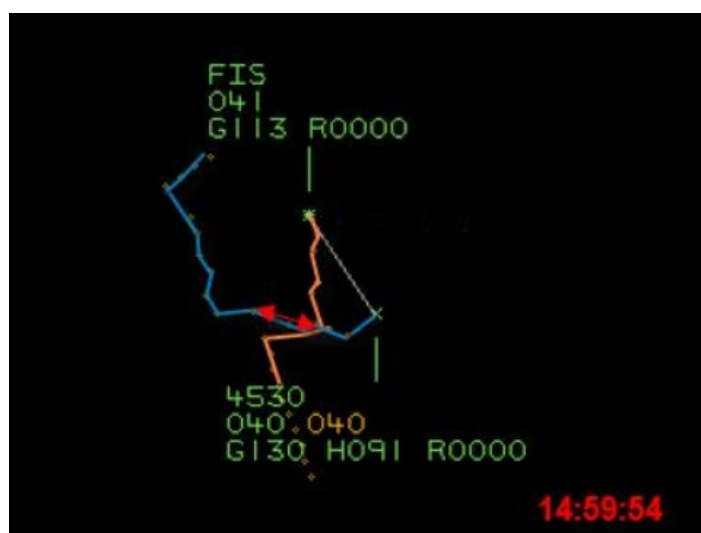
[The PA28] then continued on a northerly track, whilst [the DA42] tracked further east. Figure 3 displays the radar trails of manoeuvres prior to and after the closest point of approach based on NODE radar.

Figure 3 – Blue = DA42 Orange = PA28 Red = CPA as in Figure 2

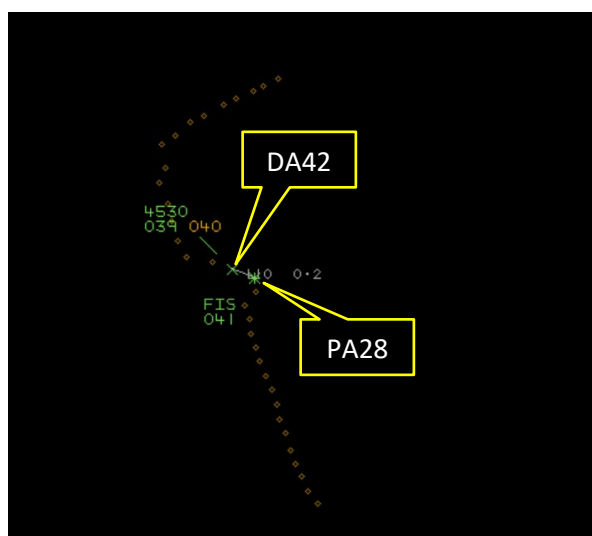
An analysis of the NATS radar replay was undertaken and both aircraft could be identified using Mode S data. CPA was assessed to be at 1459:35 when the two aircraft were 200ft vertically and 0.2NM laterally separated.

Figure 4 – CPA 1459:35

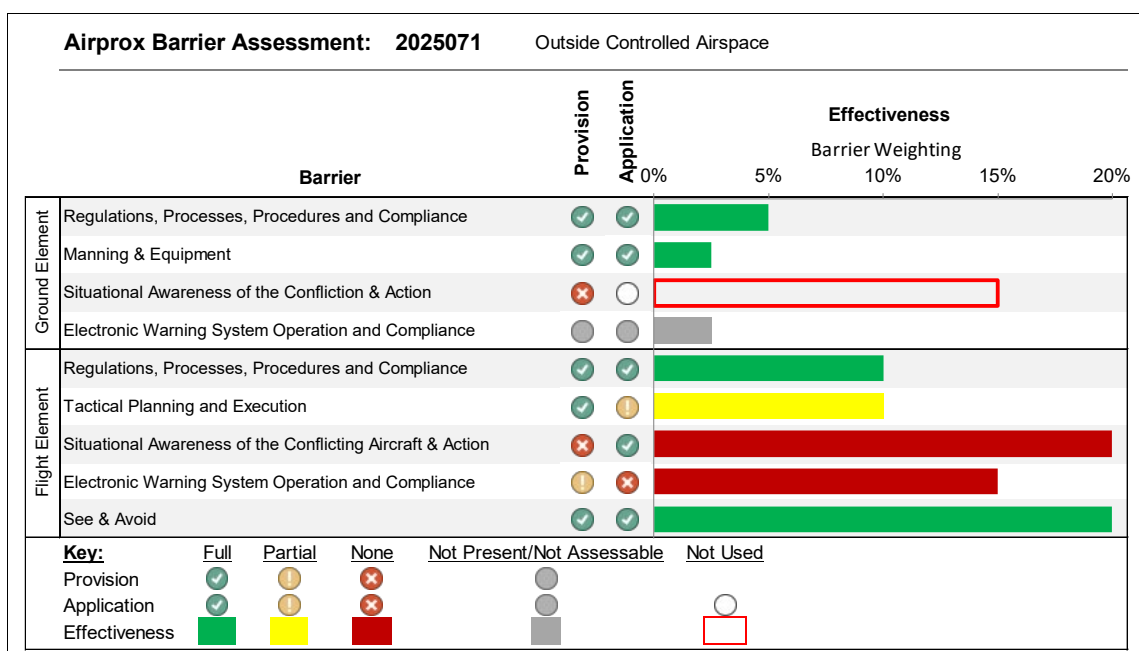
Regulations, Processes, Procedures and Compliance were assessed as **not used** because neither the London Information FISO nor the Gloster controller were required to monitor the aircraft under a Basic Service.

Tactical Planning and Execution was assessed as **partially effective** because either pilot could have called Brize Radar for a surveillance-based ATS.

Situational Awareness of the Conflicting Aircraft and Action were assessed as **ineffective** because neither pilot had any prior situational awareness about the other aircraft.

Electronic Warning System Operation and Compliance were assessed as **ineffective** because the information received from the TAS on the DA42 was not received in time for the pilot to take action.
