**AIRPROX REPORT No 2025099**

Date: 23 May 2025 Time: 1430Z Position: 5111N 00104W Location: IVO Lasham

**PART A: SUMMARY OF INFORMATION REPORTED TO UKAB**

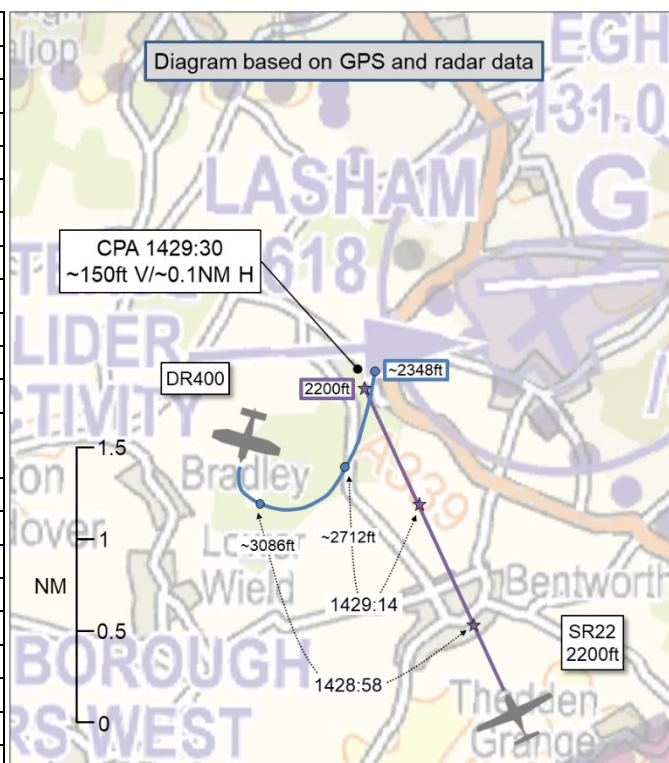
Recorded	Aircraft 1	Aircraft 2
Aircraft	DR400	SR22
Operator	Civ FW	Civ FW
Airspace	London FIR	London FIR
Class	G	G
Rules	VFR	VFR
Service	None	Basic
Provider	N/A	F'borough LARS W
Altitude/FL	~2348ft	2200ft
Transponder	None <sup>1</sup>	A, C, S
Reported		
Colours	Black, yellow	White, blue
Lighting	Anti-col, landing, taxi, nav, strobes	Strobes
Conditions	VMC	VMC
Visibility	>10km	>10km
Altitude/FL	2700ft	2200ft
Altimeter	QNH (1019hPa)	QNH
Heading	045°	"North"
Speed	110kt	150kt
ACAS/TAS	FLARM	TAS
Alert	Information	Information
Separation at CPA		
Reported	200ft V/200m H	500ft V/1NM H
Recorded	~150ft V/~0.1NM H

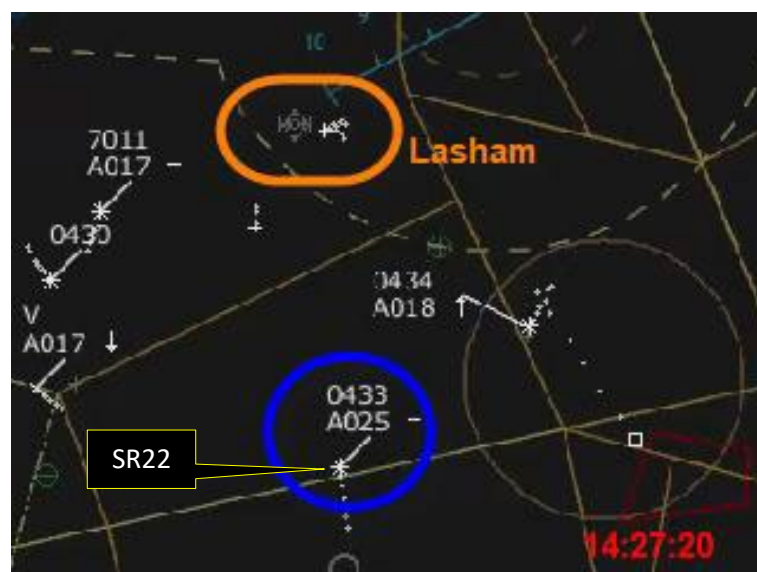
Figure 1 – Farnborough Radar (1427:20)

At the time of that advice, [the SR22] was tracking towards the Lasham overhead at altitude 2500ft, where a number of primary radar contacts were in the vicinity (Figure 1).

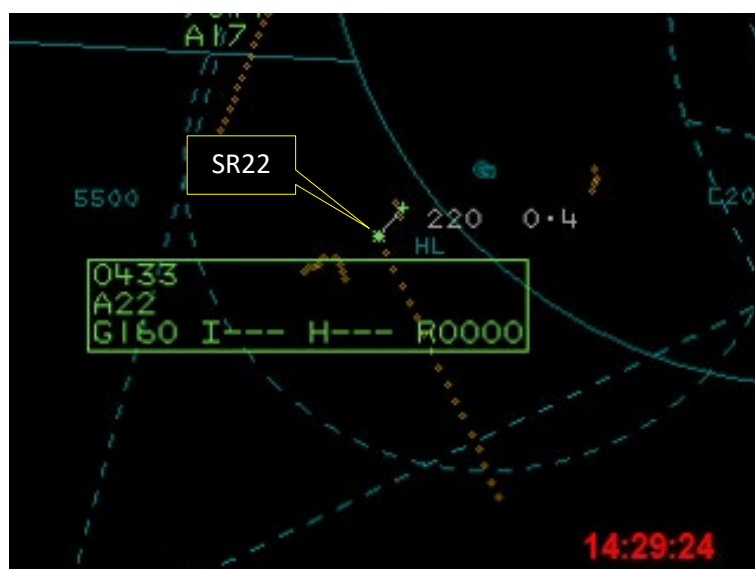
Figure 2 – NODE radar (1429:24)

At 1429:16, NODE radar displayed a single primary track that had appeared to the north-east of [the SR22] that, potentially, correlated with an aircraft which had then tracked on a similar adjacent path 0.4NM to the east of [the SR22]. Neither aircraft appeared to change track (Figure 2).

That was the Closest Point of Approach from any primary target in the vicinity and was assessed on NODE Radar as 0.4NM laterally with a vertical separation unable to be established.

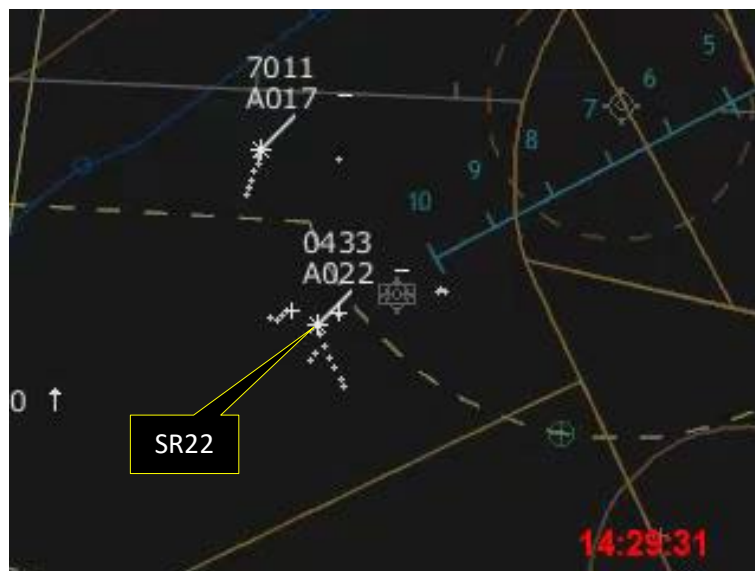
Figure 3 – Farnborough radar (1429:31)

NODE Radar displayed [the SR22] had passed 1.2NM to the west of Lasham Airfield. Prior to the reported time of the conflict, both previous primary contacts (as displayed in Figure 1) in the vicinity of Lasham had disappeared from the Farnborough Radar display, with two further primary contacts appearing within the vicinity of [the SR22] (as displayed in Figure 2) on the Farnborough radar display at 1429:31 (Figure 3).

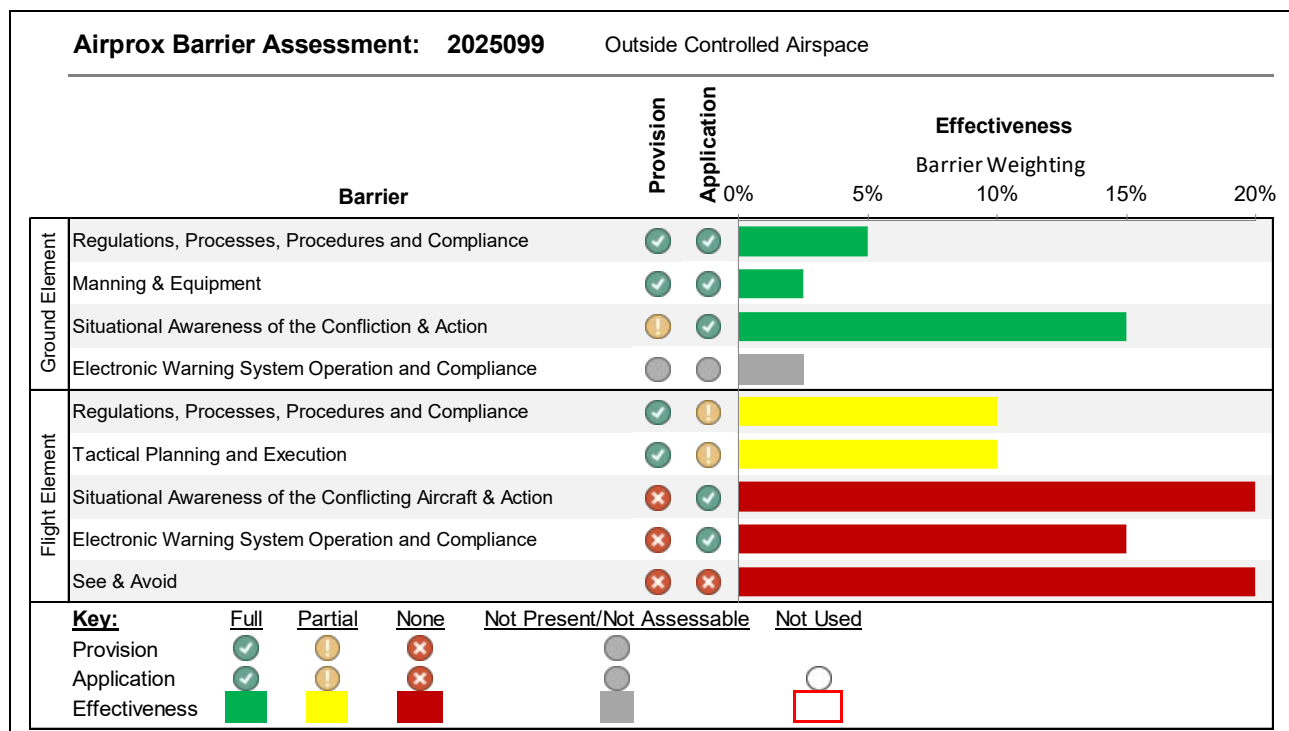
Safety Barrier Assessment<sup>7</sup>

**Regulations, Processes, Procedures and Compliance** were assessed as **partially effective** because the pilot of the DR400 had reported that the DR400 had been fitted with a transponder but no transponder returns were detected by SSR equipment.

**Tactical Planning and Execution** was assessed as **partially effective** because it may have been prudent for the pilot of the SR22 to have ensured greater separation from Lasham.

**Situational Awareness of the Conflicting Aircraft and Action** were assessed as **ineffective** because the pilot of the DR400 had not had situational awareness of the presence of the SR22.

**Electronic Warning System Operation and Compliance** were assessed as **ineffective** because the EC equipment fitted to each aircraft would not have been expected to have detected the other aircraft.

**See and Avoid** were assessed as **ineffective** because neither pilot had sighted the other aircraft in time to have taken effective avoiding action.
