**AIRPROX REPORT No 2025115**

Date: 20 Jun 2025 Time: 1116Z Position: 5232N 00054W Location: 7NM SE of Leicester Aerodrome

**PART A: SUMMARY OF INFORMATION REPORTED TO UKAB**

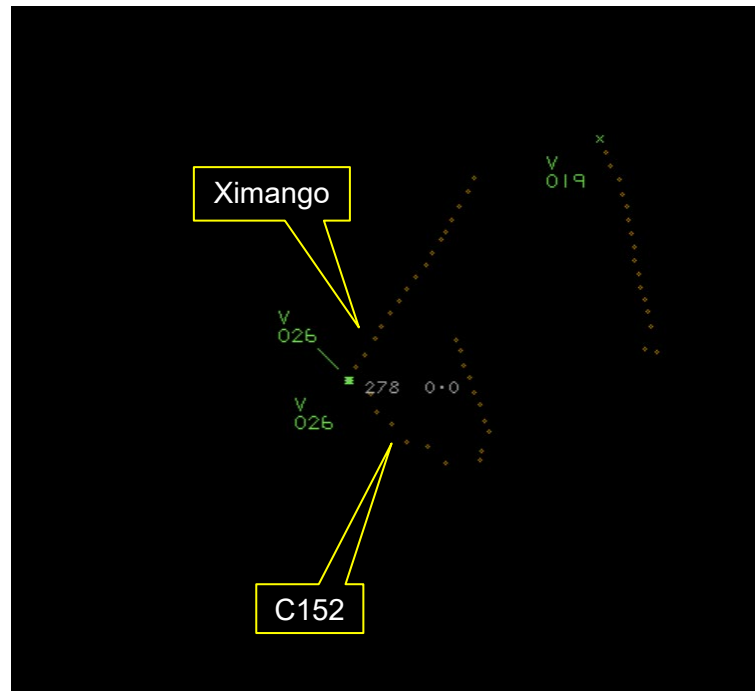
Figure 1: at CPA (1115:34) 0ft V/<0.1NM H

Both aircraft were tracked and identified using radar. The altitudes referenced in the table at page 1 are calculated by applying a QNH-to-SPS adjustment.

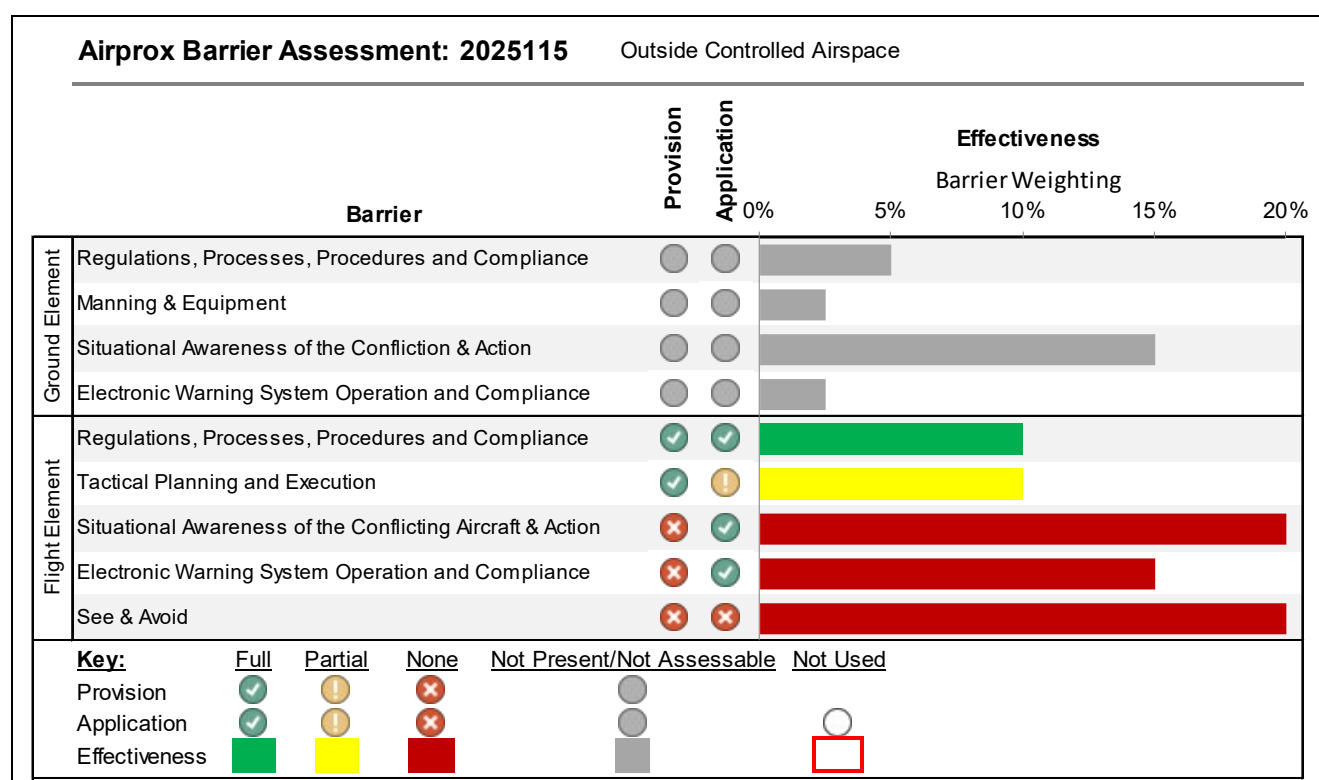
**Tactical Planning and Execution** was assessed as **partially effective** because both pilots could have considered utilising a LARS from East Midlands Radar.

**Situational Awareness of the Conflicting Aircraft and Action** were assessed as **ineffective** because neither pilot had any situational awareness of the presence of the other aircraft.

**Electronic Warning System Operation and Compliance** were assessed as **ineffective** because the electronic conspicuity equipment carried by the Ximango pilot had been unable to receive any electronic emissions from the C152, and the C152 had not been equipped with any form of EC.

**See and Avoid** were assessed as **ineffective** because both pilots had achieved visual contact with the other aircraft too late to materially increase separation.
