AIRPROX REPORT No 2025098

Date: 23 May 2025 Time: 1208Z Position: 5206N 00130W Location: IVO Edgehill/Shenington

PART A: SUMMARY OF INFORMATION REPORTED TO UKAB

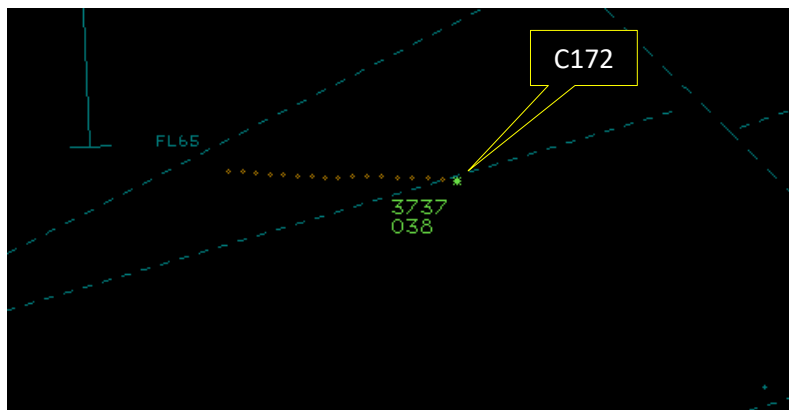
Figure 1 – CPA at 1208:24

An analysis of the NATS radar replay was undertaken and the C172 could be positively identified from Mode S data (Figure 1). The paraglider was not observed on the replay.

The paraglider pilot kindly supplied GPS track data for their flight. The diagram was constructed and the separation at CPA determined by combining the data sources. The recorded altitudes for the paraglider have been converted to Flight Levels for ease of comparison.
