AIRPROX REPORT No 2025117

Date: 21 Jun 2025 Time: 1126Z Position: 5210N 00126W Location: 6.5NM NNW Banbury

PART A: SUMMARY OF INFORMATION REPORTED TO UKAB

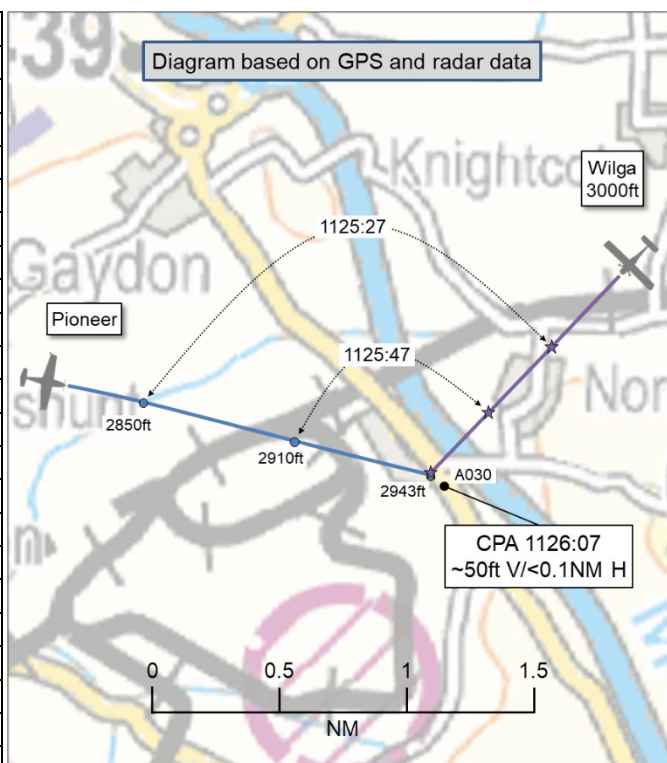
Recorded	Aircraft 1	Aircraft 2
Aircraft	Pioneer	Wilga
Operator	Civ FW	Civ FW
Airspace	London FIR	London FIR
Class	G	G
Rules	VFR	VFR
Service	None	None
Altitude/FL	2943ft	3000ft
Transponder	None ¹	A, C, S
Reported		
Colours	Silver, purple	Red, white
Lighting	Nav, strobes	Beacon, strobes
Conditions	VMC	VMC
Visibility	5-10km	>10km
Altitude/FL	2800ft	2500ft
Altimeter	QNH (1017hPa)	QNH
Heading	090°	224°
Speed	100kt	65kt
ACAS/TAS	Not fitted	SkyEcho
Alert	N/A	None
Separation at CPA		
Reported	100ft V/0m H	500ft V/0.25NM H
Recorded	~50ft V/<0.1NM H

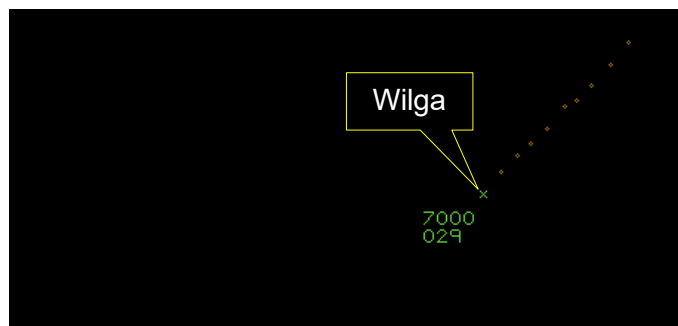
Figure 1 – 1126:10

An analysis of the NATS radar replay was undertaken and the Wilga could be positively identified from Mode S data. The Wilga was depicted on the replay as having flown at Flight Levels (Figure 1). A suitable correction was used to determine its altitude. The Pioneer was not observed on the radar replay.

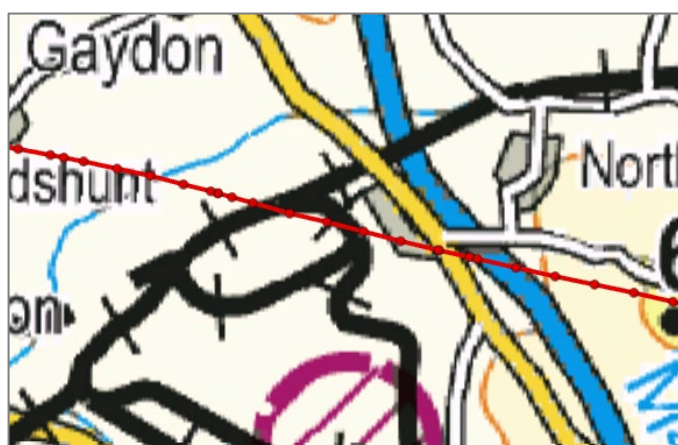
Figure 2 – The track of the Pioneer

The pilot of the Pioneer kindly supplied GPS track data for their flight (Figure 2). It was by combining the data sources that the diagram was constructed and the separation at CPA determined.
