AIRPROX REPORT No 2025116

Date: 16 Jun 2025 Time: 1555Z Position: 5411N 00121W Location: Topcliffe

PART A: SUMMARY OF INFORMATION REPORTED TO UKAB

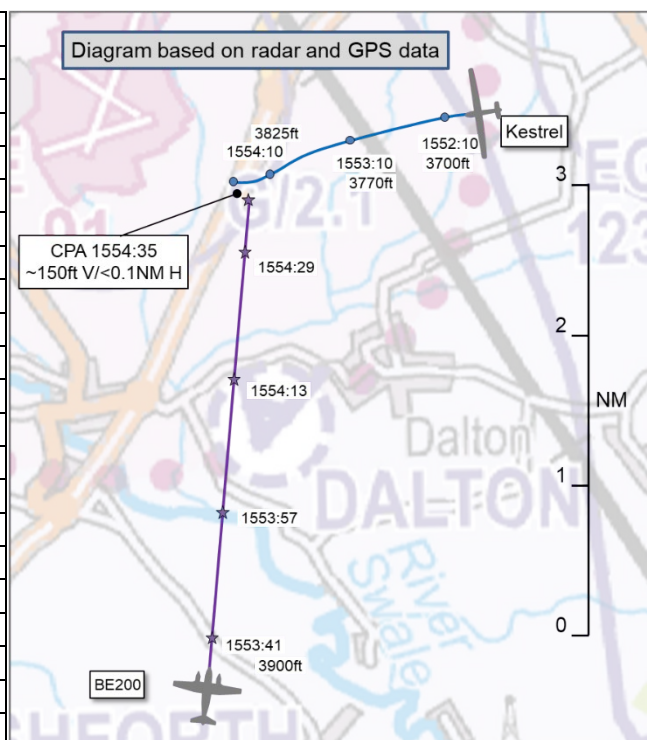
The BE200 was tracked by radar and identified through Mode S data. The Kestrel did not show on radar. The Kestrel pilot provided a GPS file, with the diagram at page 1 having been created by merging that information with the BE200 radar track.

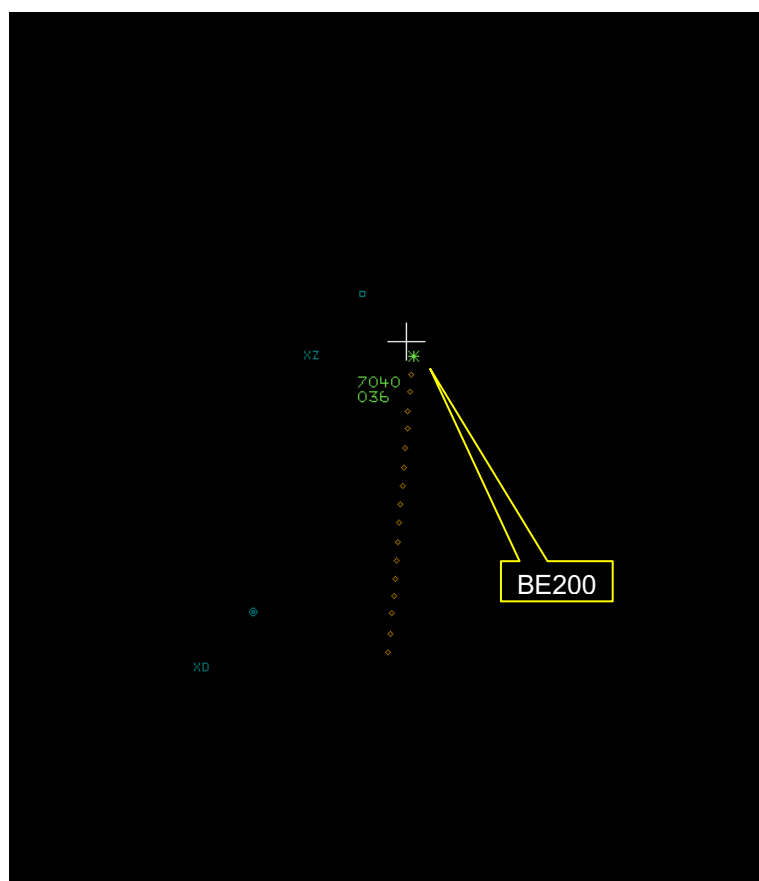
Figure 1: At 1554:35 (CPA). The Kestrel did not show on radar. The BE200 remained at a constant altitude of 3900ft AMSL toward CPA.

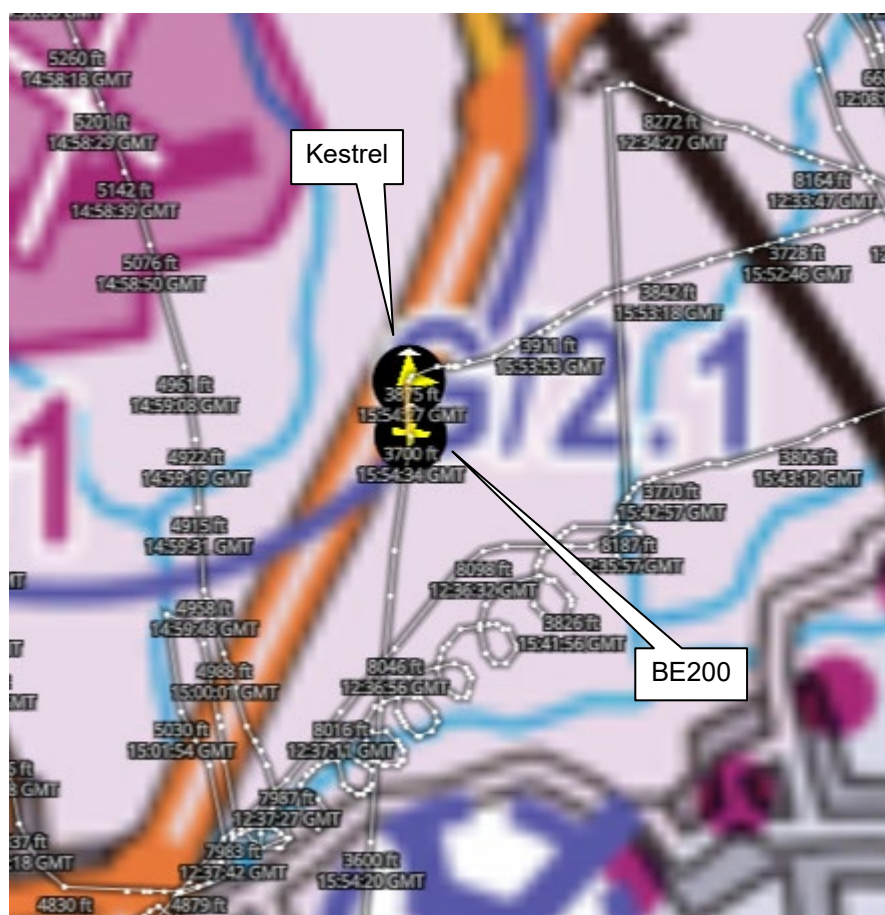
Figure 2: From the Airspace Analyser Tool – BE200 at 1554:34/005°/215kt/+192fpm/3700ft (SPS); Kestrel at 1554:28/226°/32kt/+515fpm/3882ft (SPS)
