AIRPROX REPORT No 2025125

Date: 27 Jun 2025 Time: 1623Z Position: 5110N 00101E Location: 5NM E Ashford

PART A: SUMMARY OF INFORMATION REPORTED TO UKAB

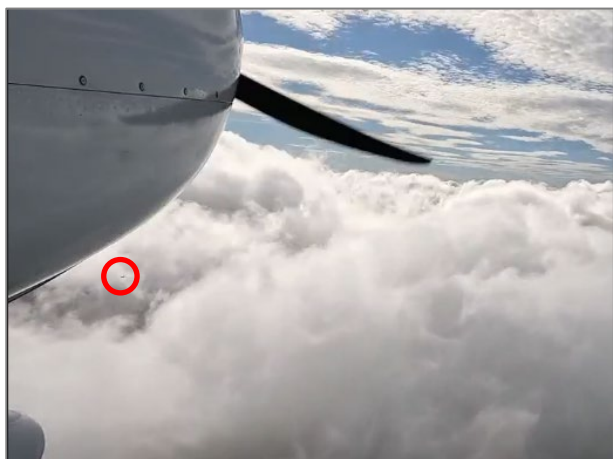
Figure 1 – A screenshot from a video taken from the flight of the C182 showing the PA28.

They were flying in 'gin-clear' VMC [they believe] with scattered/broken cloud at least 300ft below. Both they, and their passengers, saw another aircraft at a distance of at least 0.5NM, and it passed down their left-hand side at least 300ft below them. It was in and out of cloud. They attempted to identify the aircraft with their ADS-B-in full-screen function, but it did not appear. They had seen other aircraft on their display that day. They wondered what the [pilot of the PA28] was doing, flying in that location in marginal conditions.

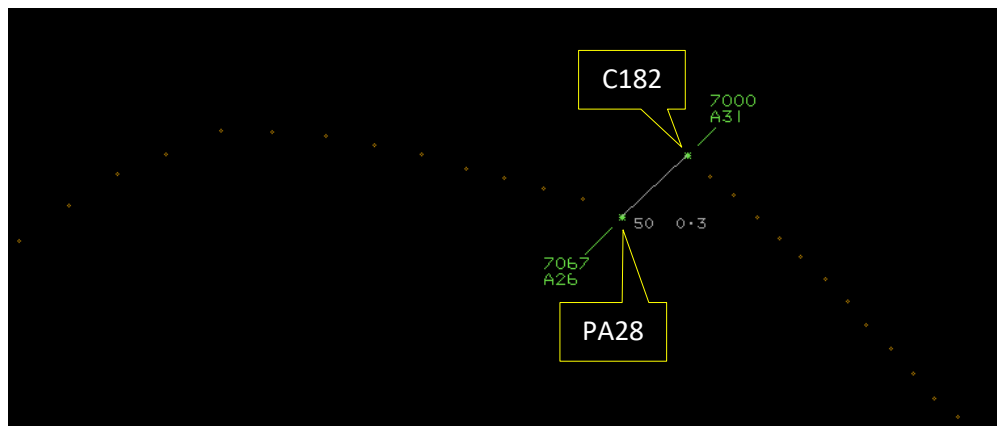
Figure 4 – CPA at 1623:10 (with Mode C altitudes corrected to ‘radar’ QNH 1020hPa).

An analysis of the NATS radar replay was undertaken and both aircraft could be positively identified from Mode S data (Figure 4). The diagram was constructed and the separation at CPA determined from the radar data. The PA28 was observed on the NATS radar replay with 'Enhanced' Mode S returns but was not observed by reference to ADS-B data sources. The C182 was observed by reference to ADS-B data sources.
