AIRPROX REPORT No 2025126

Date: 30 Jun 2025 Time: 1201Z Position: 5339N 00100W Location: 5NM southwest of Goole

PART A: SUMMARY OF INFORMATION REPORTED TO UKAB

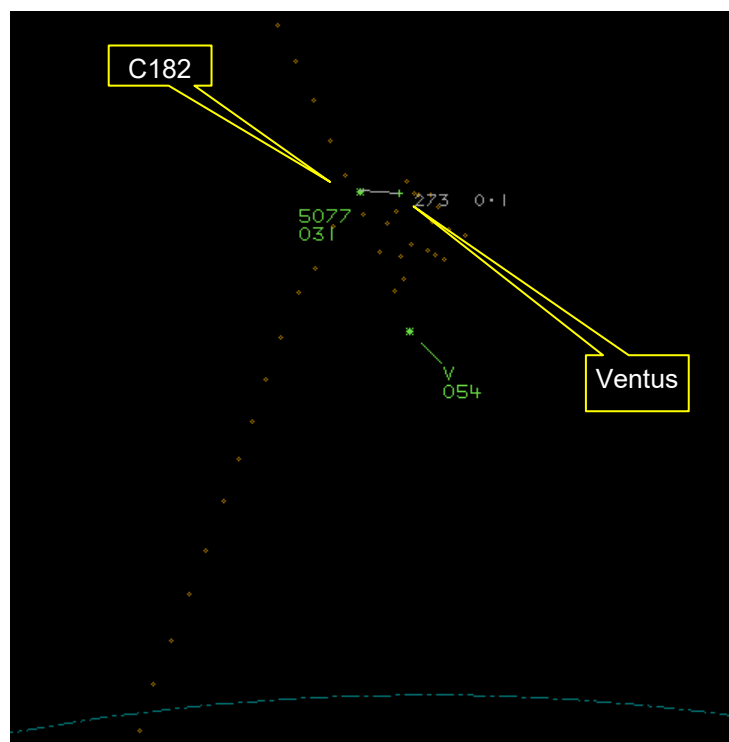
Figure 1: At CPA (1201:07)

Both aircraft were tracked by radar and identified through Mode S data. Figure 1 appears to show the C182 passing to the left of the Ventus whilst heading north, but both pilot reports and figure 3 indicate that the C182 passed the Ventus from left-to-right across its nose whilst heading easterly, with the C182 pilot having initiated their reported avoiding action.

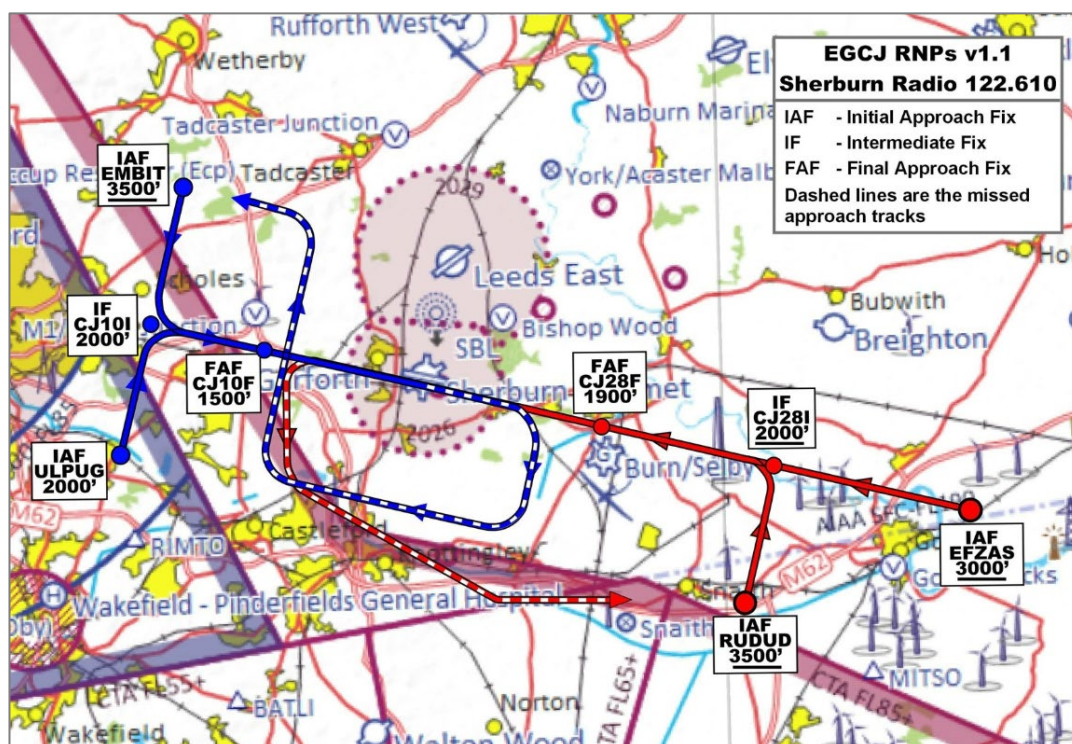
Figure 4: RNP for Sherburn – Waypoint 'RUDUD' – CPA 2.5NM south of RUDUD

Additionally, Board members noted that, at CPA, the C182 pilot had been on the Sherburn AGCS frequency which, as the CPA had been only 2.5NM from the waypoint RUDUD, was not deemed to have been unreasonable. Prior to that position, however, the pilot had not followed the direction within the Pilot Brief where, within paragraph 4.2, it states that:

Recommendation: Sherburn remove the expired AIC Y 083/2023 from their website and ensure the RNP Instrument Approach Procedures 'Pilot Brief' and 'RNP Pilot Crib Sheet' are consistent.
