AIRPROX REPORT No 2025127

Date: 29 Jun 2025 Time: 1002Z Position: 5120N 00004W Location: 1.5NM NNW Kenley Airfield

PART A: SUMMARY OF INFORMATION REPORTED TO UKAB

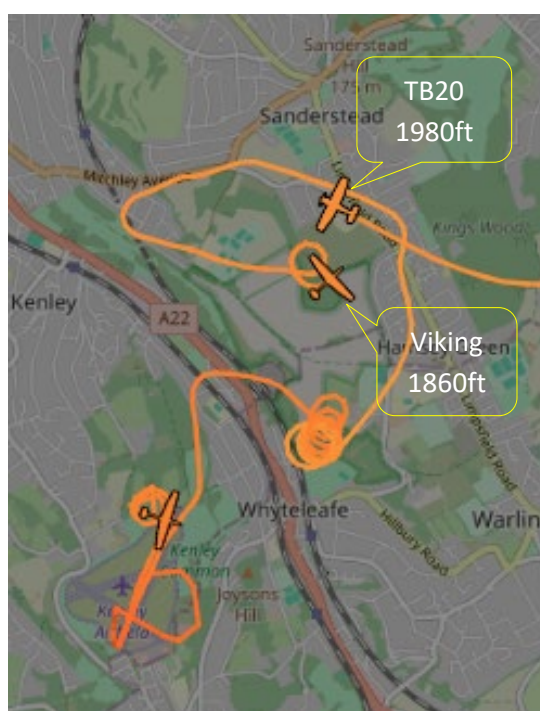
Figure 1 - Time ~1001:30

An analysis of the NATS radar replay was undertaken and the TB20 was positively identified using Mode S data. The Viking glider was seen as a primary-only track. Further analysis of ADS-B data sources was undertaken and both aircraft were identified using ADS-B data (Figure 1).

Shortly before CPA, the Viking was seen to be tracking approximately east prior to circling, and the TB20 tracking approximately west-northwest. CPA was assessed to have occurred at 1001:38 with approximately 120ft vertical and 0.2NM lateral separation.
