AIRPROX REPORT No 2025129

Date: 01 Jul 2025 Time: 1344Z Position: 5140N 00204W Location: Kemble Aerodrome

PART A: SUMMARY OF INFORMATION REPORTED TO UKAB

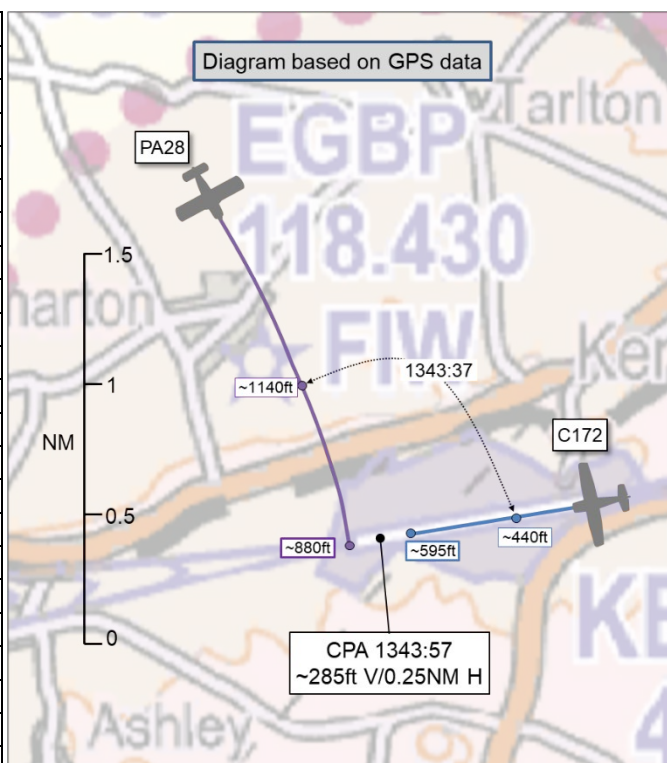
Recorded	Aircraft 1	Aircraft 2
Aircraft	C172	PA28
Operator	Civ FW	Civ FW
Airspace	Kemble ATZ	Kemble ATZ
Class	G	G
Rules	VFR	VFR
Service	AFIS	AFIS
Provider	Kemble Info	Kemble Info
Altitude	~595ft	~880ft
Transponder	A, C, S	A, C, S
Reported		
Colours	Blue and white	Blue/silver
Lighting	Bcn, strobe & Idg	Wingtip strobes
Conditions	VMC	VMC
Visibility	>10km	>10km
Altitude/FL	NK	700ft
Altimeter	QNH	QNH (1016hPa)
Heading	260°	170°
Speed	80kt	105kt
ACAS/TAS	Not fitted	Not fitted
Separation at CPA		
Reported	200ft V/200m H	Not seen
Recorded	~285ft V/0.25NM H

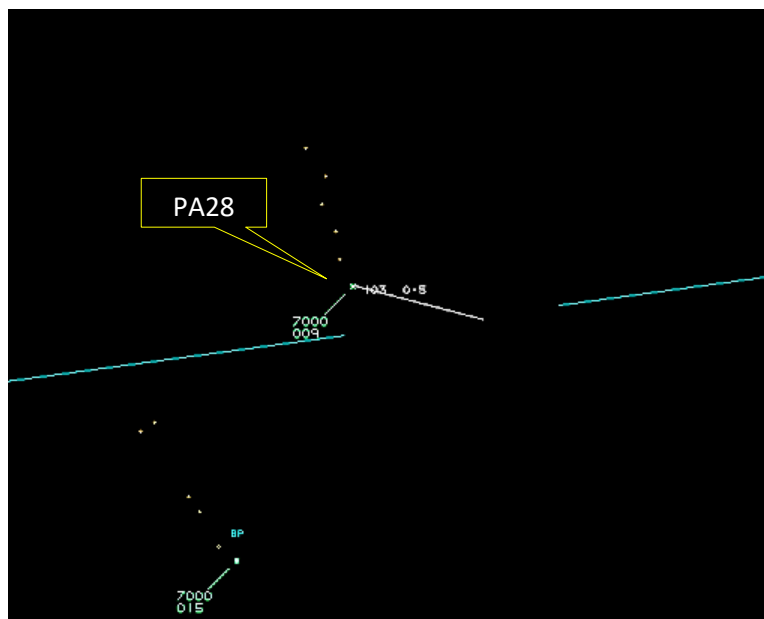
Figure 1 – Time 1343:55

At 1343:55 the pilot of [the PA28] reported overhead. The aircraft was 0.5NM west-northwest of the airfield at a height of approximately 800ft (snapshot of the radar replay with the aircraft's level being displayed as a FL, Figure 1):

The pilot of [the PA28] did not complete an overhead join, routing straight from the north into a crosswind position, well below circuit height. They [may not] have had time to assimilate the traffic situation and integrate with the existing traffic pattern.

The timeframe between initial contact and the AFISO warning the pilot they appeared very low when joining crosswind suggests a crosswind join was flown, possibly on QNH, which would place the aircraft at 600ft AGL, not the 1000ft expected or the 800ft suggested by the PIC.
