AIRPROX REPORT No 2025135

Date: 03 Jul 2025 Time: ~1202Z Position: 5058N 00113W Location: IVO Lower Upham

PART A: SUMMARY OF INFORMATION REPORTED TO UKAB

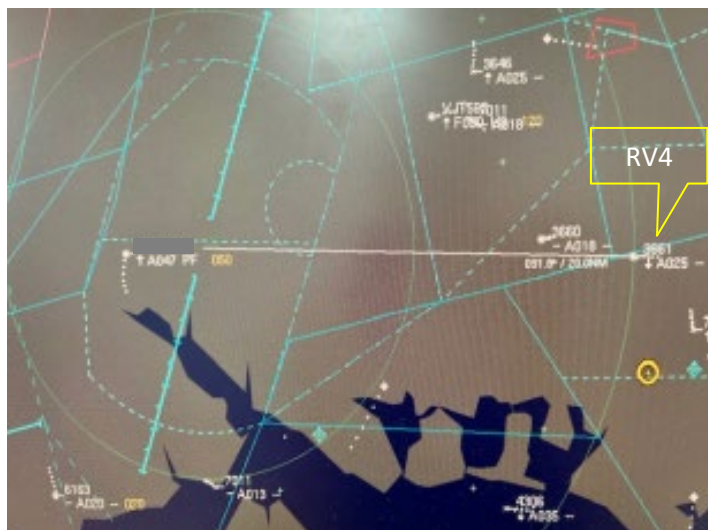
Figure 3

At this time 3661 was seen on the radar display approximately 20NM east of Southampton at 2500ft.

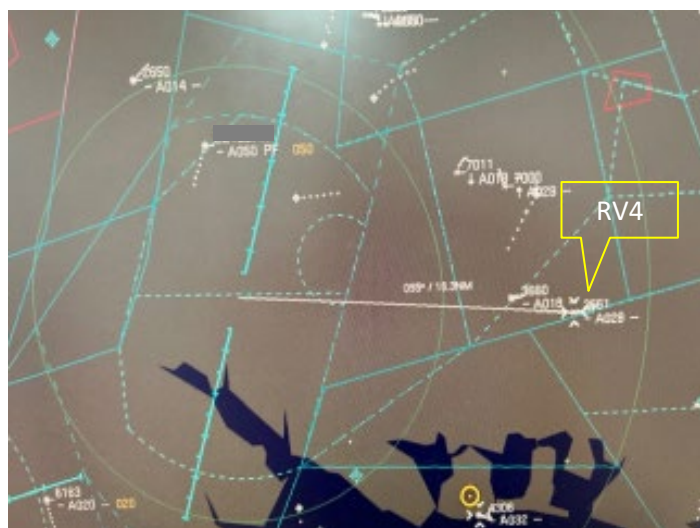
Figure 4

This was the first of 2 messages to the RV4 pilot, warning them of the presence of the Bishops Waltham Flying Area. [The RV4] was bearing 095° from Southampton, at a distance of 16.3NM and altitude of 2800ft (Figure 4).

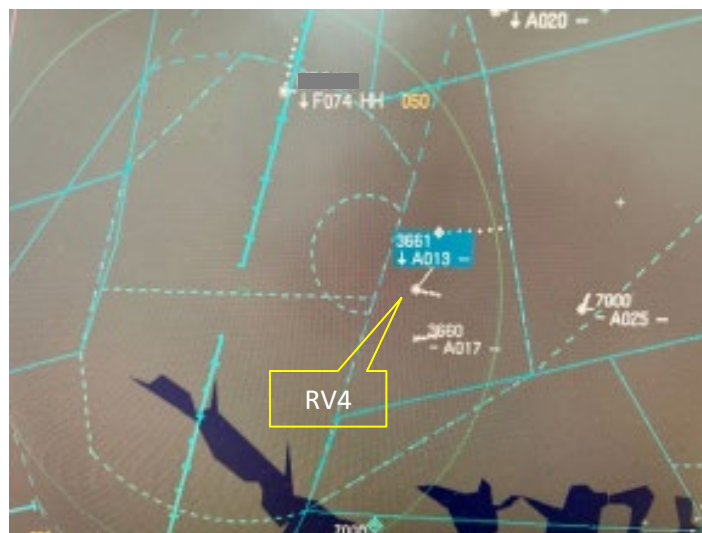
Figure 6

At this point [the unrelated aircraft squawking] 3660 was approximately 7NM to the east of Southampton airfield indicating A017 having been cleared to transit controlled airspace not above altitude 2000ft VFR. [The RV4 squawking] 3661 was approximately 7NM east of Southampton airfield indicating A013 and 1.7NM due north of the other aircraft.

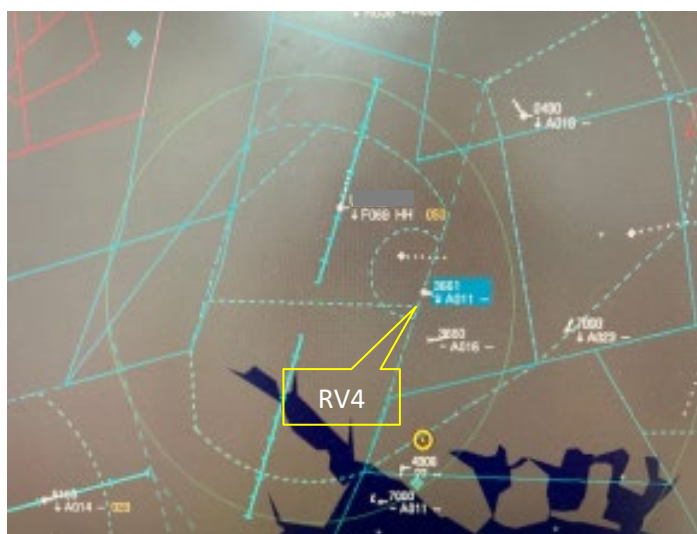
Figure 7

[The RV4] crossed the Southampton CTR boundary and entered controlled airspace at 1201:10, indicating 1100ft. There were no PSR or SSR contacts observed in the BWFA.

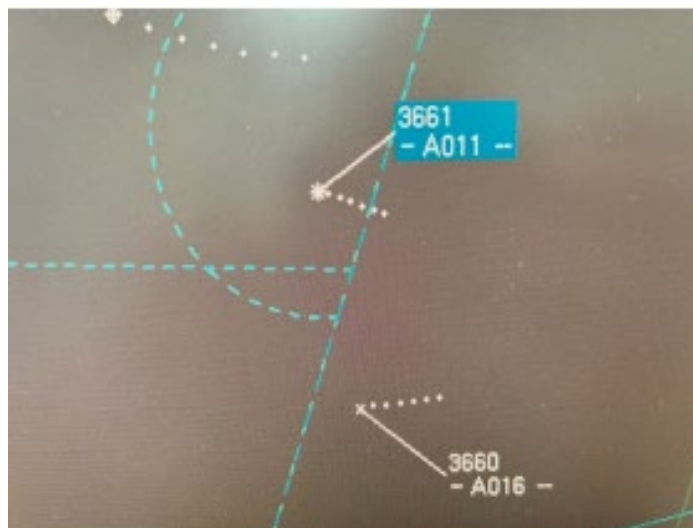
Figure 8

There was no indicated significant deviation to the track of [the RV4] with no displayed PSR or SSR contacts within the Bishops Waltham Flying Area (BWFA).

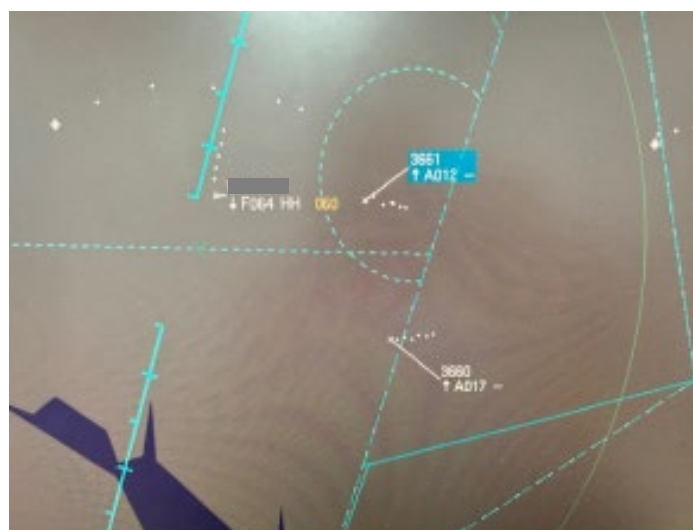
Figure 9

When [the C42 pilot] reported that they had been overflown there were no visible primary or secondary radar returns to indicate that an aircraft was airborne in the BWFA.

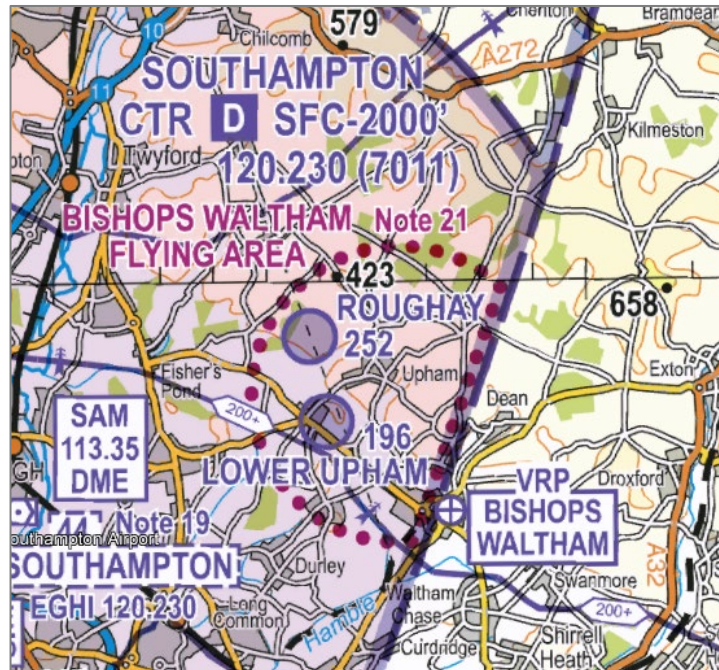
Figure 10 – CAA VFR Chart 1:250,000

21. BISHOPS WALTHAM FLYING AREA. Aircraft arriving or departing at Roughay or Lower Upham without a requirement to establish RTF contact with SOLENT RADAR or SOUTHAMPTON RADAR are to remain within the area. See UK AIP AD 2.EGHI.

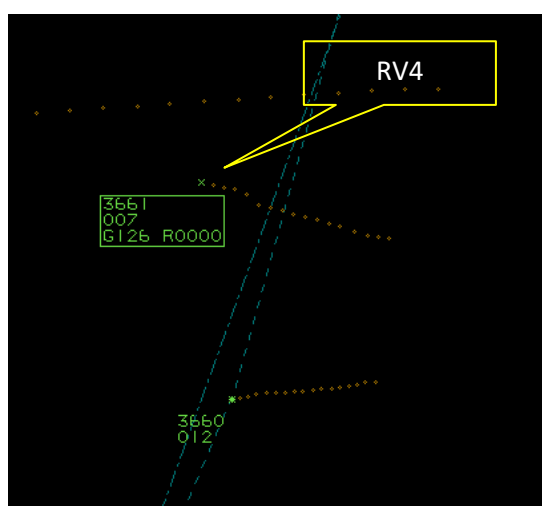
Figure 12 – 1201:38

An analysis of the NATS radar replay was undertaken and the RV4 could be identified using Mode S data. The RV4 had an indicated ground speed of 126kt and an altitude of FL007 (Southampton QNH was 1029hPa, therefore an approximate altitude of around 1130ft), see Figure 12. The C42 could not be seen on the radar, nor could it be seen on the CAA's airspace analysis tool, or any other open-source ADS-B tracking sites. Therefore, the exact separation between the two aircraft could not be ascertained.
