AIRPROX REPORT No 2025141

Date: 08 Jul 2025 Time: ~1152Z Position: 5026N 00446W Location: ivo of Roche airstrip

PART A: SUMMARY OF INFORMATION REPORTED TO UKAB

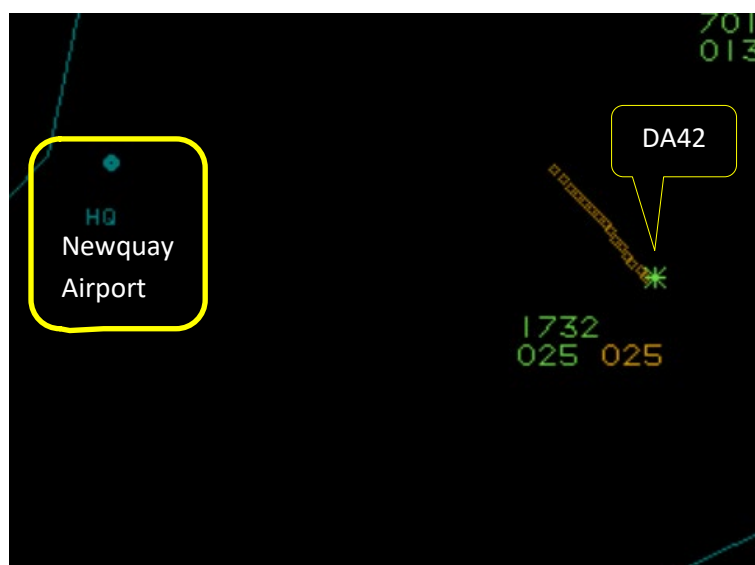
Figure 1 – Time 1152:40 after DA42 track deviation

An analysis of the NATS radar replay was undertaken and the DA42 was positively identified using Mode S data. The DA42 was seen deviating from their track at 1152:11 and gaining 200ft in altitude at 1152:31. The aircraft altitude and track were recovered at 1152:47. The hang-glider was not detected.

CPA was estimated to have occurred at approximately 1152:07 based on the RTF call from the DA42 pilot and subsequent manoeuvring detected by radar and MLAT sources. The hang-glider could not be detected and no GPS track was available, therefore separation at CPA cannot be assessed. No other hang-gliders were known to be operating in the vicinity.

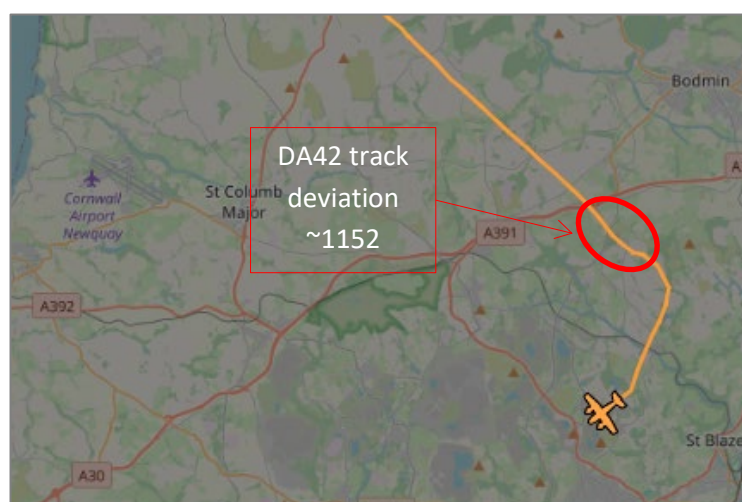
Figure 2 – Time 1154 DA42 on base-leg for RW30

A further analysis of third party aircraft tracking software was undertaken and the DA42 was seen on a steady heading, approximately downwind for RW30, and having made a deviation from track at approximately 1152, just prior to changing to a base-leg track for RW30 (Figure 2).

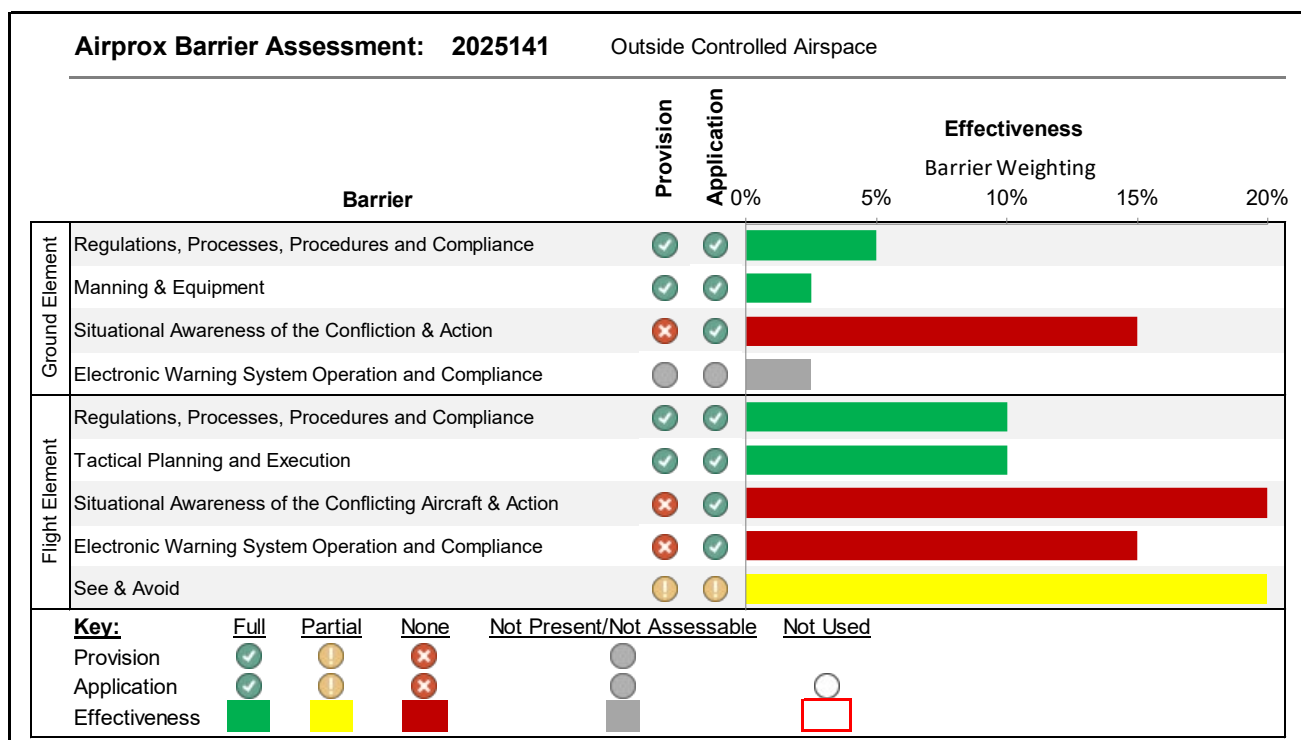
Situational Awareness of the Confliction and Action were assessed as **ineffective** because the Newquay Radar controller had no situational awareness of the presence of the hang-glider.

Situational Awareness of the Conflicting Aircraft and Action were assessed as **ineffective** because neither the DA42 pilot nor the hang-glider pilot had situational awareness of the other aircraft.

Electronic Warning System Operation and Compliance were assessed as **ineffective** because the EC equipment in the DA42 was unable to detect the hang-glider.

See and Avoid were assessed as **partially effective** because DA42 pilot had sighted the hang-glider at a late stage, and the hang-glider pilot had not seen the DA42.
