AIRPROX REPORT No 2025142

Date: 05 Jul 2025 Time: 1636Z Position: 5203N 00056W Location: 3.5NM ESE Silverstone

PART A: SUMMARY OF INFORMATION REPORTED TO UKAB

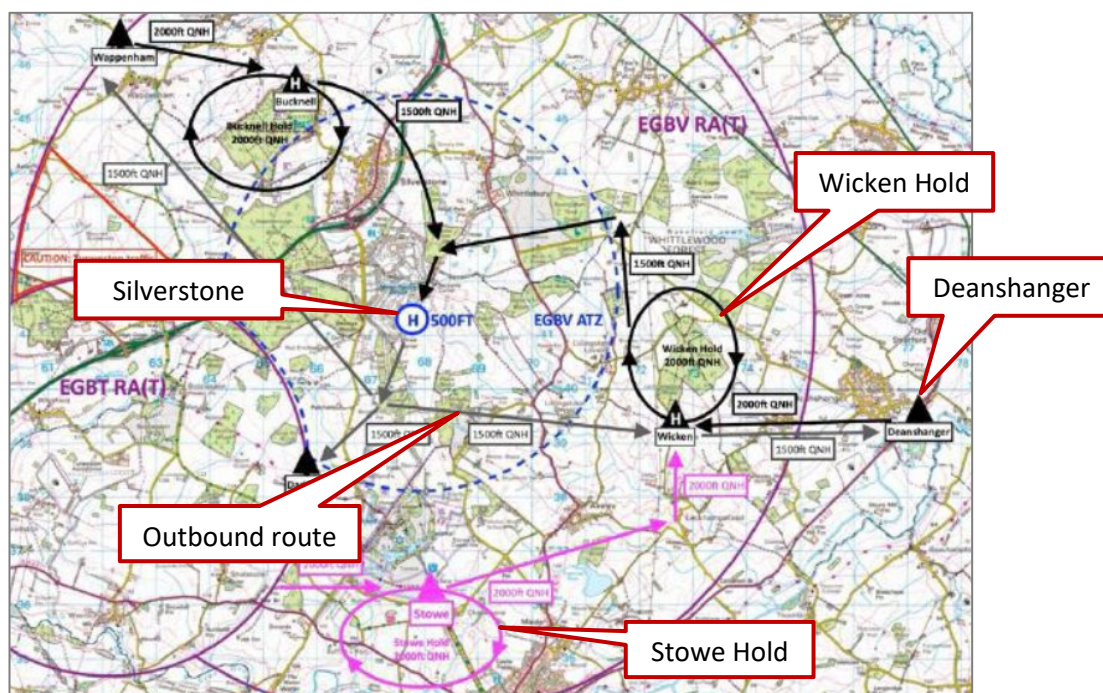
Figure 2 – An extract from the Silverstone Pilot's Briefing document.

There were no Silverstone TWR elements to this incident: the pilots were operating under VFR in Class G airspace and responsible for their own separation. To overcome wake turbulence issues with ‘Small’ and ‘Light’ helicopters in the visual holds, ‘Small’ helicopters were required to hold at 1700ft beneath the ‘Lights’ at 2000ft. This reduced the altitude difference between an inbound ‘Small’ routeing via Deanshanger and Wicken and an outbound ‘Light’ to 200ft rather than the standard 500ft. At the time the procedures were designed, there were only two AW139s booked for this event. Three weeks before the event, this had increased to seven AW139s and an S92, all operating multiple flights. The altitude difference of 200ft between inbound ‘Small’ helicopters and outbound helicopters may have caused the AW139 pilots some surprise when they may have been expecting the usual 500ft at such events.

Reviewing this incident highlighted that, whilst deconflicting 'Small' and 'Light' helicopters when inbound and within the visual holds, the proximity of the outbound routeing (at 1500ft) via Deanshanger [past] the Wicken hold (with 'Small' helicopters holding at 1700ft) had been overlooked. Although this was not a wake turbulence incident, there remained a possibility for this to have occurred with the present routeings. As a result of this incident, the airspace and routeings have been reviewed. In 2026, there will be one RA(T) protecting both Silverstone and Turweston traffic. The routes will be redrawn to avoid inbound and outbound helicopters tracking close to each other.

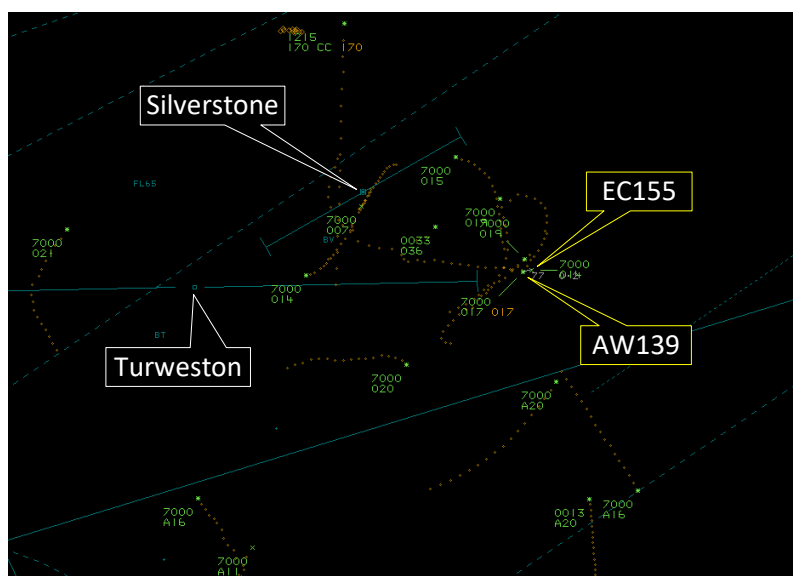
Figure 3 – The traffic situation at 1636:02

An analysis of the NATS radar replay was undertaken and both aircraft could be positively identified from Mode S data (Figure 3) and were displayed flying at Flight Levels. An appropriate conversion factor was used to calculate their respective altitudes. The pilot of the EC155 kindly supplied GPS track data for their flight. The diagram was constructed and the separation determined by combining the data sources.

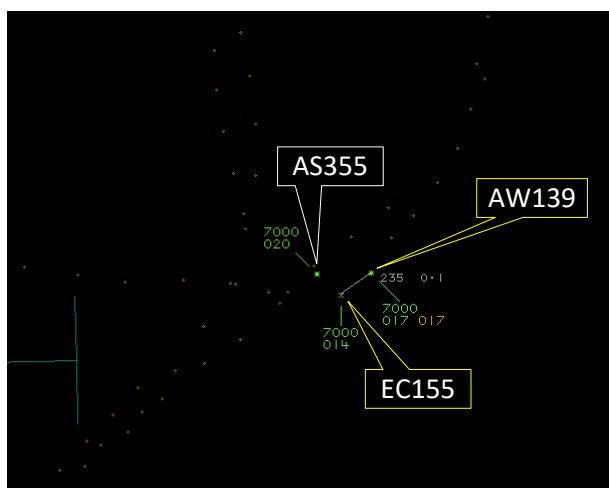
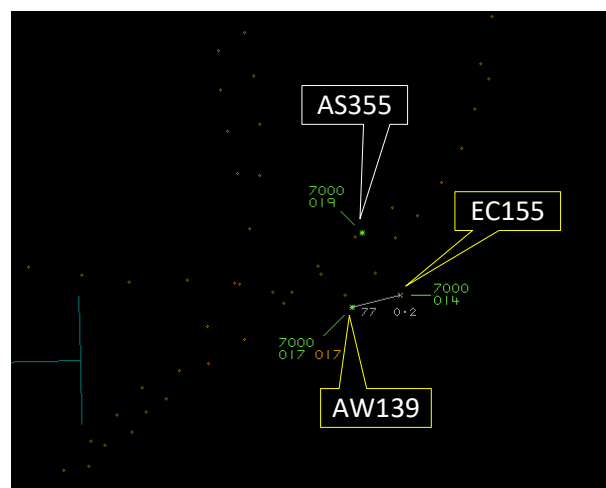
CPA was determined to have occurred between the radar sweeps at 1635:58 and 1636:02 (Figures 4 and 5).

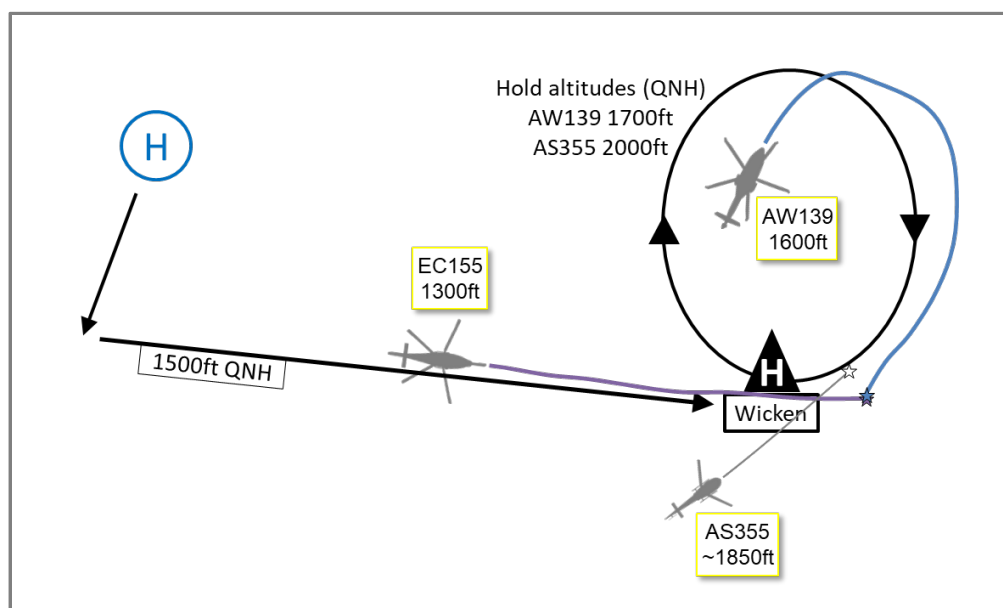
Figure 7 – The relative positions of the helicopters at CPA

The AW139 and EC155 pilots shared an equal responsibility for collision avoidance and not to operate in such proximity to other aircraft as to create a collision hazard.¹ If the incident geometry is considered as converging then the AW139 pilot was required to give way to the EC155.²
