**AIRPROX REPORT No 2025145**

Date: 16 Jul 2025 Time: 1301Z Position: 5249N 00142W Location: Tatenhill ATZ

**PART A: SUMMARY OF INFORMATION REPORTED TO UKAB**

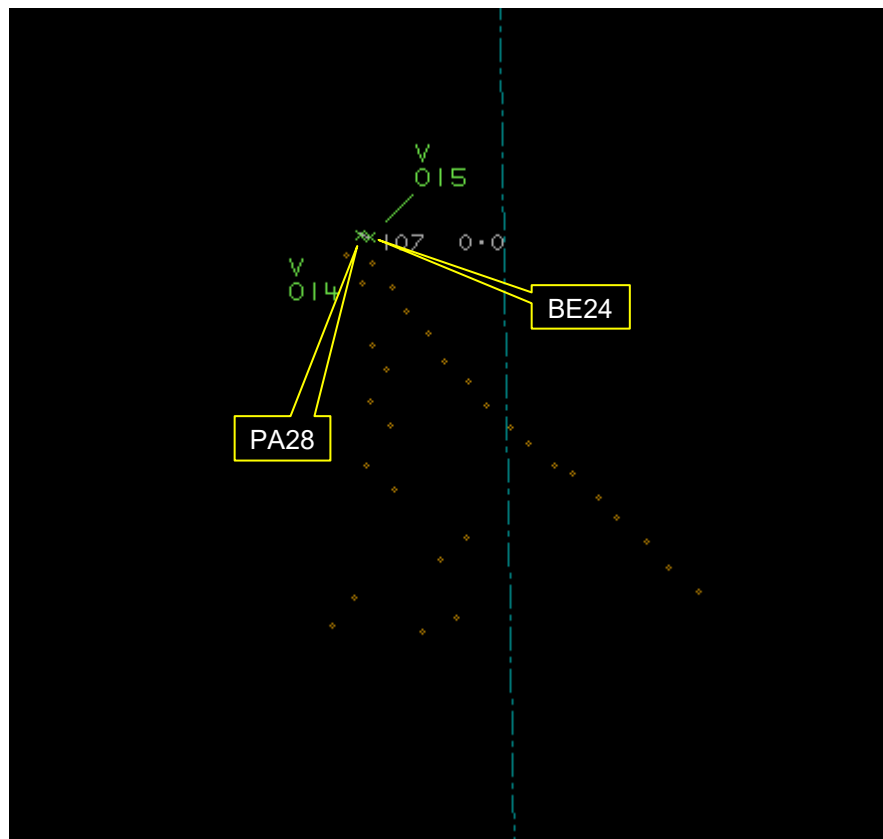
Figure 1: At CPA (1300:42) 100ft V/<0.1NM H.
