AIRPROX REPORT No 2025131

Date: 03 Jul 2025 Time: ~0925Z Position: 5202N 00338W Location: EGD203

PART A: SUMMARY OF INFORMATION REPORTED TO UKAB

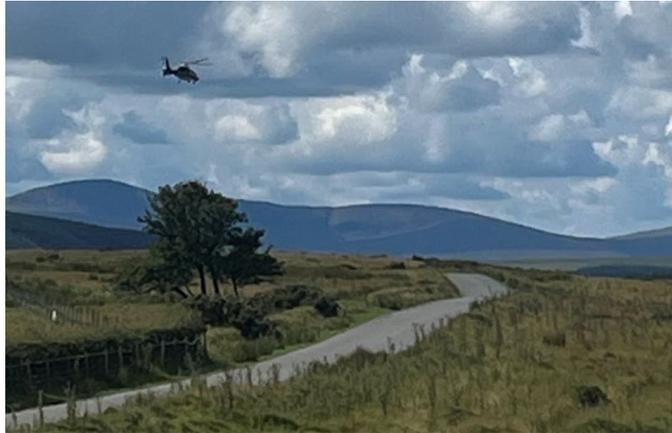
At roughly 0900, the Wraith was launched and it was in a loiter over SENTA Area 3 at around 1300ft AGL. In addition, they had a Puma RPAS crew flying in Area 2. At 0925, [the Dauphin] flew directly over the top of their launch point at 100-200ft AGL before flying east [they recall] where it proceeded to fly, what they believe had been, directly under the [Puma] RPAS.

Figure 1 – A photograph of the Dauphin as it passed the Puma RPAS GCS (after CPA)
