AIRPROX REPORT No 2025190

Date: 26 Aug 2025 Time: 1613Z Position: 5108N 00157W Location: S of Steeple Langford

PART A: SUMMARY OF INFORMATION REPORTED TO UKAB

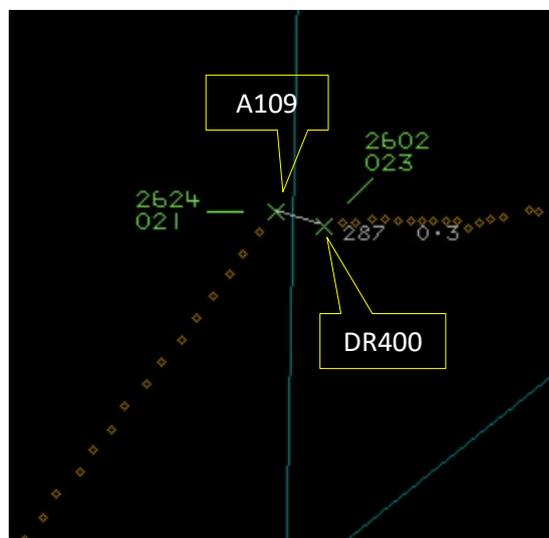
Figure 1 – Time 1612:59

An analysis of the NATS radar was undertaken and both aircraft were positively identified using Mode S data. CPA was assessed to have occurred at 1612:59 with 0.3NM and 200ft lateral separation (Figure 1).

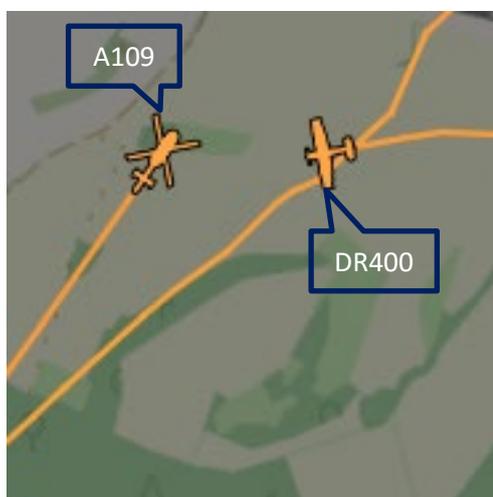
Figure 2 – 1612:50

Further analysis of aircraft tracking software was undertaken. The A109 was detected using ADS-B data and the DR400 detected using MLAT data only. The DR400 was seen to pass behind the A109 at 1613:00 using different data sources (Figure 3).

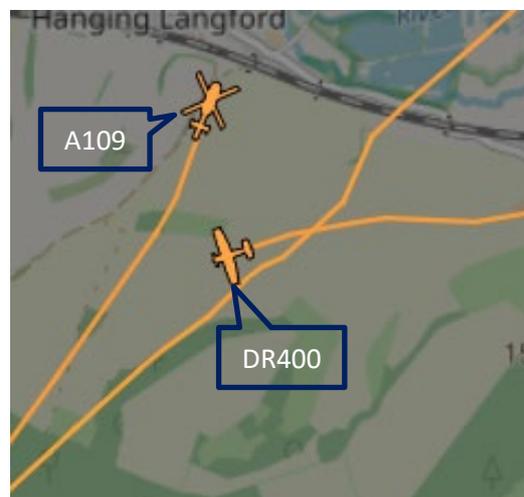
Figure 3 – 1613:00

The A109 was seen in a turn to the left at 1613:10 as described in the pilot's report, after the DR400 passed behind it.
