AIRPROX REPORT No 2025176

Date: 10 Aug 2025 Time: 1005Z Position: 5049N 00016W Location: Shoreham

PART A: SUMMARY OF INFORMATION REPORTED TO UKAB

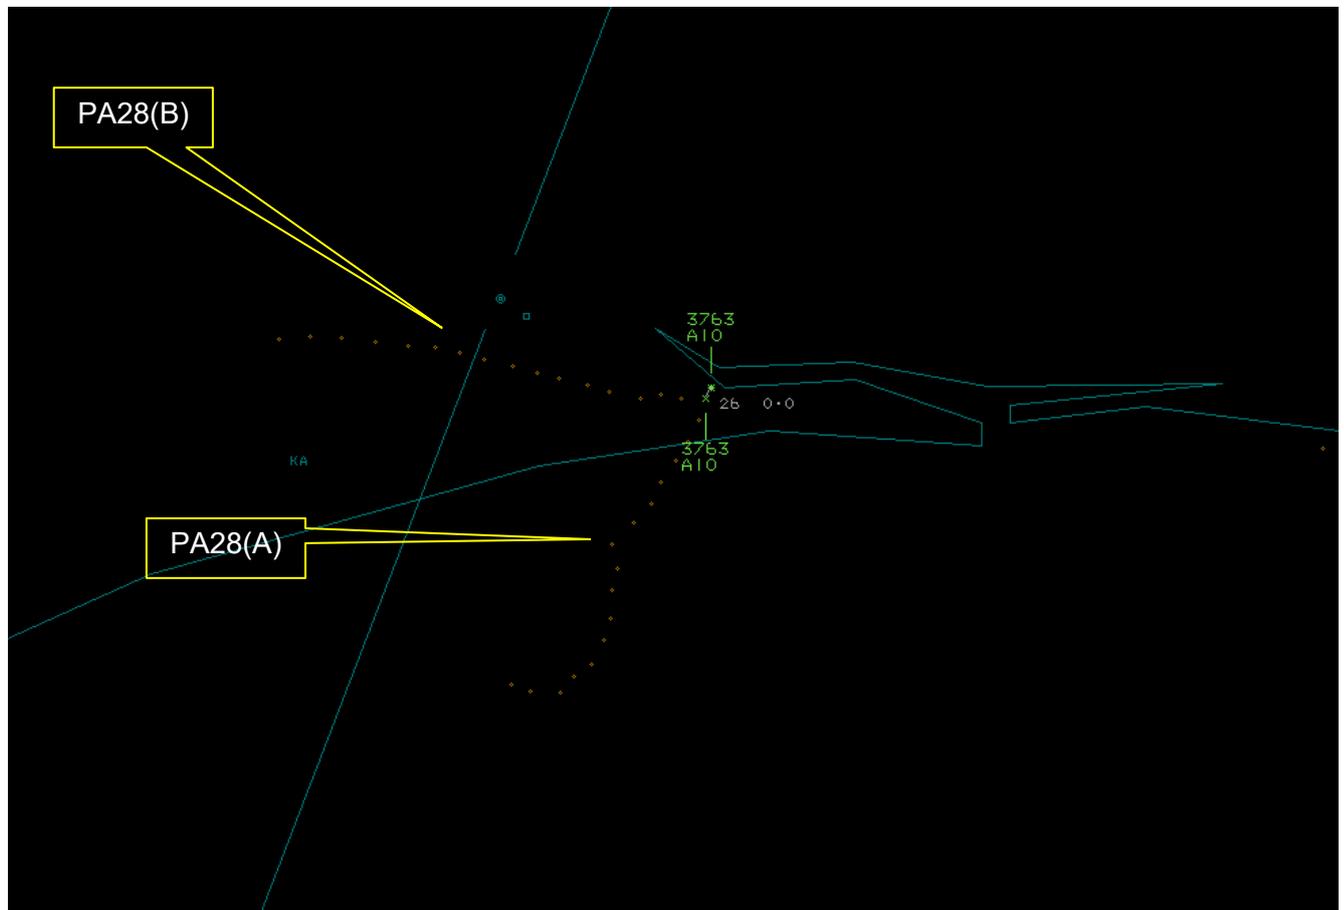
Figure 1: At CPA – 1004:46 0ft V/<0.1NM H

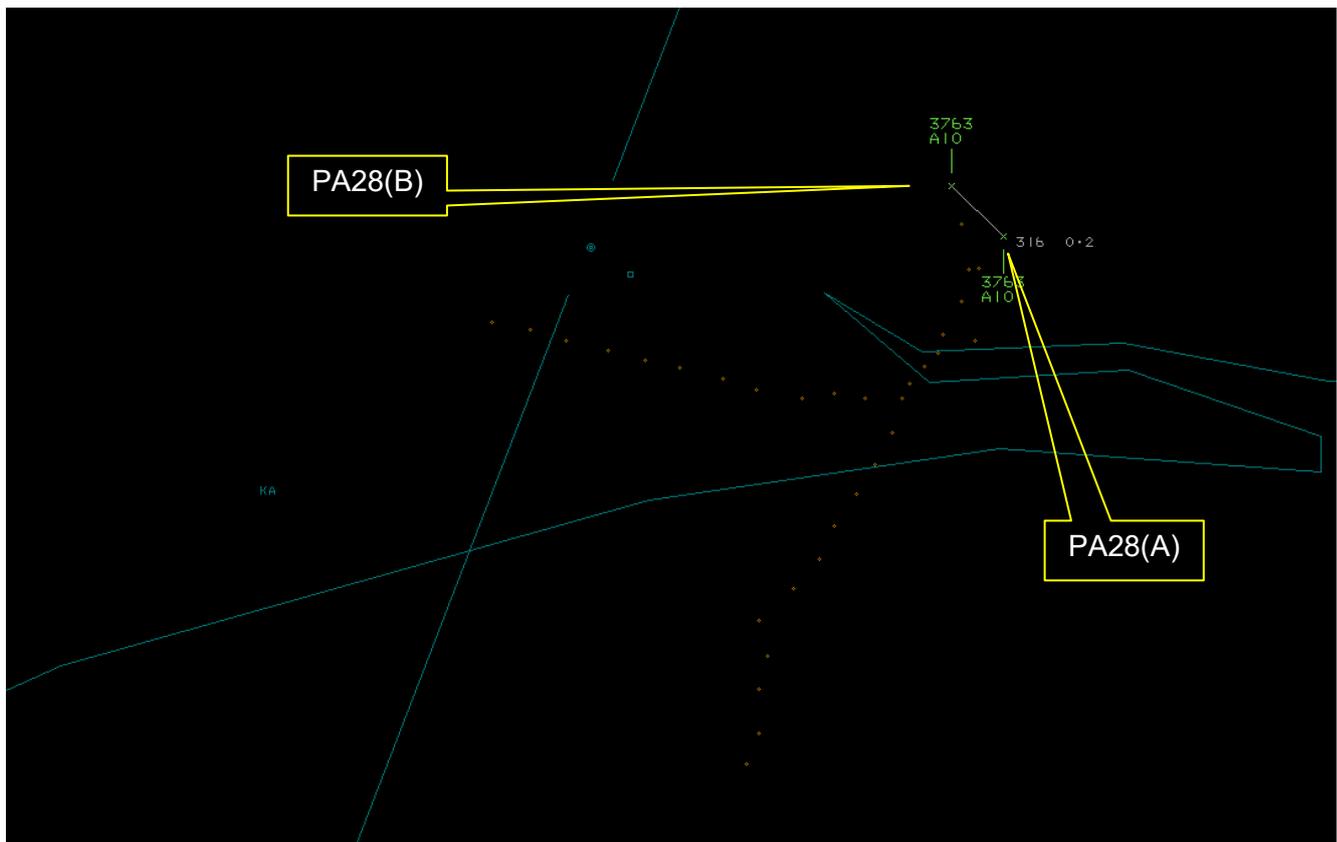
Figure 2: At CPA + 20sec (1005:06). PA28(B) appears to have passed through the 12 o'clock of PA28(A), turned back through the 12 o'clock and then sat to the west of PA28(A) paralleling their track.
