AIRPROX REPORT No 2025183

Date: 16 Aug 2025 Time: 1107Z Position: 5347N 00114W Location: ivo Sherburn-In-Elmet Airfield

PART A: SUMMARY OF INFORMATION REPORTED TO UKAB

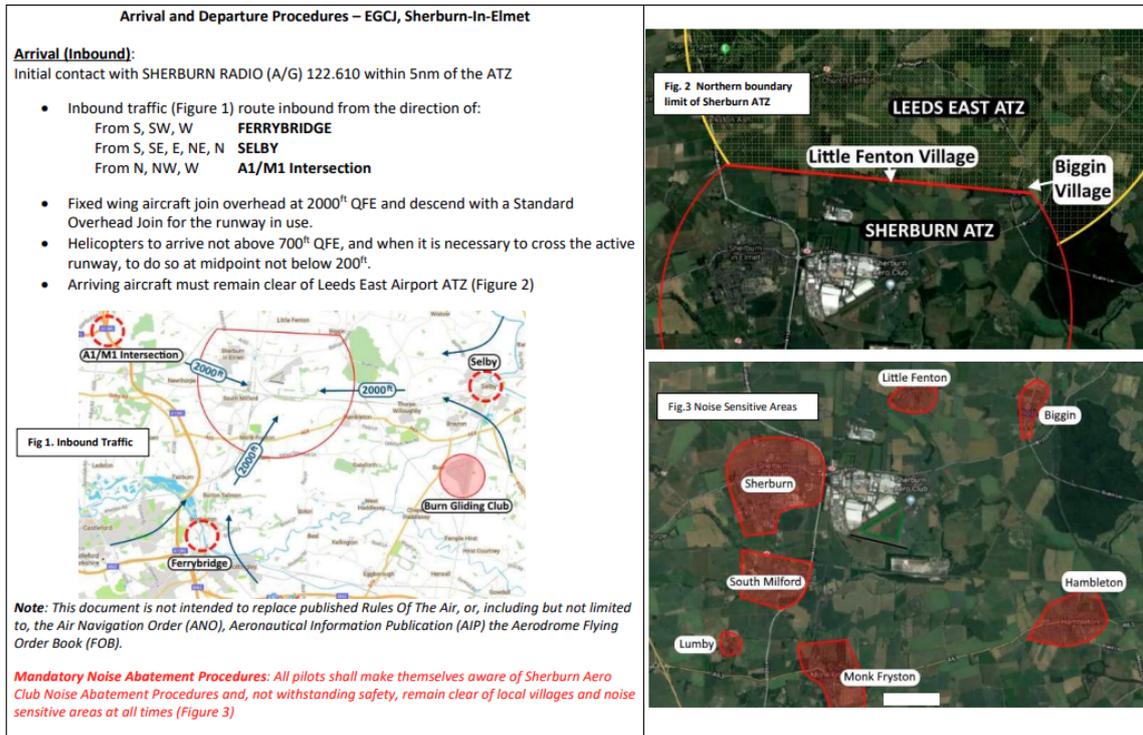
Figure 1 – Arrival procedures as published on the Sherburn Aeroclub website indicates a Standard Overhead Join (no circuit direction mentioned).

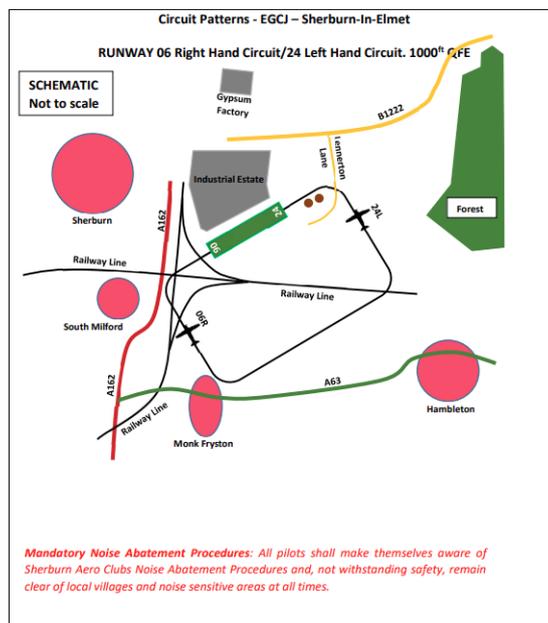
Figure 2 - RW06 depicted as right-hand

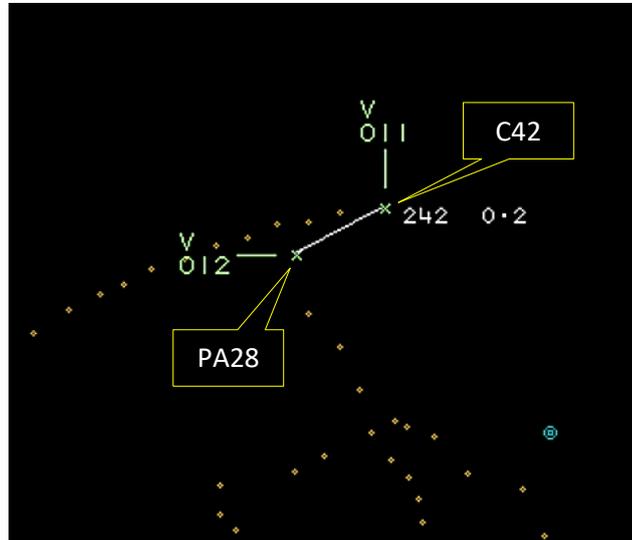
An analysis of the NATS radar replay was undertaken and both aircraft were identified using Mode S data. CPA was assessed to have occurred at 1107:02 with 100ft vertical and 0.2NM lateral separation (Figure 4).

Figure 4 – Time 1107:02 CPA 100ft vertical and 0.2NM lateral separation

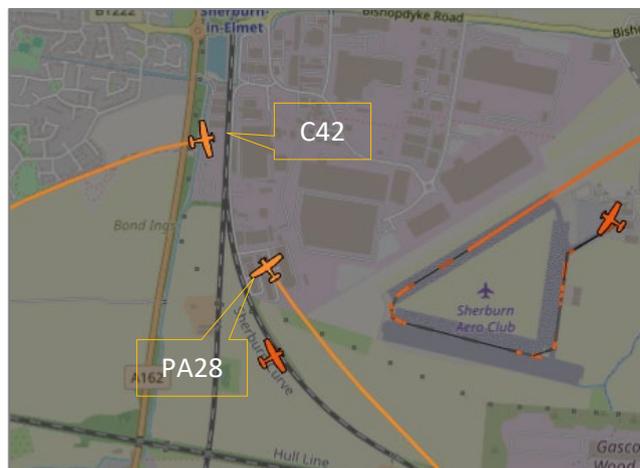
Further analysis of aircraft tracking software was undertaken and both aircraft were identified using ADS-B data sources. The C42 was seen to pass in front of the PA28 at 1106:50 (Figure 5).

Figure 5 – Time 1106:50 300ft vertical and 0.4NM lateral separation.

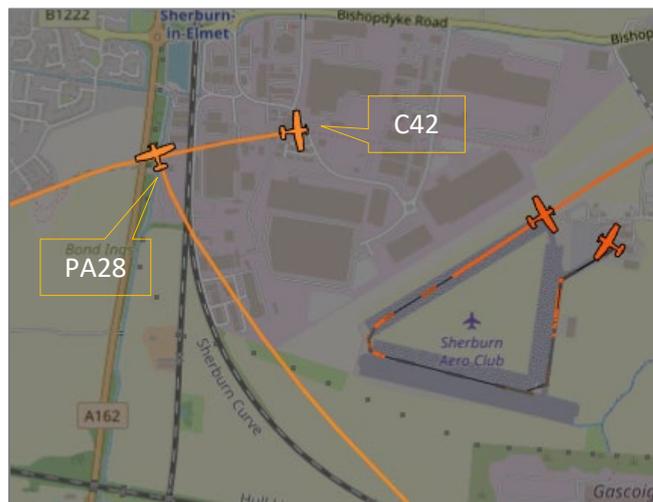
At 1107 the PA28 was seen to descend behind the C42 (Figure 6).

Figure 6 – Time 1107
