AIRPROX REPORT No 2025178

Date: 10 Aug 2025 Time: 1035Z Position: 5227N 00110E Location: E of Tibenham Airfield

PART A: SUMMARY OF INFORMATION REPORTED TO UKAB

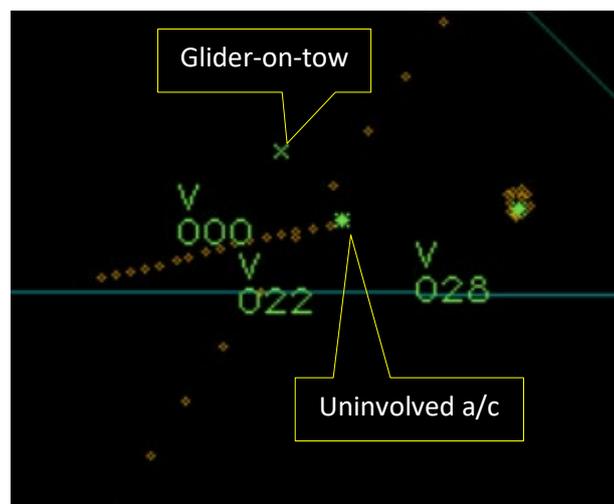
Figure 1 – Time 1033:22

An analysis of the NATS radar replay was undertaken and the glider-on-tow was positively identified using Mode S data, first seen at 1033:22 (Figure 1).

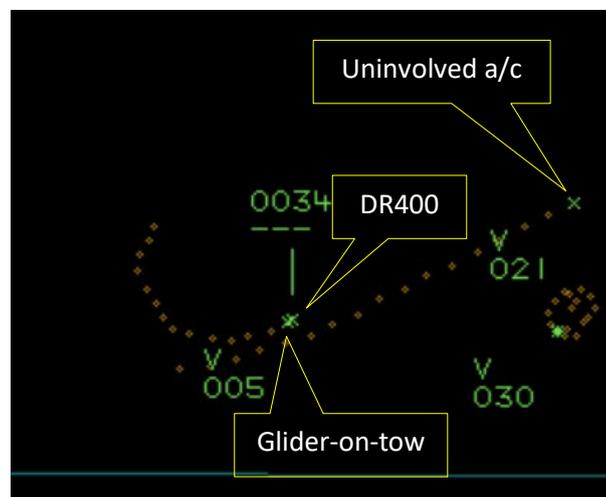
Figure 2 – Time 1034:15

At 1034:15 the DR400 was seen on radar, identified by the 'glider towing' squawk 0034 (Figure 2).
