**AIRPROX REPORT No 2025173**

Date: 05 Aug 2025 Time: 1059Z Position: 5117N 00015W Location: NW of Walton-on-the-Hill

**PART A: SUMMARY OF INFORMATION REPORTED TO UKAB**

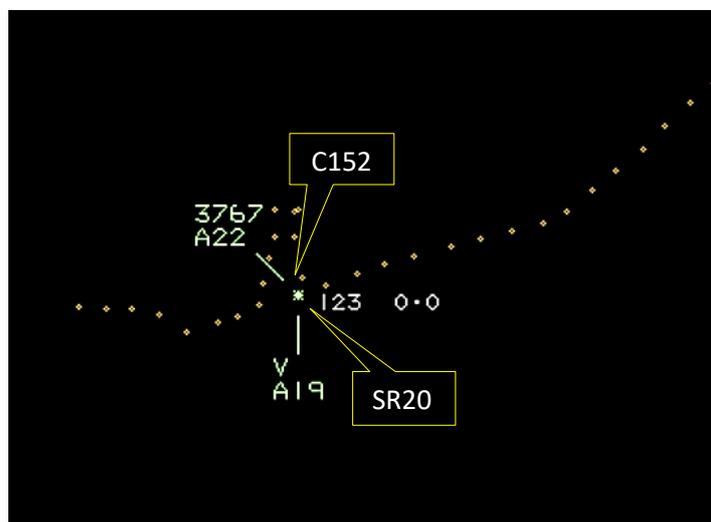
Fig 1 - Time 1059:18

CPA was assessed to have occurred at 1059:18 with less than 0.1NM lateral and 300ft vertical separation (Figure 1).
