AIRPROX REPORT No 2025192

Date: 29 Aug 2025 Time: 1039Z Position: 5215N 00123W Location: IVO Southam

PART A: SUMMARY OF INFORMATION REPORTED TO UKAB

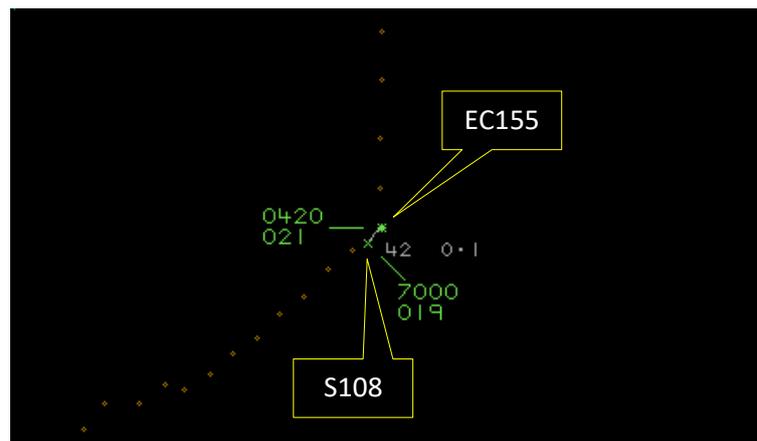
Figure 1 – Aircraft positions at 1038:46 (1sec before CPA)

An analysis of the NATS radar replay was undertaken and both aircraft could be positively identified from Mode S data. The S108, but not the EC155, was observed by reference to ADS-B data sources. The pilot of the EC155 kindly supplied GPS track data for their flight. The moment of CPA was assessed to have occurred between the radar sweeps at 1038:46 and 1038:50 (Figures 1 and 2). The diagram was constructed and the separation at CPA determined by combining the data sources.
