AIRPROX REPORT No 2025186

Date: 14 Aug 2025 Time: 1431Z Position: 5141N 00034W Location: Chesham

PART A: SUMMARY OF INFORMATION REPORTED TO UKAB

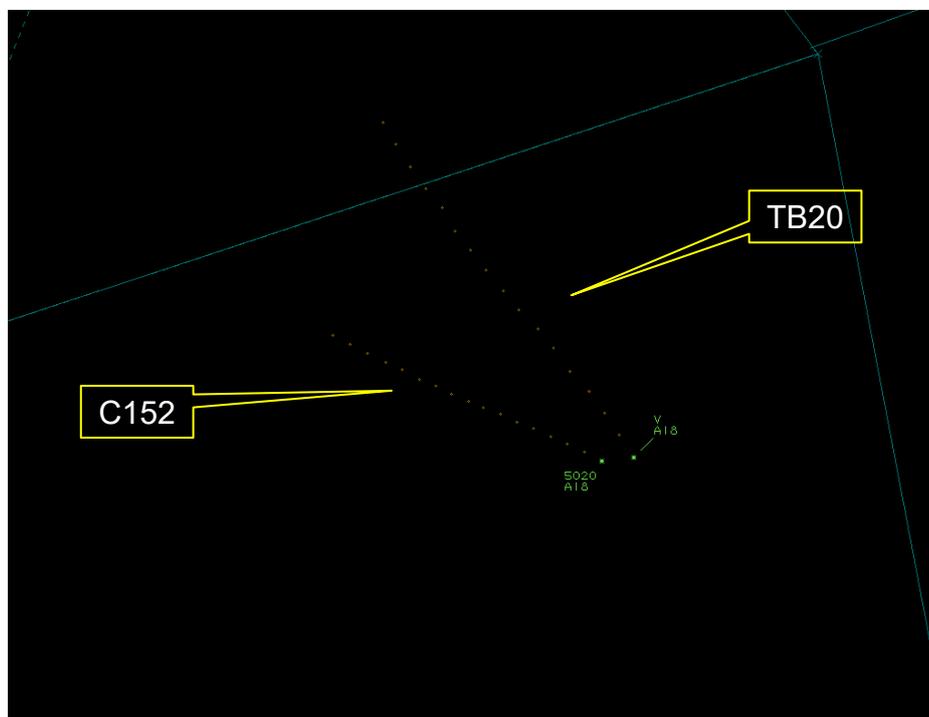
Figure 1: At CPA – 1431:14

At the time of the transmission from the unrelated aircraft, 1430:54, the TB20 had been 0.5NM north of the C152, 400ft above, with both aircraft displaying in level flight. As the transmission with the unrelated aircraft concluded, the confliction between the two aircraft had passed, with no further opportunity for the LARS controller to issue pertinent Traffic Information to the pilot of the C152, with CAP774 detailing there was no requirement for the controller to have monitored the flights.

Both aircraft were tracked via radar and identified through Mode S data. The C152 and TB20 pilots shared an equal responsibility for collision avoidance and not to operate in such proximity to other
