AIRPROX REPORT No 2025180

Date: 10 Aug 2025 Time: 1432Z Position: 5135N 00151W Location: 2NM W Swindon

PART A: SUMMARY OF INFORMATION REPORTED TO UKAB

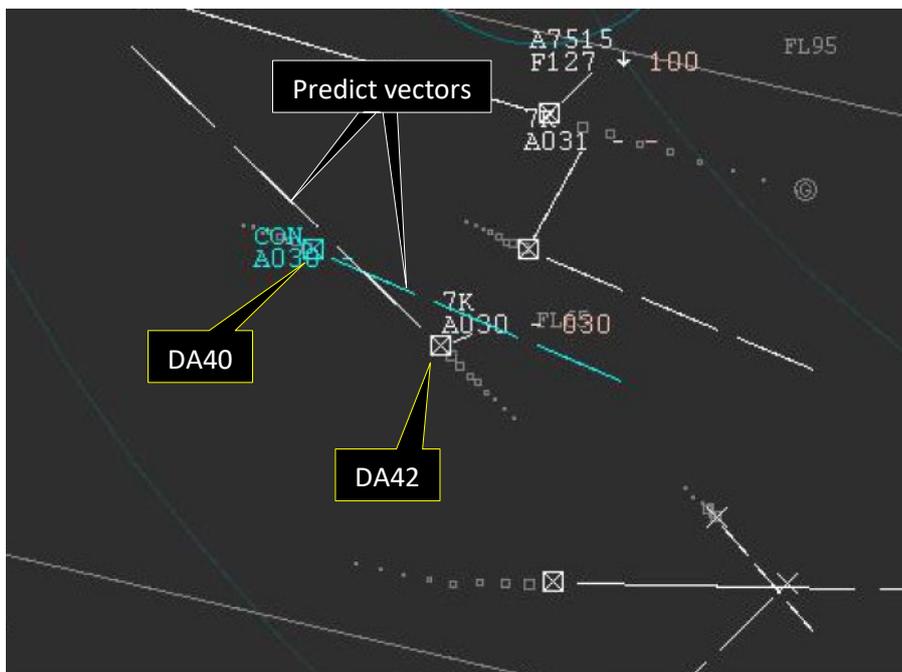
Figure 1 - 1431:32 (Labels displayed in cyan highlight aircraft with the Oxford conspicuity squawk selected)

1431:35 The controller selected the predict-vectors (Figure 1) as [the pilot of an unrelated aircraft] called to leave the frequency to change to Cranfield approach. The pilot was told to standby.

The controller then transmitted "[DA40 C/S], *just a Basic Service but there's traffic 12 o'clock, 1-mile, opposite direction, indicating same level*".

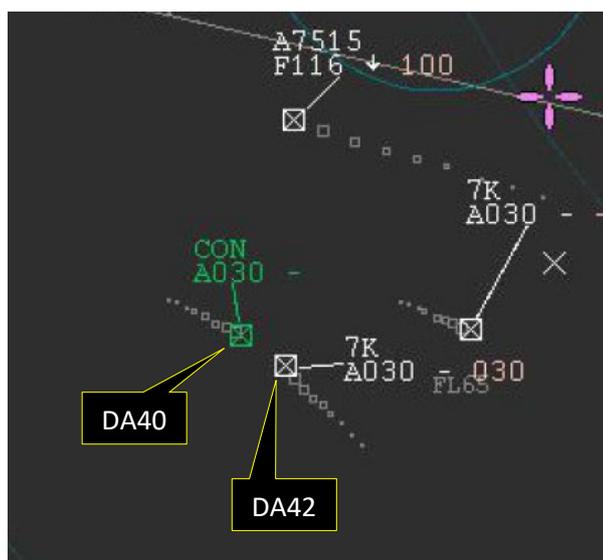
Figure 2 - 1432:00 (Labels displayed in green depict a selection made by the controller)

1432:00 "[DA40 C/S] *we're visual*" (Figure 2).

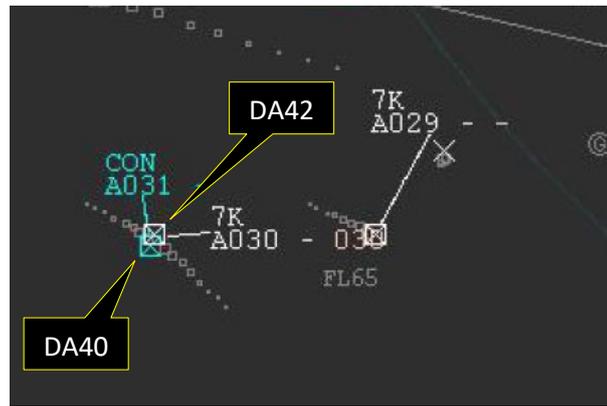
Figure 3 – CPA at 1432:11

The conflicting traffic had been in straight-and-level flight for the preceding 10min or so. No report of an Airprox was made on the RTF at the time. Just prior to the Closest Point of Approach, it looked like [the pilot of the DA40] may have turned a little to the right. (Figure 3).

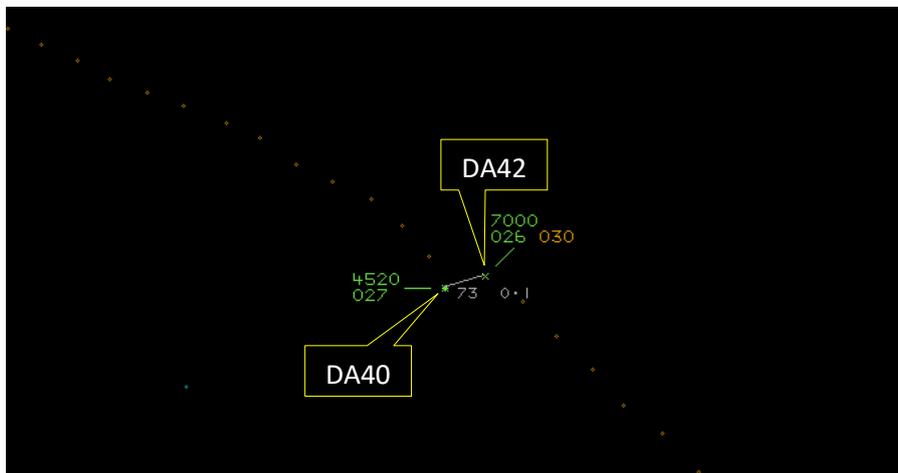
Figure 4 – CPA at 1432:11

An analysis of the NATS radar replay was undertaken and both aircraft could be positively identified from Mode S data (Figure 4). Neither aircraft was observed by reference to ADS-B data sources. The pilot of the DA42 kindly supplied GPS track data from their flight. It was by combining the data sources that the diagram was constructed and the separation at CPA determined.
