AIRPROX REPORT No 2025196

Date: 04 Sep 2025 Time: 1228Z Position: 5114N 00133W Location: ivo of Thruxton Airfield

PART A: SUMMARY OF INFORMATION REPORTED TO UKAB

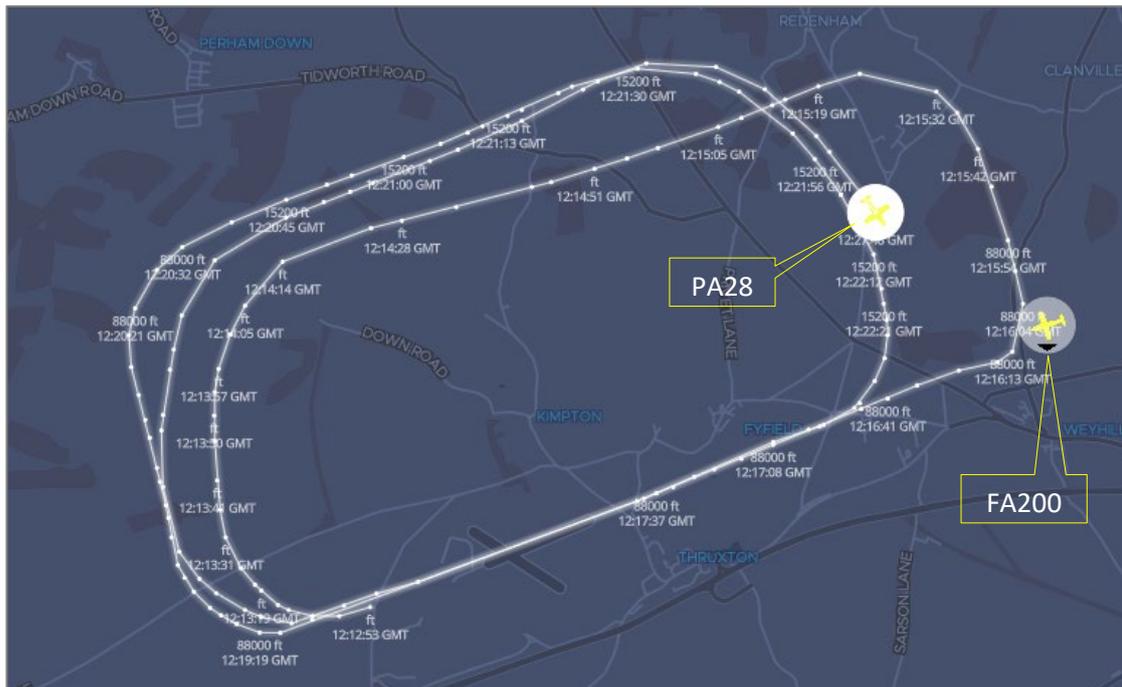
Figure 1 – Time ~1227:45

An analysis of aircraft tracking sources was undertaken and both the PA28 and the FA200 were detected using ADS-B data sources (Figure 1). Given that neither the PA28 pilot nor the FA200 pilot reported having additional electronic conspicuity equipment fitted to their aircraft, it was assessed that the ADS-B data for both was likely emitted from a working transponder, even though there were no transponder Modes A,C, or S detected at the time of this Airprox. It was acknowledged that, due to poor radar coverage, particularly at low level, neither aircraft was detected on the NATS radar replay at the time of the CPA, but the PA28 had been observed operating Mode S on an earlier flight.

Unfortunately, the altitude readouts for the PA28 were unreliable, mostly reading 0ft during the circuit prior to CPA, which was assessed to have occurred at 1227:58 by interpolation of positions viewed on ADS-B data sources. The lateral separation between the aircraft was recorded as 0.25NM but the vertical separation could not be established.
