**AIRPROX REPORT No 2025185**

Date: 15 Aug 2025 Time: 1253Z Position: 5346N 00114W Location: Sherburn-in-Elmet ATZ

**PART A: SUMMARY OF INFORMATION REPORTED TO UKAB**

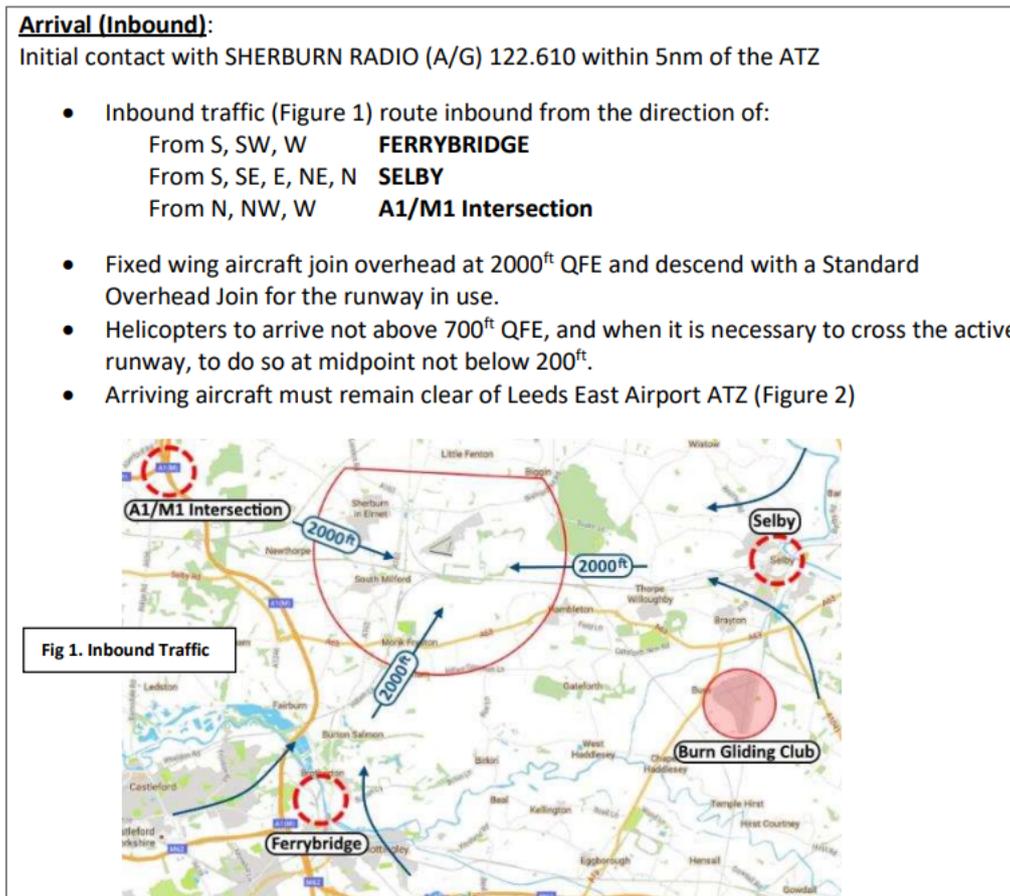
Figure 1

- a. Fixed wing aircraft to join overhead at 2000FT QFE and descend in accordance with the 'Standard Overhead Join' procedure.

The website for Sherburn-in-Elmet airfield provides the following diagram for arriving pilots:

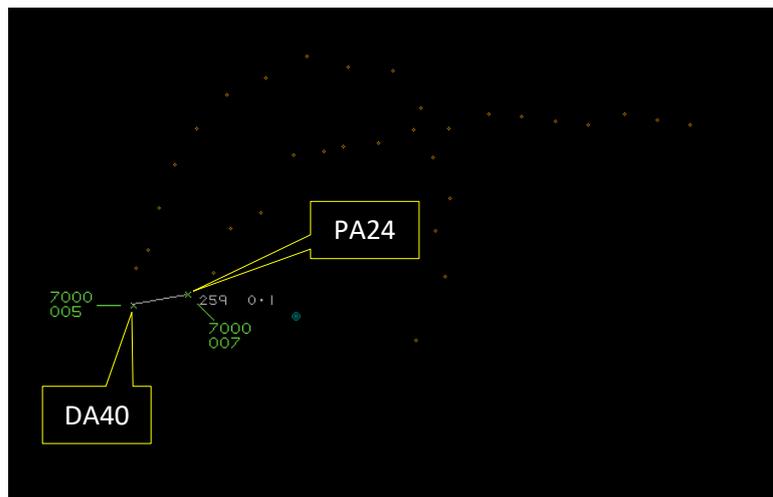
Whilst descending, a short sequence of radio traffic followed. The pilot of [the DA40] called descending deadside (the pilot of the PA24 was not aware of any previous calls from them). The Sherburn Radio AGO asked if [the pilot of the PA24] was visual with [the DA40]. They replied "negative, just starting crosswind 28", and [the pilot of the DA40] then called "visual [with the PA24] at 8 o'clock". At the point of that transmission, both aircraft were crosswind RW28 at 1000ft. [The DA40] had 50ft separation from their right, slightly above and half-a-fuselage ahead, at 2 o'clock. Both aircraft were flying a parallel course.

Figure 1 – The pilots of the PA24 and DA40 had been on parallel tracks at 1252:46

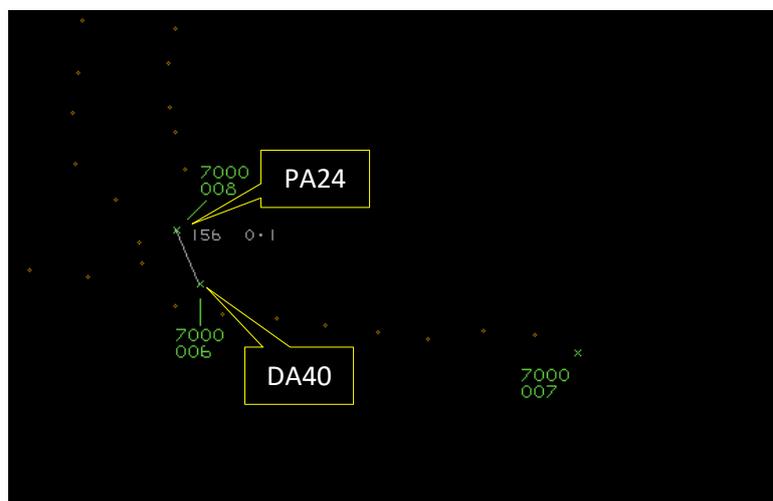
As the DA40 turned across the nose of the PA24, the aircraft converged rapidly and alarmingly. Passing their nose, they would estimate a separation of 50ft [ahead], and 50ft below. The distance may be an estimate, but this was terribly close. They made an exclamatory radio transmission, and then turned downwind. Downwind, [there was an uninvolved PA28], then [the DA40], then their PA24 and then [another uninvolved PA28]. They called "Sherburn Radio [PA24 C/S], downwind 28 left, number 3". They were not aware of any other downwind calls.

Figure 2 – CPA at 1253:22

the proximity. The Board agreed that there had been a risk of collision (**CF10**) and assigned Risk Category B to this event.

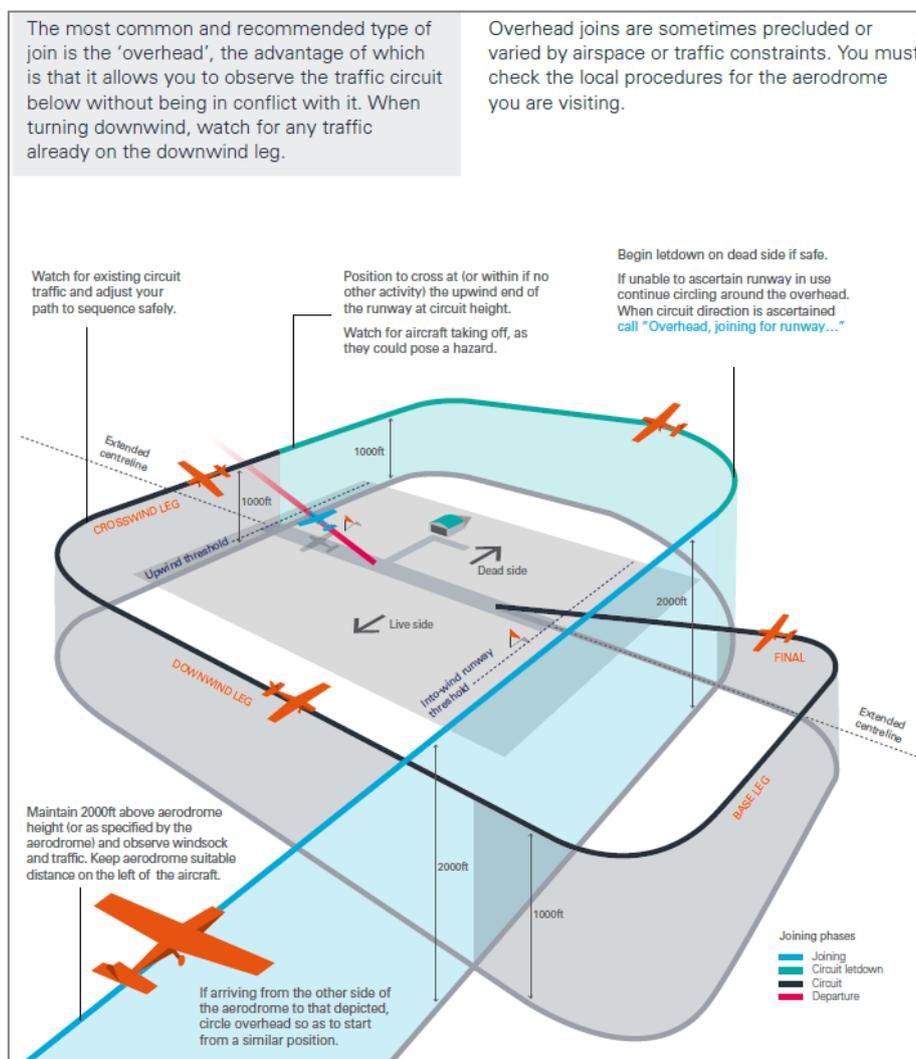
Members agreed that the pilot of the PA24 had perhaps misunderstood the AGO's stated 'preference' for an overhead join, and emphasised that it had been their responsibility to have conformed with Sherburn airfield's local procedures in addition to those specified in the UK AIP. As the pilot of the PA24 had not performed an overhead join, it was agreed that they had not complied with the aforementioned published procedures (CF1) and had not executed their join to the circuit correctly (CF3). This, members suggested, had also restricted their opportunity to have gathered situational awareness of, and to have sighted, other traffic in the circuit. The correct execution of a typical Overhead Join is shown in Figure 3.

Figure 3 – A diagram of a typical Overhead Join as shown in CAP1535 'The Skyway Code'
