AIRPROX REPORT No 2025175

Date: 02 Aug 2025 Time: 1200Z Position: 5350N 00111W Location: Leeds East ATZ

PART A: SUMMARY OF INFORMATION REPORTED TO UKAB

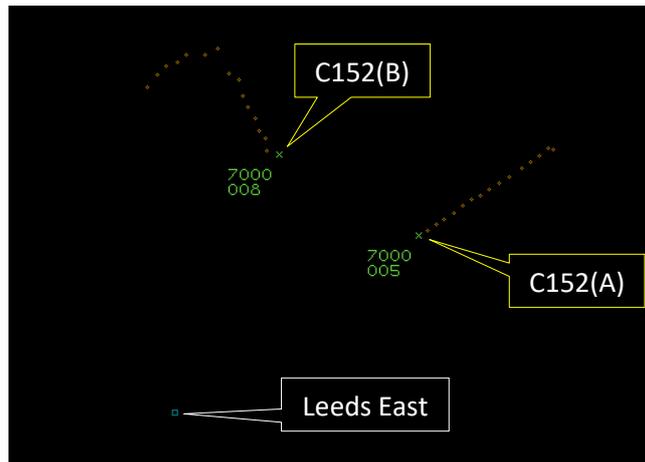
Figure 1

An analysis of the NATS radar replay was undertaken and both aircraft could be positively identified from Mode S data (Figure 1). The C152(B), but not C152(A), was observed by reference to ADS-B data sources.

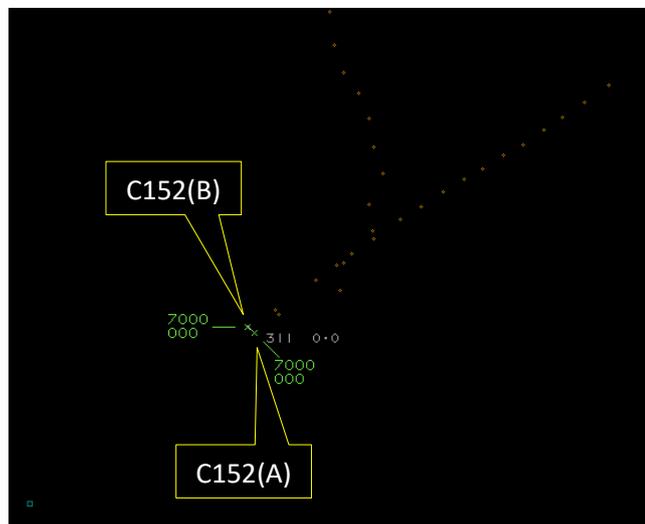
The aircraft were depicted on the radar replay as having flown at Flight Levels. A suitable correction was applied to determine their respective altitudes. The diagram was constructed and the separation at CPA determined from the radar data.

Figure 2 – CPA at 1200:06 (radar data)

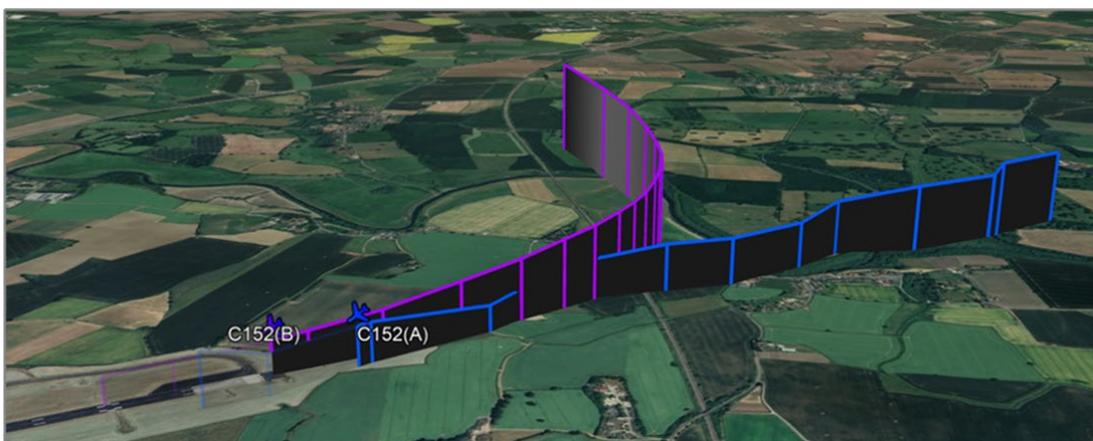
Figure 3 – Aircraft positions at the approximate time of CPA (ADS-B and MLAT data)
