AIRPROX REPORT No 2025244

Date: 02 Dec 2025 Time: 1052Z Position: 5210N 00000W Location: Toft

PART A: SUMMARY OF INFORMATION REPORTED TO UKAB

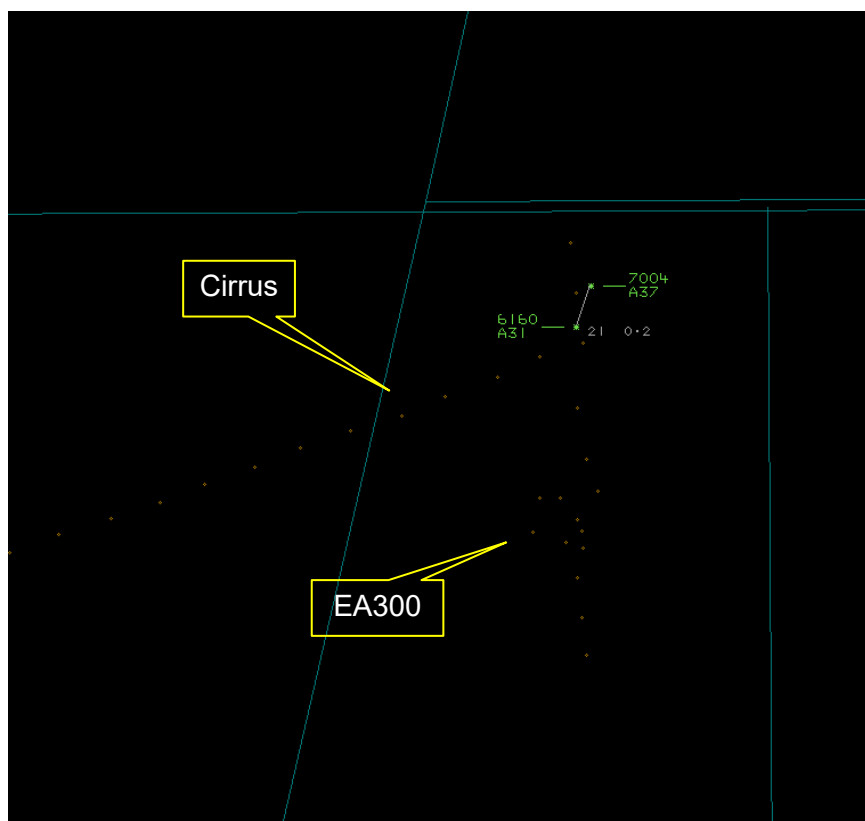
Figure 1: CPA minus 4 sec (1052:11).

Both aircraft were tracked by radar and identified via Mode S data.

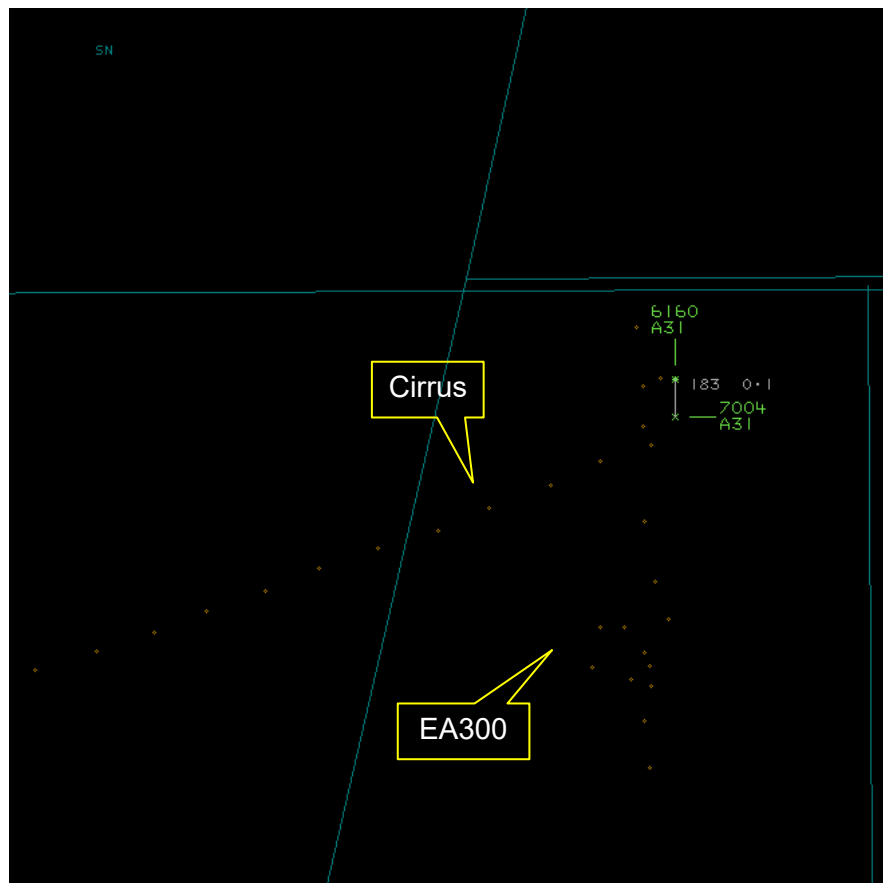
Figure 2: At CPA – 1052:15.

The Cirrus and EA300 pilots shared an equal responsibility for collision avoidance and not to operate in such proximity to other aircraft as to create a collision hazard.³

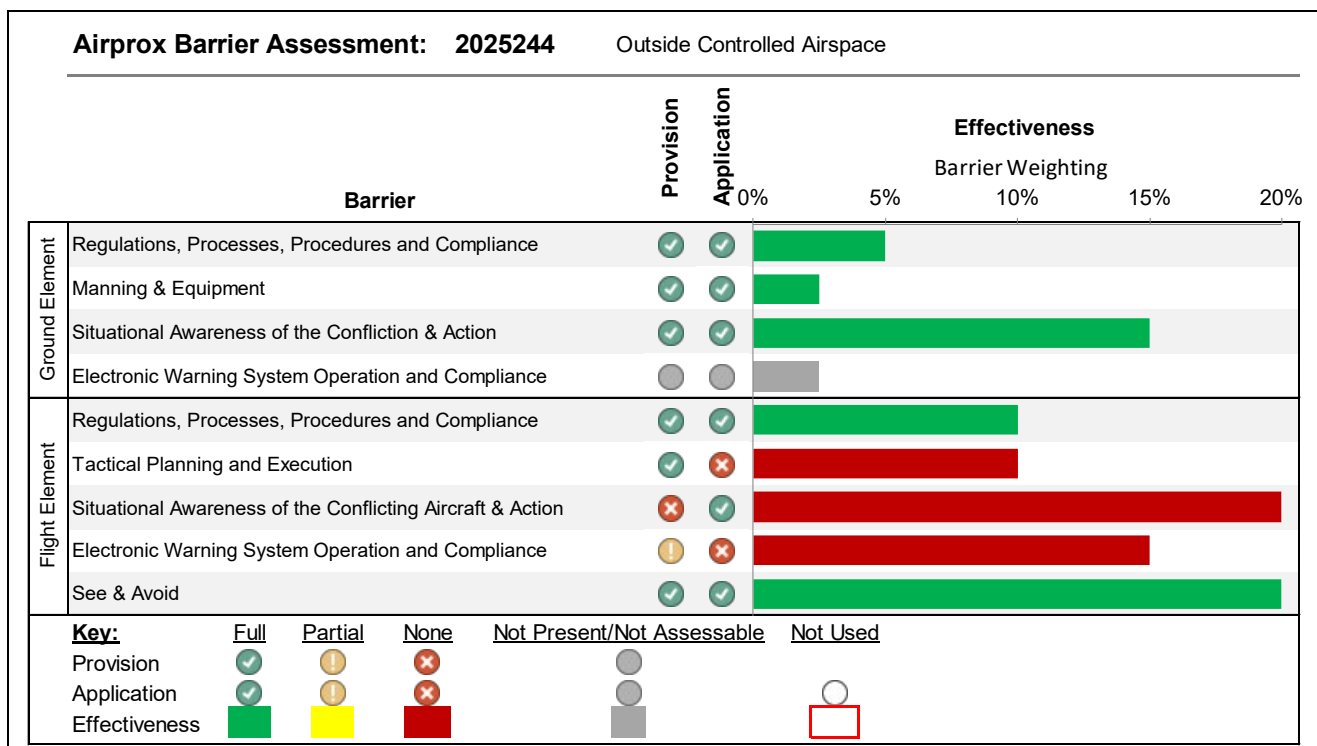
Tactical Planning and Execution was assessed as **ineffective** because, having become aware of the presence of the EA300, the Cirrus pilot had not taken sufficient avoiding action to remove any risk of collision, and the EA300 pilot could have chosen to take a Flight Information Service whilst performing their aerobatics exercise.

Situational Awareness of the Conflicting Aircraft and Action were assessed as **ineffective** because the EA300 pilot had no situational awareness of the presence of the Cirrus.

Electronic Warning System Operation and Compliance were assessed as **ineffective** because the equipment carried by the Cirrus had not registered any electronic emissions from the EA300.
