AIRPROX REPORT No 2025246

Date: 04 Dec 2025 Time: 1100Z Position: 5333N 00049E Location: 32NM E Grimsby

PART A: SUMMARY OF INFORMATION REPORTED TO UKAB

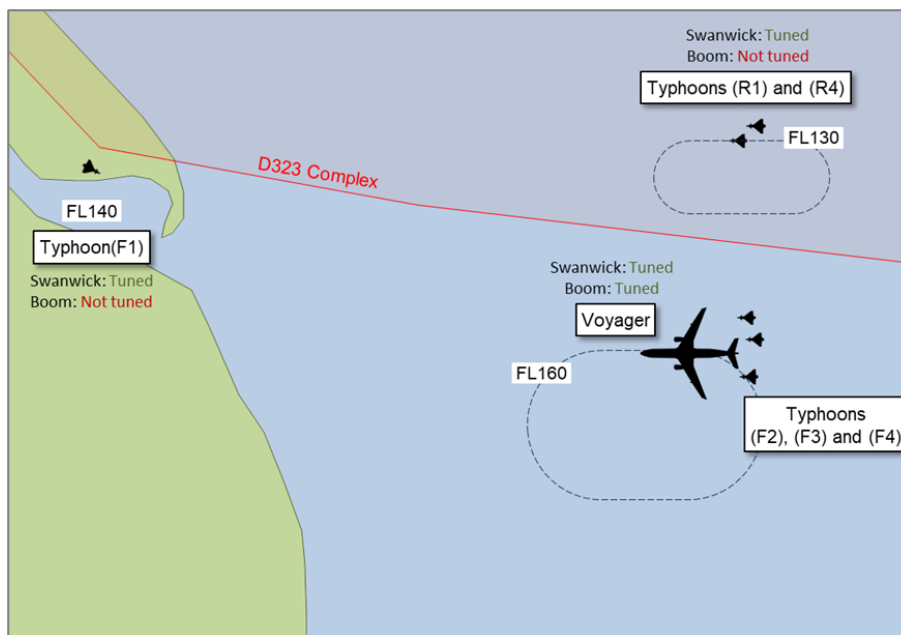
Figure 1 – A schematic representation of the aircraft positions at 1055

[Typhoon(F1)] was heading southbound to the west of D323 and was [tasked] to join for a [refuelling] slot ahead of [Typhoons (R1) and (R4)] but was geographically behind them for the tanker join.

[Typhoon(F formation)], a 3-ship receiving fuel from [the Voyager], arranged for [the Voyager crew] to remain in an orbit to collect [Typhoon(F1)] and agreed with [Typhoons (R1) and (R4)] for [Typhoon(F1)] to receive fuel ahead of them.

[Typhoons (R1) and (R4)], orbiting in the south of D323 waiting for clearance to depart, achieved radar-SA on [Typhoon(F1)] transiting to the west of D323. [They were] assigned FL130 by Swanwick Military and were informed they were number 2 to join behind [Typhoon(F1)].

The [Voyager] was maintaining a left-hand orbit on request of [Typhoon(F formation)] to allow [Typhoon(F1)] to join sooner, at FL160. [They were] assigned the block FL140-170 in the towline (FL140 and FL150 were the designated joining levels). [Typhoon(H formation)] was departing, [Typhoon(F formation)] was receiving. The joining level (FL150) was clear, but this had not been communicated to Swanwick Military.

Time:	Amplification:
1055:26	
[Typhoons (R1) and (R4)] departed D323 at FL130.	[Typhoons (R1) and (R4)] were allocated FL130 due to Swanwick's perception that the joining level was not clear, and that [Typhoon(F1)] was joining ahead of them.
1055:46	
Swanwick informed [Typhoon(R1)] that [Typhoon(F1)] will be refuelling ahead of [Typhoons (R1) and (R4)].	[Typhoon(R1)] perception: [Typhoon(F1)] was west of the towline but they no longer had on-board, or off-board, SA on [Typhoon(F1)].

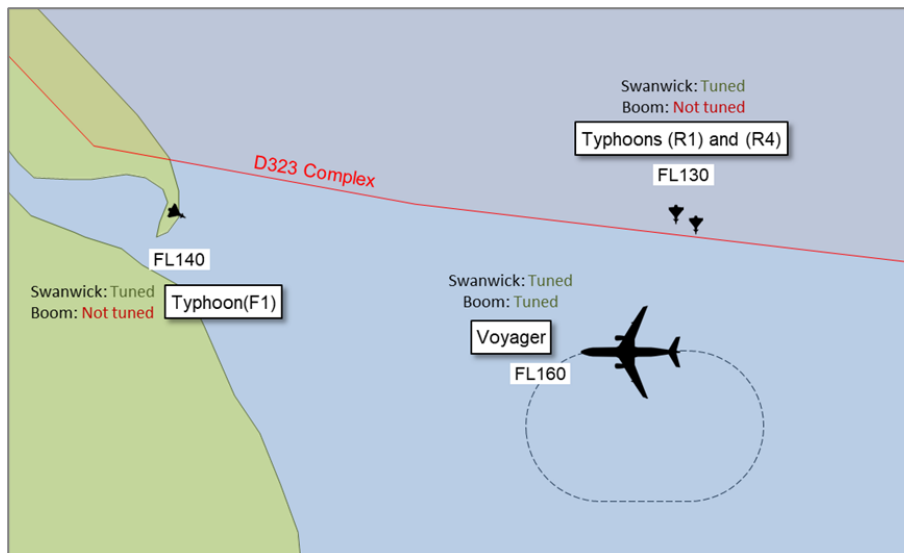
Figure 2 – A schematic representation of the aircraft positions at ~1056

<p>Reality: [Typhoon(F1)] was west of towline. No RV communications were received from the [Voyager crew] by [Typhoon(R1)] on the Swanwick frequency.</p>
<p>1056:52</p> <p>Swanwick frequency: [Typhoon(R1)] called "<i>visual</i>" with the Voyager. Swanwick instructed [Typhoons (R1) and (R4)] to "<i>Squawk standby</i>" and "<i>Push Boom</i>".</p>	<p>[Typhoon(R1)]'s perception: [Typhoon(F1)] was no factor.</p> <p>Reality: [Typhoon(F1)] was no <i>immediate</i> factor, but [Typhoon(F1)] was allocated (and was maintaining) FL140 by Swanwick.</p>
<p>1057:00 (approx.)</p> <p>Boom frequency: [Typhoon(R1)]: "<i>Request join</i>", and the [Voyager] crew subsequently cleared [Typhoon(R1)] to join.</p> <p>[Typhoon(R1)] questioned if [Typhoon(F1)] was joining ahead. The Voyager crew responded "<i>at some point yes, but not at the moment</i>".</p> <p>[Typhoon(R1)]: "<i>Elevating for join</i>".</p>

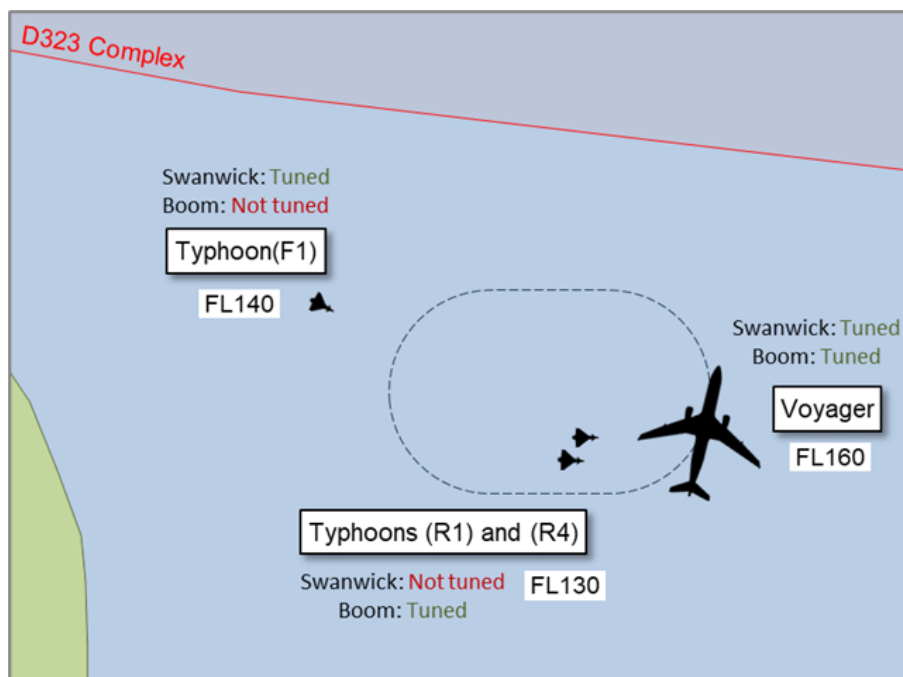
Figure 3 – A schematic representation of the aircraft positions at ~1057

<p>1057:20</p> <p>Swanwick frequency: [Typhoon(F1)]: "[Typhoon(F1)] <i>confirm, am I ahead of [Typhoon(R1)] or behind?</i>"</p> <p>Swanwick responded: "[Typhoon(R1)] <i>joining the tanker now but they are 1000ft below you</i>".</p>	<p>No RV communications were received from the Voyager crew by [Typhoon(F1)] on the Swanwick frequency.</p>
---	---

<p>“[Typhoon(F1)] <i>copied, visual, switching Boom</i>”.</p>	
<p>Concurrently, on Boom frequency: The [Voyager crew] cancelled [Typhoon (R1) and (R4)]’s joining clearance and informed them to “<i>maintain FL150</i>”.</p> <p>[Typhoon(R1)] elected to descend the 2-ship to FL130.</p> <p>[Typhoons (R1) and (R4)] maintained FL130 in 1NM trail behind the [Voyager] and informed the [Voyager crew] that FL130 was their previously assigned level.</p> <p>The [Voyager crew] did not respond to the radio call that [Typhoons (R1) and (R4)] were now maintaining FL130.</p>	<p>The [Voyager crew’s] perception: [Typhoons (R1) and (R4)] were joining ahead of [Typhoon(F1)], and their previous level was FL150.</p> <p>Reality: [Typhoons (R1) and (R4)] were joining at FL130.</p> <p>[Typhoon(R1)]’s perception: The [Voyager crew] had erroneously called FL150 and elected to descend to the level previously cleared with Swanwick.</p> <p>Reality: Assessed as a correct perception.</p> <p>The message from [Typhoon(R1)] to the [Voyager crew] that they were maintaining FL130 was the first transmission heard by [Typhoon(F1)] on the Boom frequency.</p>

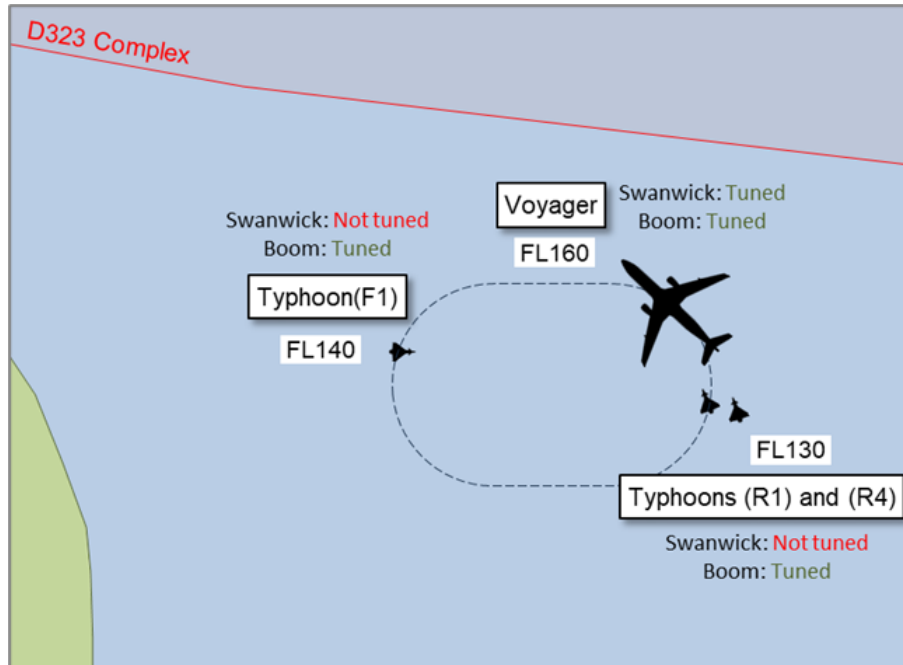
Figure 4 – A schematic representation of the aircraft positions at ~1058

<p>1057:58</p> <p>[Typhoon(F1)] called visual with the [Voyager] and [Typhoons (R1) and (R4)], but the [Voyager crew] did not acknowledge, or provide a clearance to join at that stage.</p>	<p>All aircraft were now on a common frequency: [Typhoons (R1), (R4) and (F1)] were listening out on Boom, but not Swanwick. The [Voyager crew] was listening on both Swanwick and Boom.</p>
<p>1058:20</p> <p>[Typhoon(F formation)] to [Typhoon(R1)]: “[R1] are you happy for [F1] to get on the</p>

hoses ahead, in front of you guys? Have you got the fuel for that?

[Typhoon(R1)]: *"Affirm, I'm waiting at FL130 to let [F1] ahead"*.

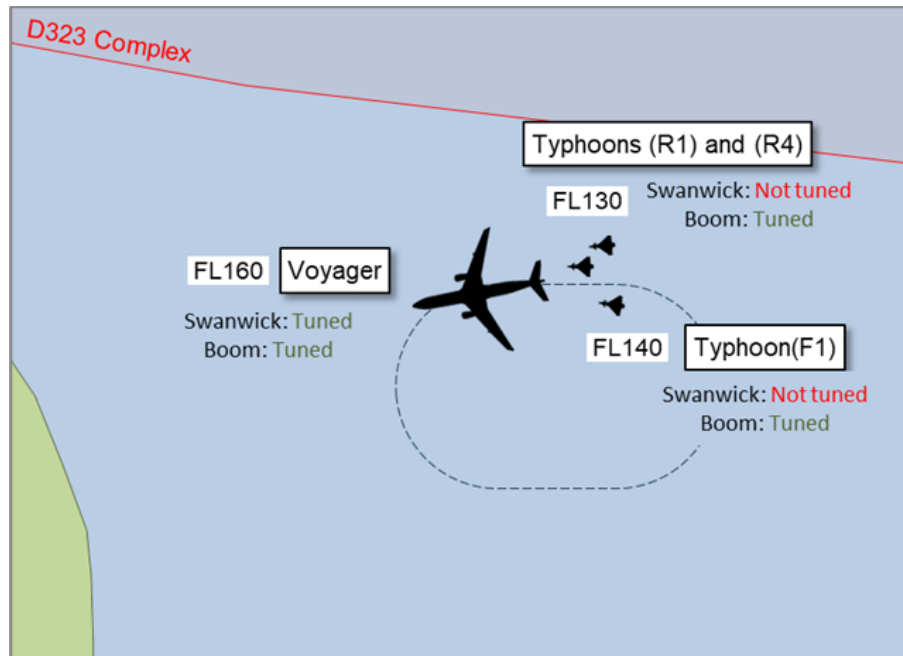
Figure 5 – A schematic representation of the aircraft positions at ~1059

[Typhoon(R1)] became visual with [Typhoon(F1)] at a visually judged separation of 300ft. [Typhoon(R1)] took avoiding action. [Typhoon(F1)] was unaware of [Typhoon(R1)]'s proximity, although their LHW (Low Height Warner) was activated and their RadAlt momentarily read 740ft.

- The Voyager crew did not communicate to Swanwick that the joining level (FL150) was clear, which led to the Swanwick controller assigning unexpected altitude blocks for [Typhoon(F1)] (FL140) and [Typhoon(R1)] (FL130) for their joins.

- [Typhoon(R formation)] was, initially, two-dimensionally ahead of [Typhoon(F1)] for the [refuelling] join but was assigned number two in the join by Swanwick.

- Swanwick assigned [Typhoon(R1)] FL130, which was not one of the Voyager crew's assigned joining levels (which were FL140 and FL150).
- The Voyager crew never transmitted SOP RV communications to [Typhoon(R1)] or [Typhoon(F1)] on the Swanwick frequency, meaning the opportunity for the Swanwick controller and the Voyager crew to notice a difference in expected joining levels was missed.

- The Voyager crew did not fully understand which callsigns were joining at which Flight Levels.
- The Voyager crew incorrectly communicated to [Typhoon(R1)] that [Typhoon(F1)] was joining at FL150 and stated they can climb to FL140 "*when cleared*". [Typhoon(R1)] incorrectly assumed that [Typhoon(F1)] had clearance to elevate to FL150 with Swanwick. [Typhoon(R1)] and [Typhoon(F1)] were not listening out on the Swanwick frequency at that stage.

- It is normal procedure for [Typhoon pilots] to listen to either ATC or Boom frequency, [consequently], [Typhoon(R1)] perceived that [the communication highlighted in the previous point] had been a clearance to climb. [Typhoon(R1)] initiated a climb to FL140 based on that clearance and incorrect SA of [Typhoon(F1)]'s Flight Level from the Voyager crew.

- [Typhoon(F1)] did not hear [Typhoon(R1)]'s transmission informing the Boom frequency of their intention to climb to FL140.

1. Tanker crews communicating that the joining level is clear is important for aircraft to be assigned SOP altitudes for the join and help prevent SA breakdown.

2. Tanker RV communication on the controlling ATC frequency [provides] important SA for joining [pilots], as well as the controller.

3. Fighters should be permitted to join the tanker in the order that makes sense based on instantaneous geographical position, rather than the order in which they requested a join. Letting [pilots] ahead to conduct [refuelling] first can be arranged on the wing of the tanker, assuming no more than four aircraft will be waiting for [refuelling].
