**AIRPROX REPORT No 2025245**

Date: 02 Dec 2025 Time: 1141Z Position: 5200N 00156W Location: ivo Toddington

**PART A: SUMMARY OF INFORMATION REPORTED TO UKAB**

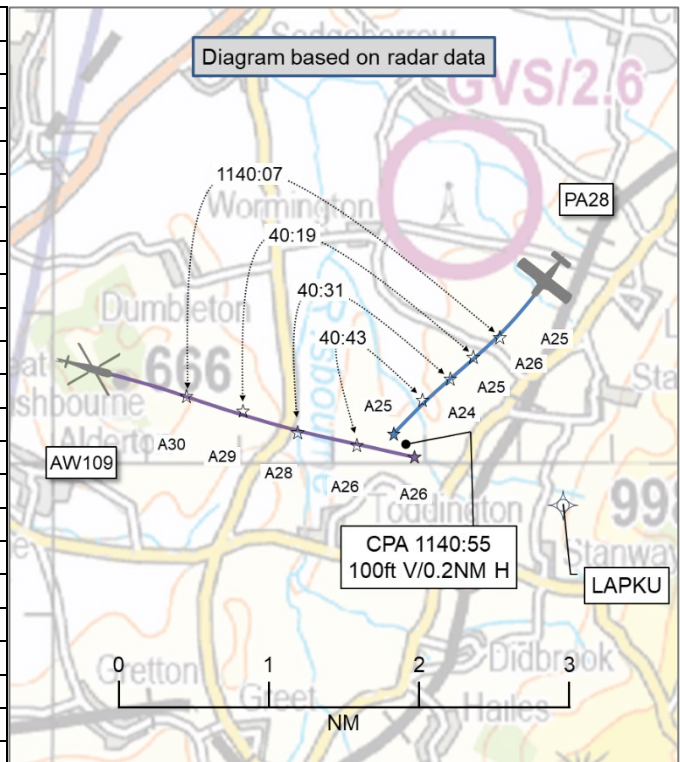
Recorded	Aircraft 1	Aircraft 2
Aircraft	PA28	AW109
Operator	Civ FW	Civ Comm
Airspace	London FIR	London FIR
Class	G	G
Rules	VFR	IFR
Service	Basic	Procedural
Provider	Gloster	Gloster
Altitude/FL	FL028	FL029
Transponder	A, C, S	A, C, S+
<b>Reported</b>		
Colours	White/blue	Blue/white
Lighting	Nav, strobes	Nav, anti-col, land
Conditions	VMC	VMC
Visibility	>10km	>10km
Altitude/FL	2500ft	2700ft
Altimeter	QNH (1001hPa)	QNH (NK hPa)
Heading	230°	080°
Speed	90kt	100kt
ACAS/TAS	Not fitted	TAS
Alert	N/A	None
<b>Separation at CPA</b>		
Reported	~100ft V/~1/4NM H	0ft V/100m H
Recorded	100ft V/0.2NM (370m) H

separation at CPA (0ft V/100m H) when compared with the separation from the radar replay (100ft V/370m H) which had been closer to the PA28 instructor's assessment of separation (100ft V/460m H) with less of a 'startle factor'. In the absence of a surveillance-based FIS or the aircraft being separated procedurally, only EC and lookout remained to mitigate collision risk. In this case, lookout from the PA28 crew achieved the aim but the Board was unable definitively to ascertain why the AW109 TAS had not alerted (CF5).
